Volume 1, Issue 1

November, 2008

NEW YORK STATE DEPARTMENT OF TRANSPORTATION

# Bridge Maintenance News

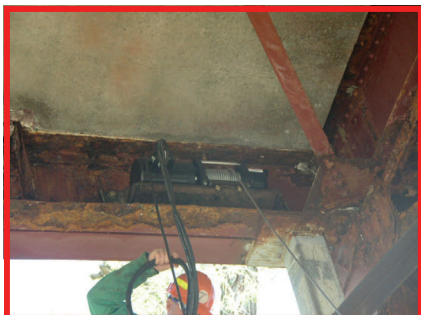
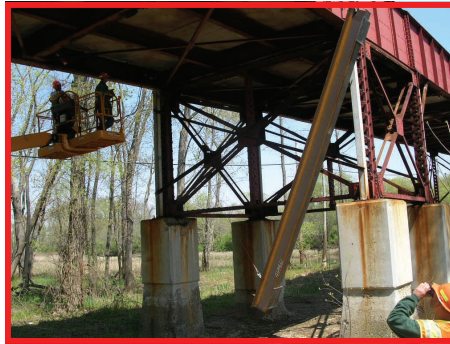
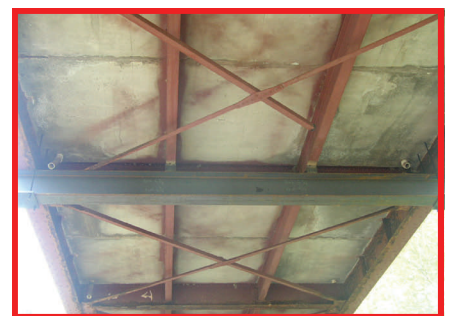
## Region 1: Vischer Ferry over the Back Channel of Mohawk River

Inspection initially found severe deterioration of 7 steel floorbeams and their connections to the girders. Repair of these floorbeams and the connections would be costly and time consuming and the bridge is currently to be replaced in 2010(?) so Structures wanted to keep it simple and relatively cheap.

Install new beam to be supported on its ends by the Thru Girder and carry the load of the floorbeam and stringers. They will be supported using 4 - ¾” threaded rods on each end and will be drawn up to the bottom of the girder and tightened down to a plate that is welded to the top

of the thru girder and the bottom of the new beam.

Each Beam had plates pre-welded to the bottom of both ends and the plates were drilled with 4 holes to accommodate the threaded rod. The beam had a steel angle welded on the top flange at one end which would act as a pivot point. A hole was drilled in the web where a clevis would be installed for the attachment of the crane cable. A D-Block was also welded to the top of the flange at the other end where a winch cable would be attached. 2 holes were drilled in the bridge deck on each side of the bridge to accommodate the interior threaded rods. Another hole was drilled in the deck on the winch side to anchor a pulley that carried the winch cable. Beams were hoisted into place using a combination of a 7- Ton Crane on the bridge deck and a 1 ton winch that sat on a seat which was anchored to the web of the girder under the deck. Once the crane and winch were readied the beam was dropped off on the deck. The crane cable was attached to the clevis and the beam was drawn up so that it was hanging vertically. It was swung out over the opposite side of the bridge from where the winch was anchored and slowly lowered down into location. The beam was lowered until the angle, welded on top of beam, rested on bottom flange of girder. The winch cable was then attached to the D-Block and then drew the lower end of the beam up into place as the upper end pivoted on the welded angle. Once the beam was in place workers on the deck placed a top plate on the girder’s top flange and then lowered the outer two rods down through the holes in the top and lower plates and hand tight-

ened nuts. Then the 2 interior rods were installed the same way except they went through the holes drilled in the deck. The nuts were cranked down and the same

procedure was done to the other end of beam. Once all the nuts were tightened down the cables were removed and plates and nuts were tack welded. Steel benches were then welded to the top of the new beam to support the stringers. Once all the bugs were worked out the crews were easily able to install 2 beams a day. After the initial 7 beams were installed 12 other locations mysteriously appeared to have similar deterioration and we returned a month later to address those locations.

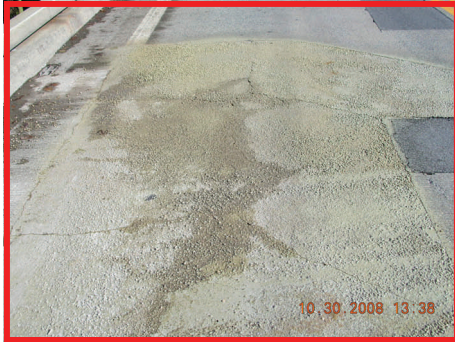
## Region 1 Uses BASF IC-2415, Polyurea

Field application: Wednesday, September 24, 2008 R1 Bridge crew placed BASF Polyurea at deck joint and in partial depth deck repair at BIN 1016020, US Rt. 20 over the Kinderhook Creek. BASF factory rep Peter Badger on site. All work performed as per manufacturers recommendation. The existing armored angle was left in place at the deck joint. The deck area was removed to the top mat of rebar prior to installing the Polyurea.

Results: The deck joint is holding up, but the partial depth deck repair has experienced considerable cracking. R1 did not report any pump clogging, as they were aware of the problems R2 had prior to performing this work.
