# POST-EARTHQUAKE SAFETY EVALUATION OF BRIDGES AND ROADS

Purdue University and  
Joint Transportation Research Board

Bridges and Damage Examples

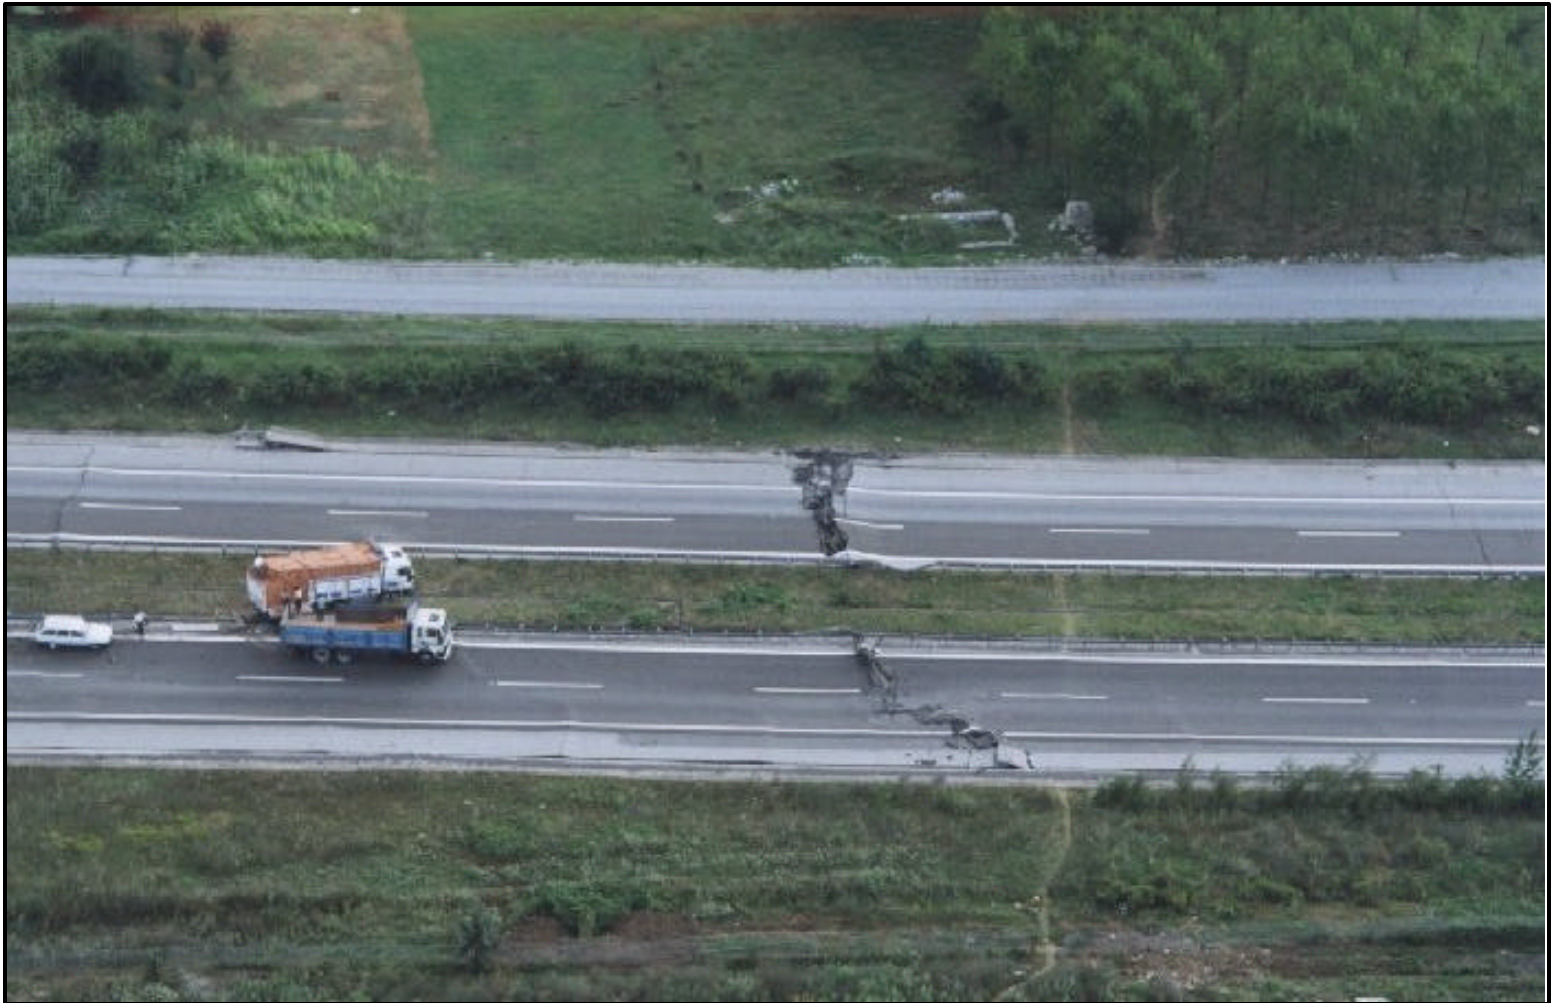
**Roadway closure/fault rupture after  
Izmit EQ 8/17/1999 (KOERI)  
Red Tag**

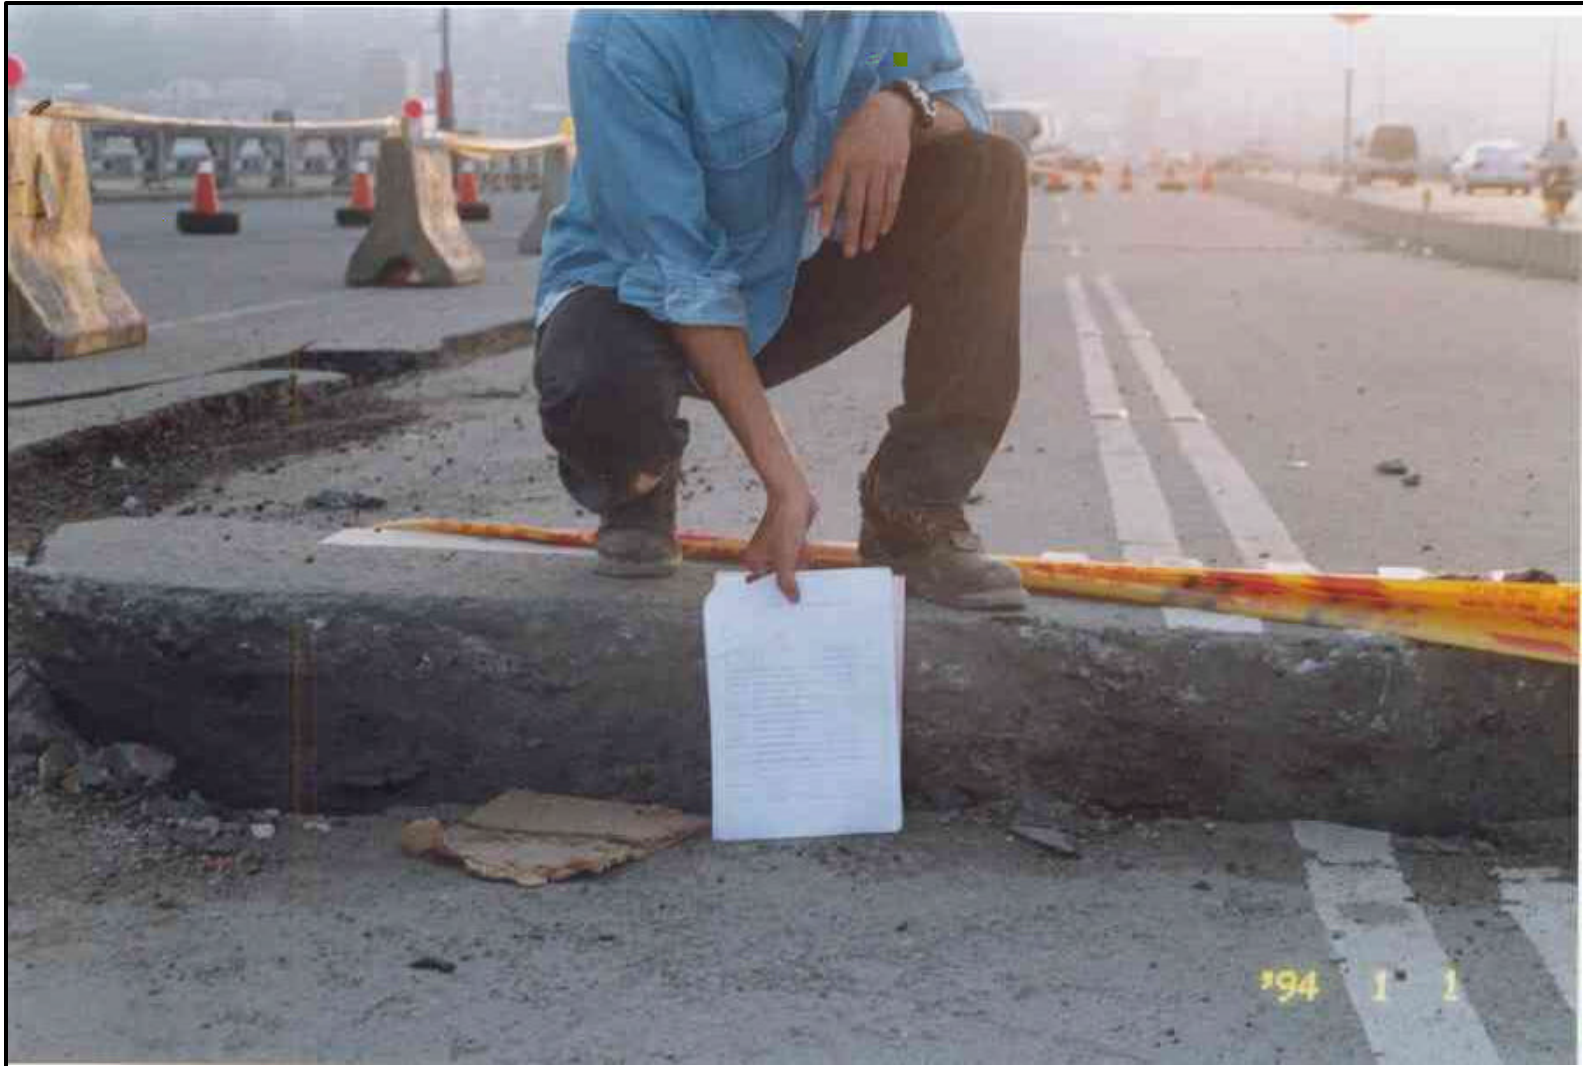
## Deck settlement > 6" (UCSD) Red Tag

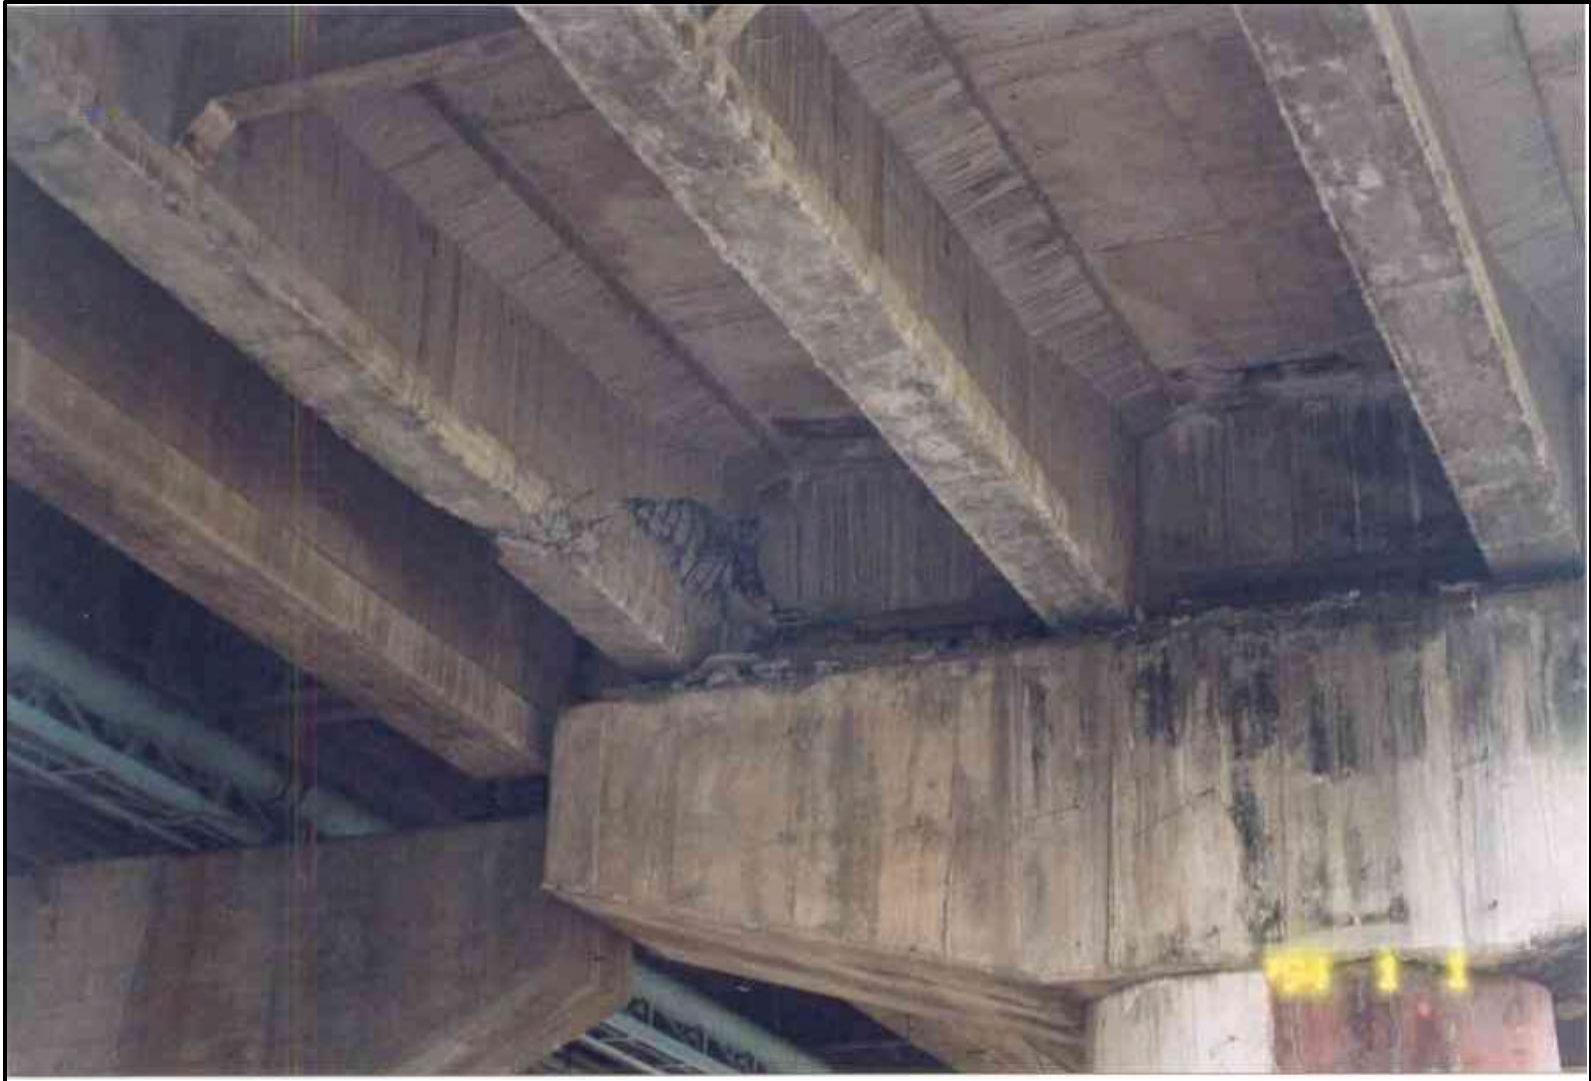
## **Shear cracks RC girder near support (UCSD)- Red Tag**

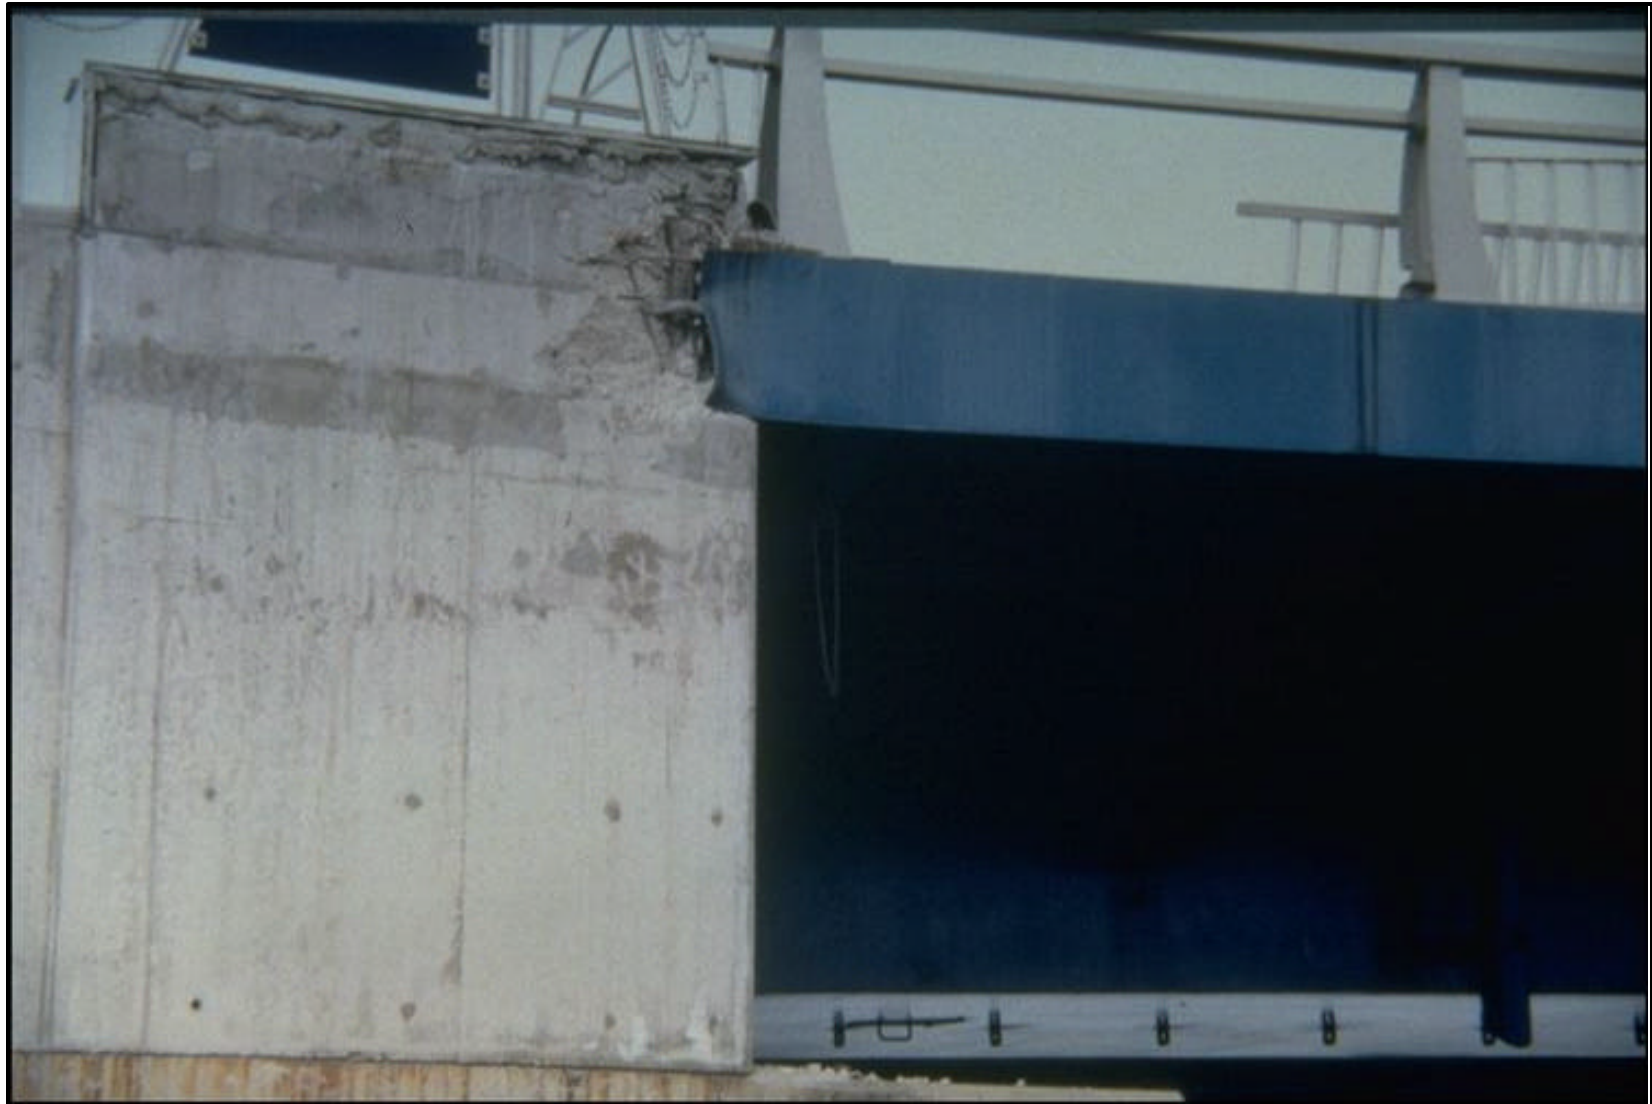
## **Pounding damage at abutment (EERC) Yellow Tag**

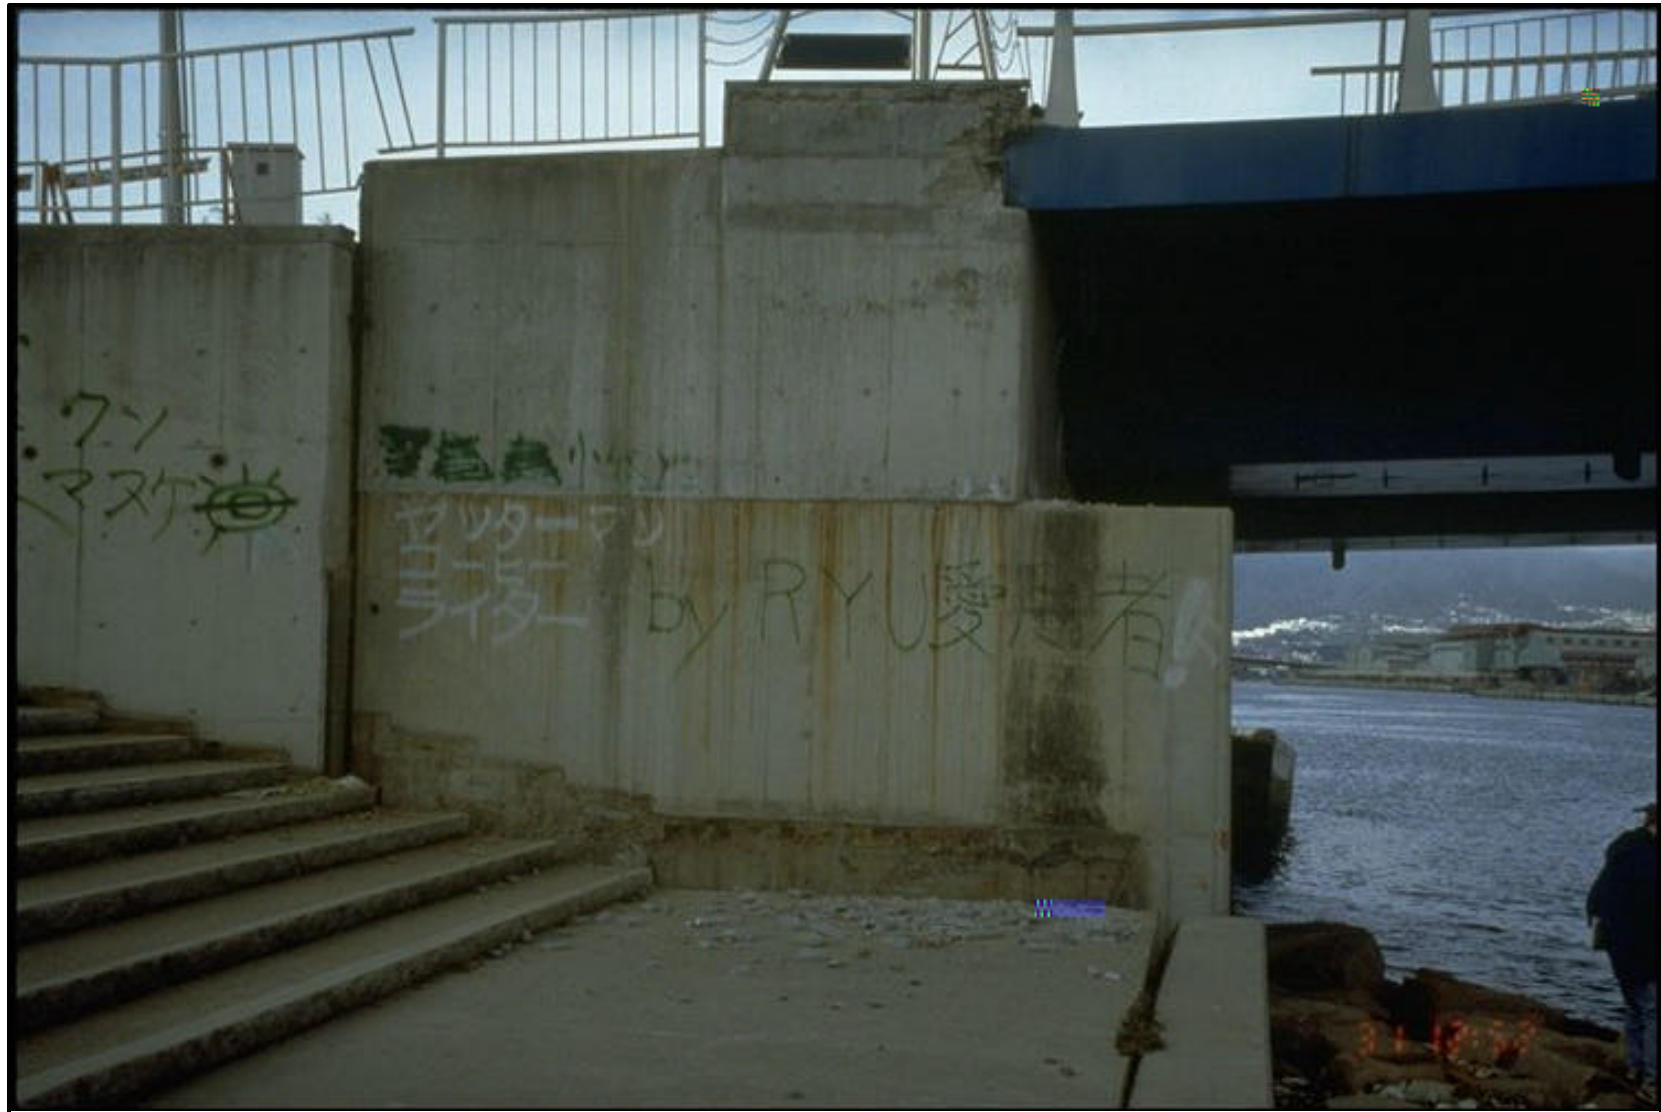
# Transverse movement of abutment (EERC)- Yellow Tag

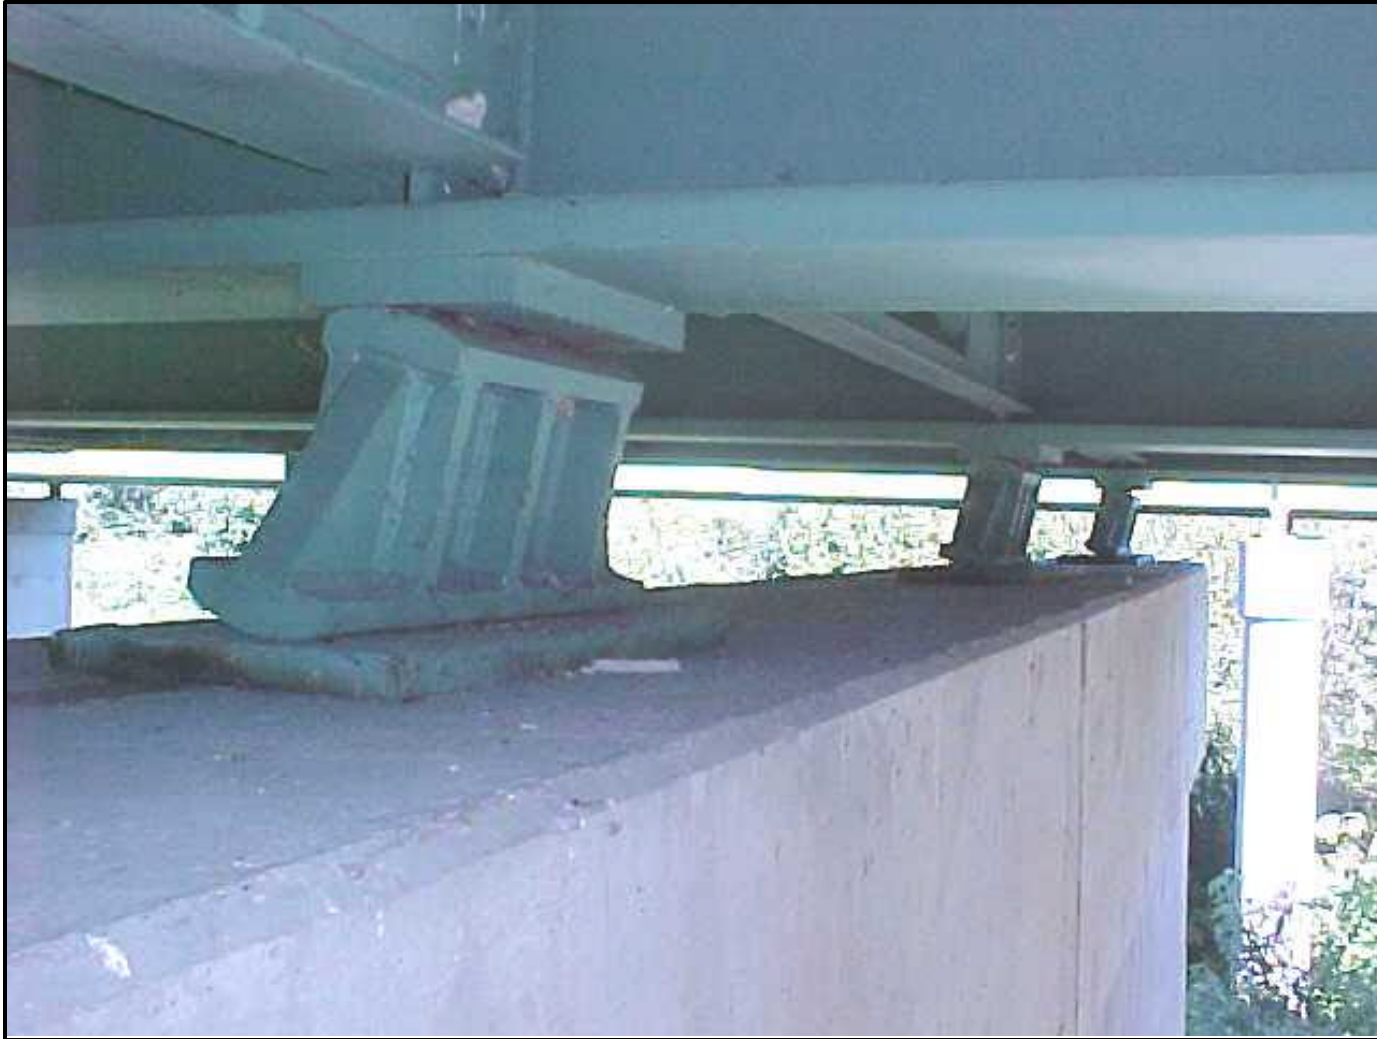
## **Tilted rocker bearings (INDOT)- Yellow Tag**

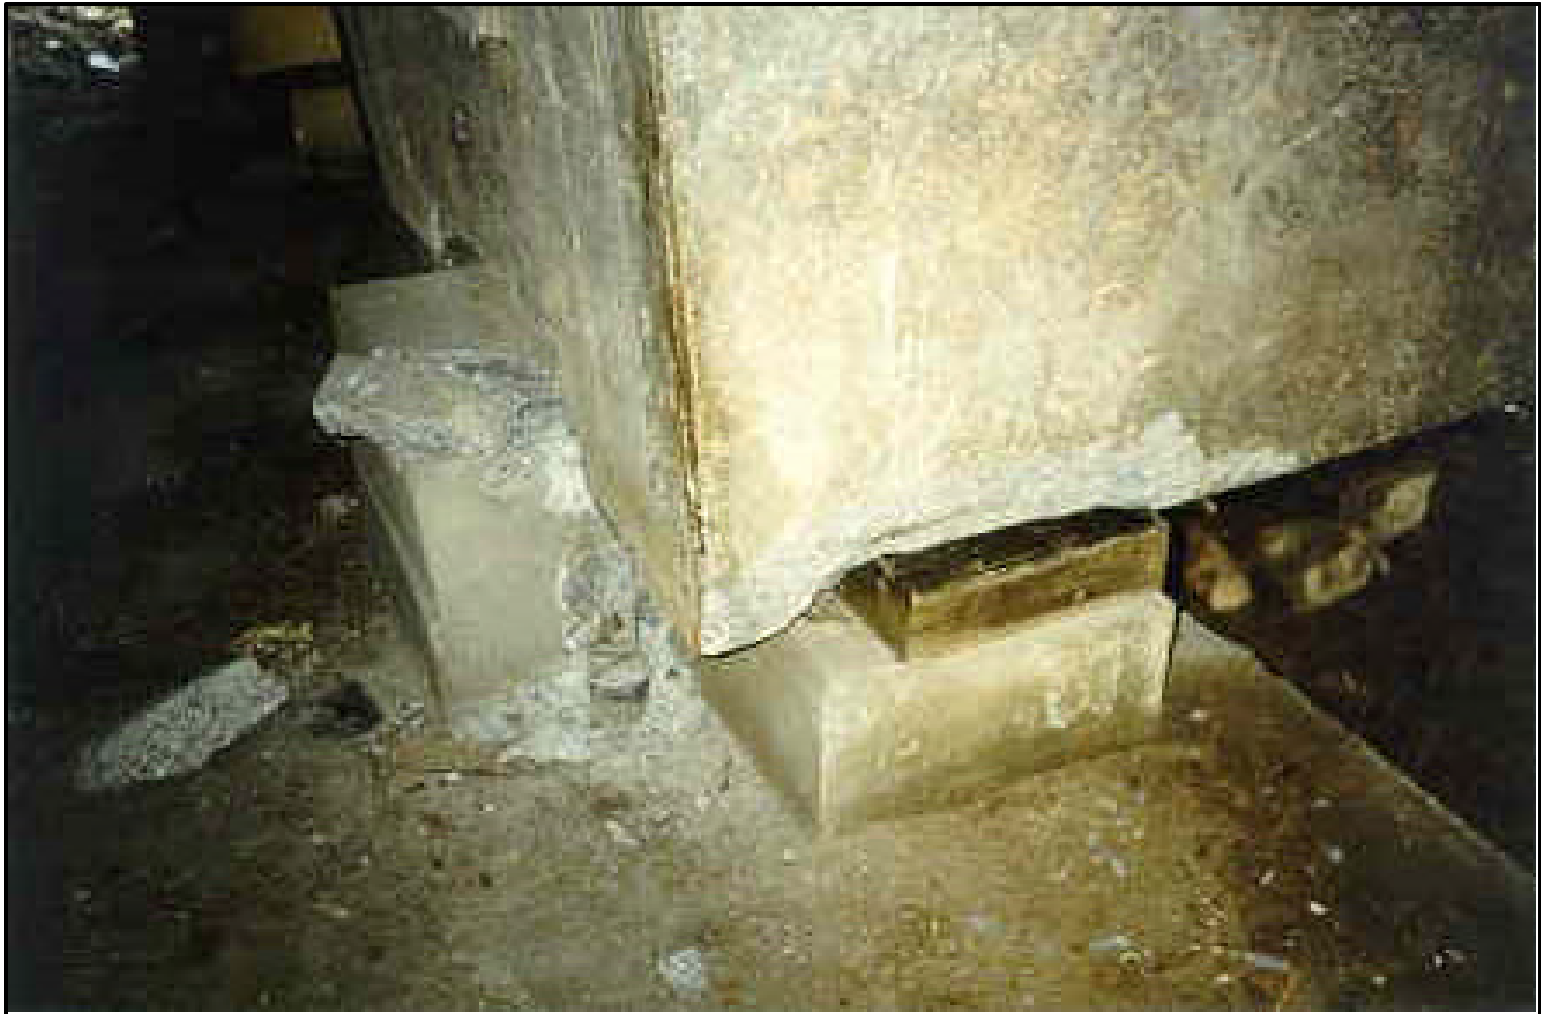
## **Elastomeric bearing after Izmit EQ 1999 (KOERI)- Yellow Tag**

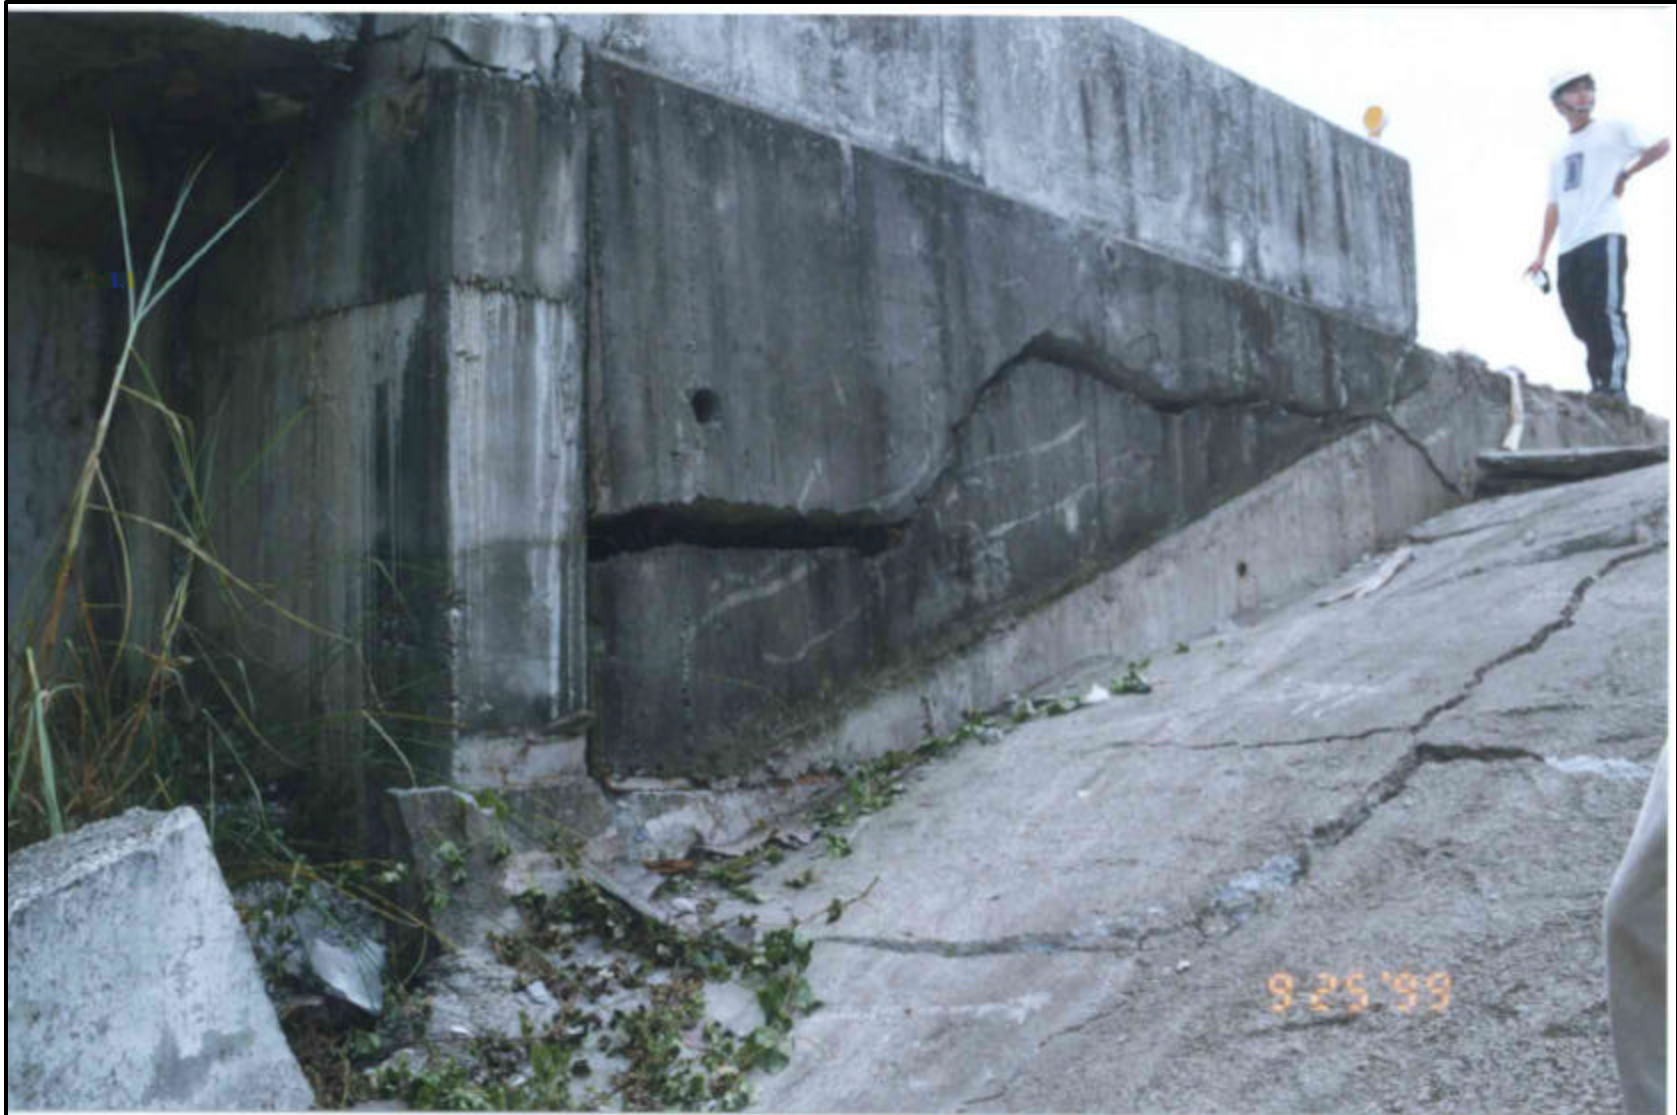
## Cracks at abutment wingwall and slope (UCSD)- Yellow Tag

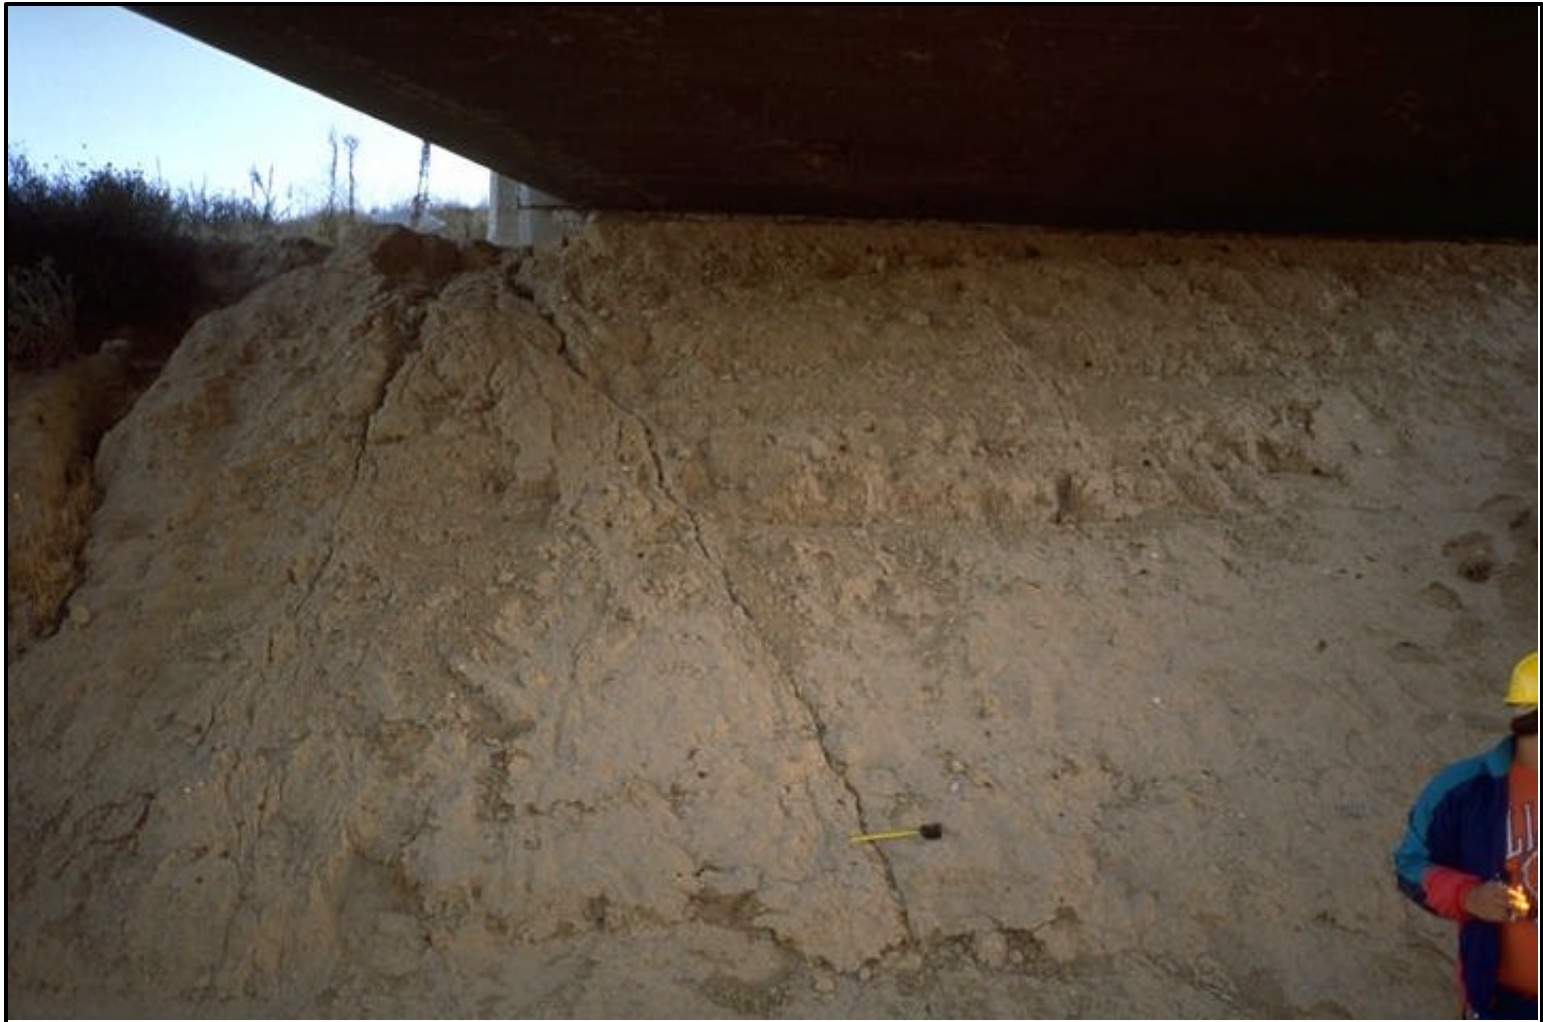
## **Diagonal ground crack extending under bridge (EERC)- Yellow Tag**

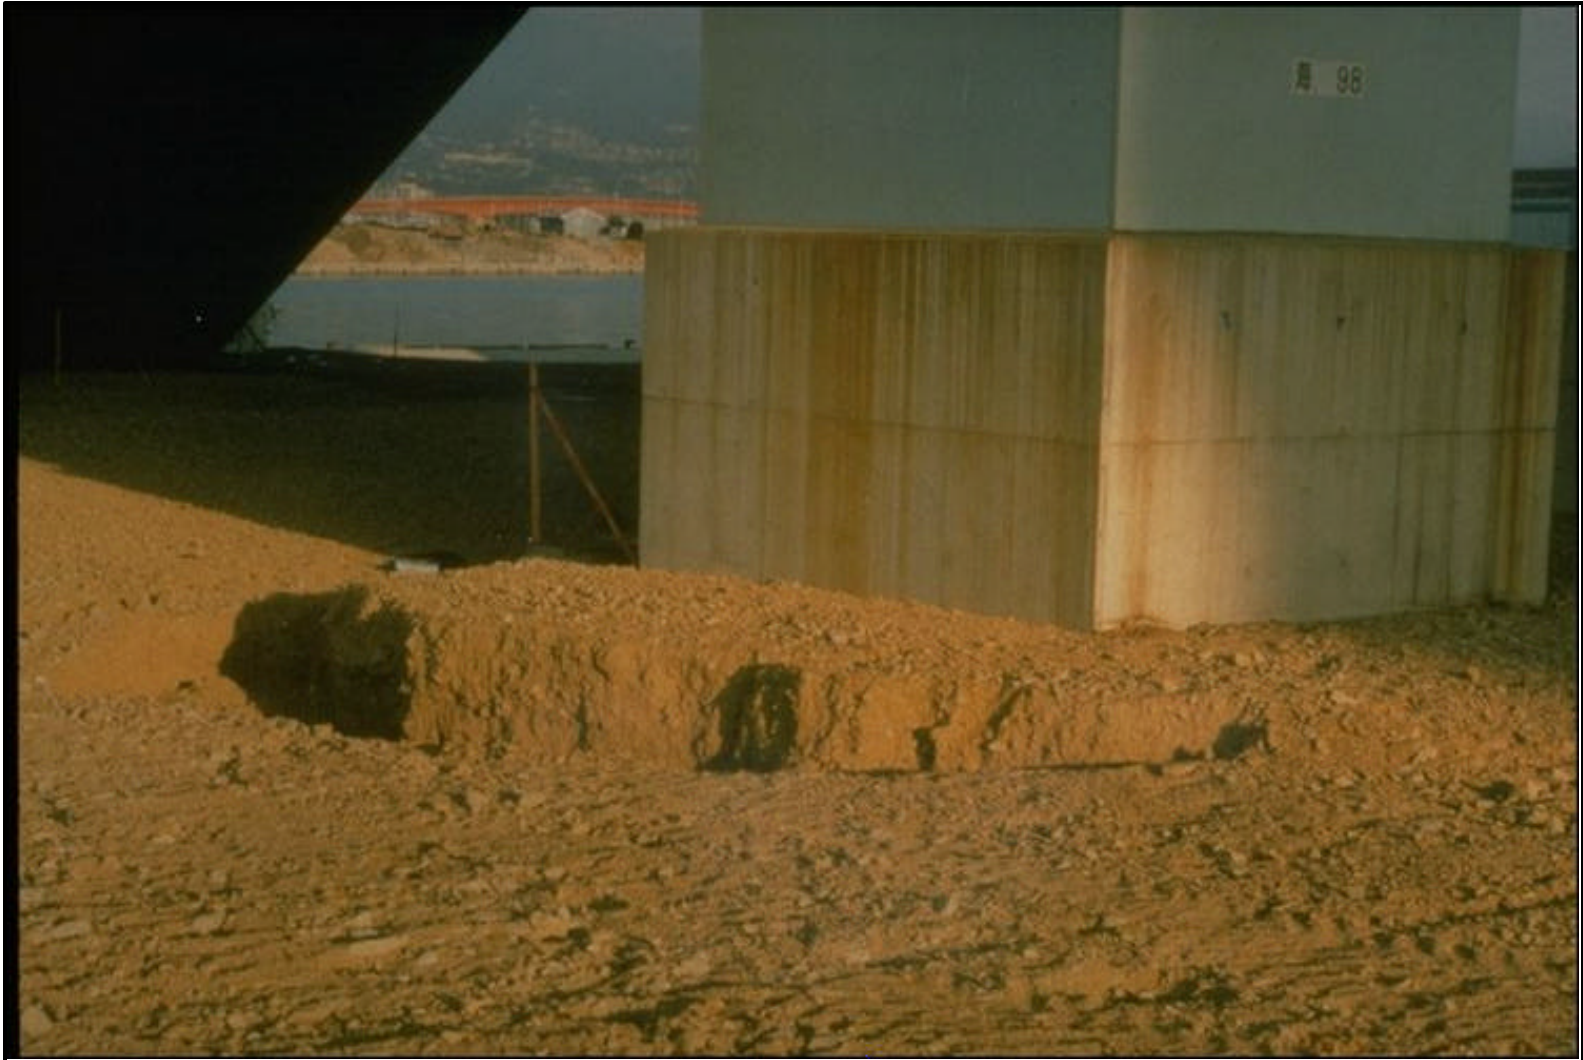
## Settlement around pier on pile foundation (EERC)- Yellow Tag

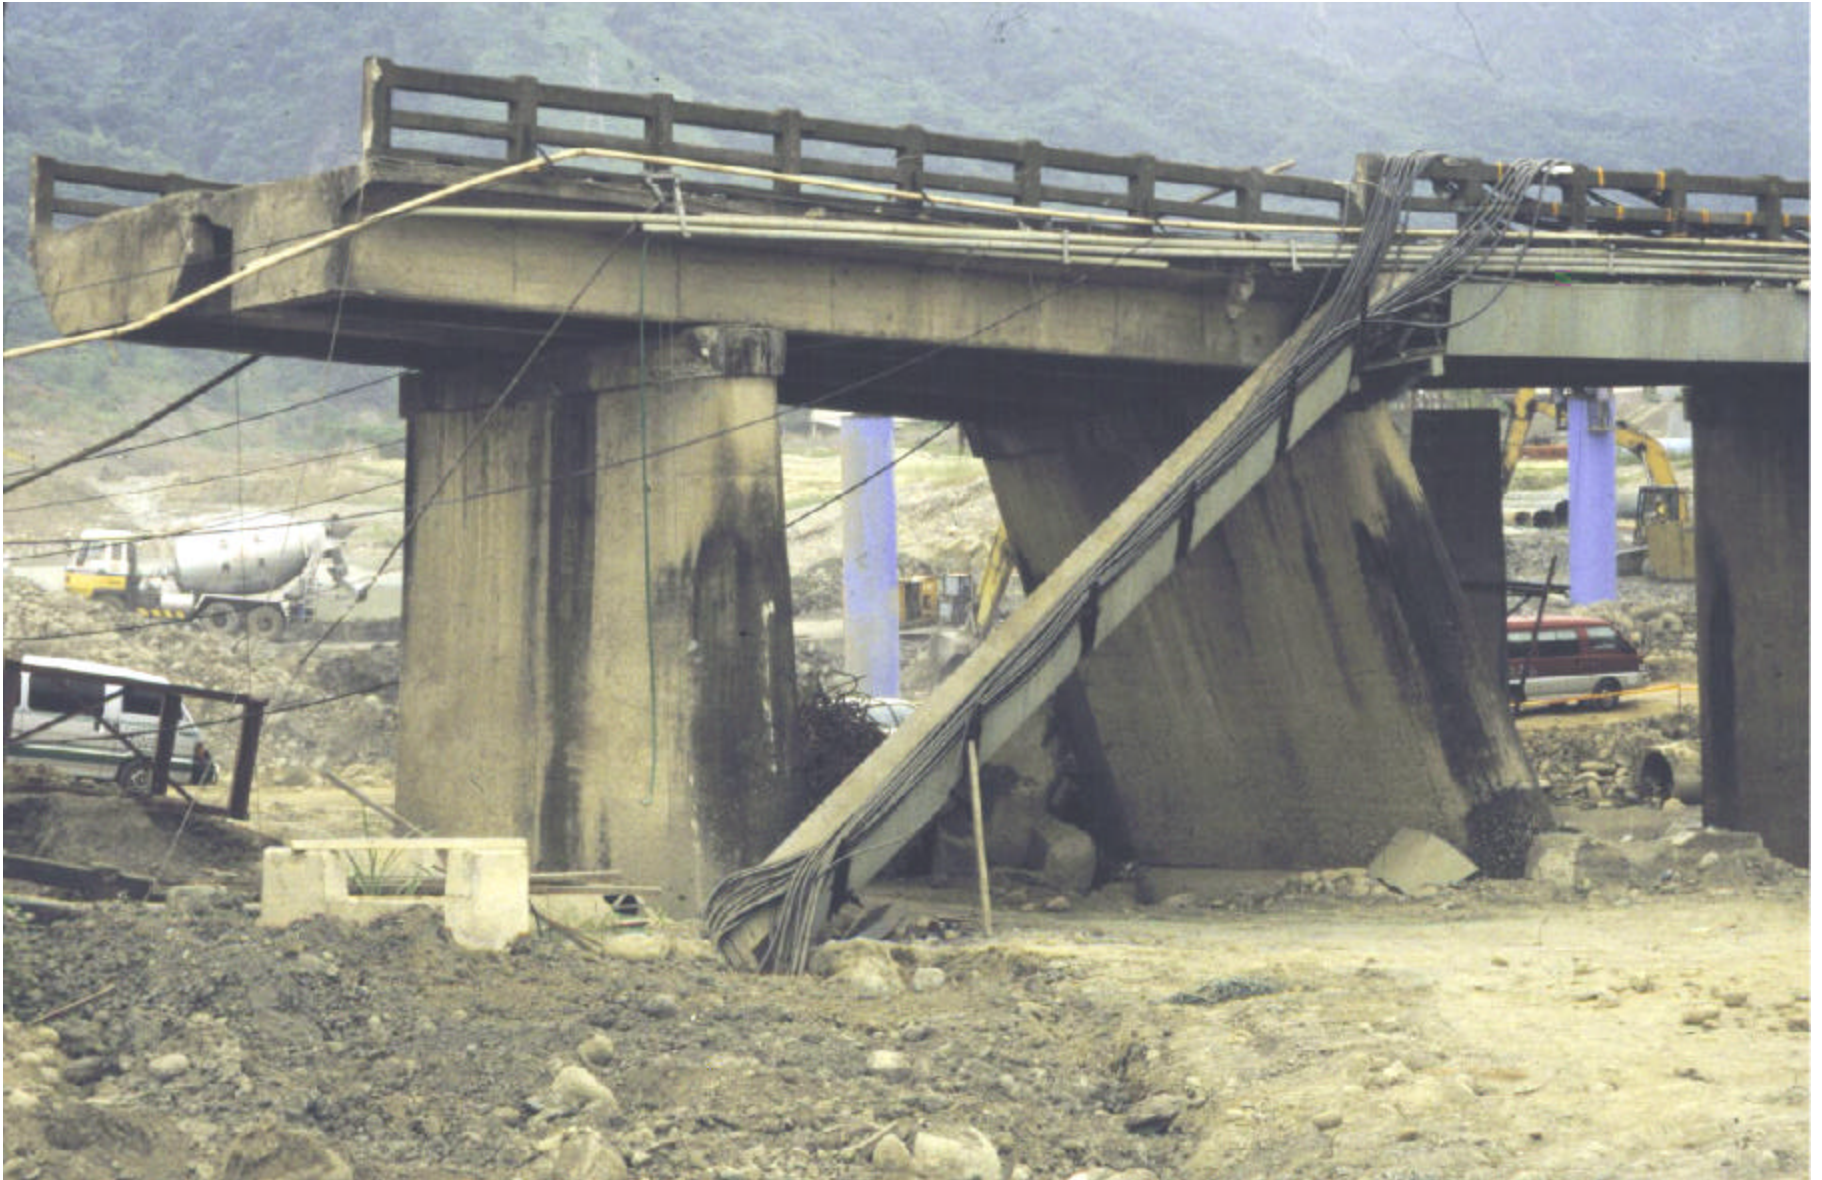
I-Jiang Bridge, 1999 Chi-Chi Eq. (M.O. Eberhard)

# Unseating at Expansion Joints
