# POST-EARTHQUAKE SAFETY EVALUATION OF BRIDGES AND ROADS

Purdue University and  
Joint Transportation Research Board

Bridges and Damage Examples

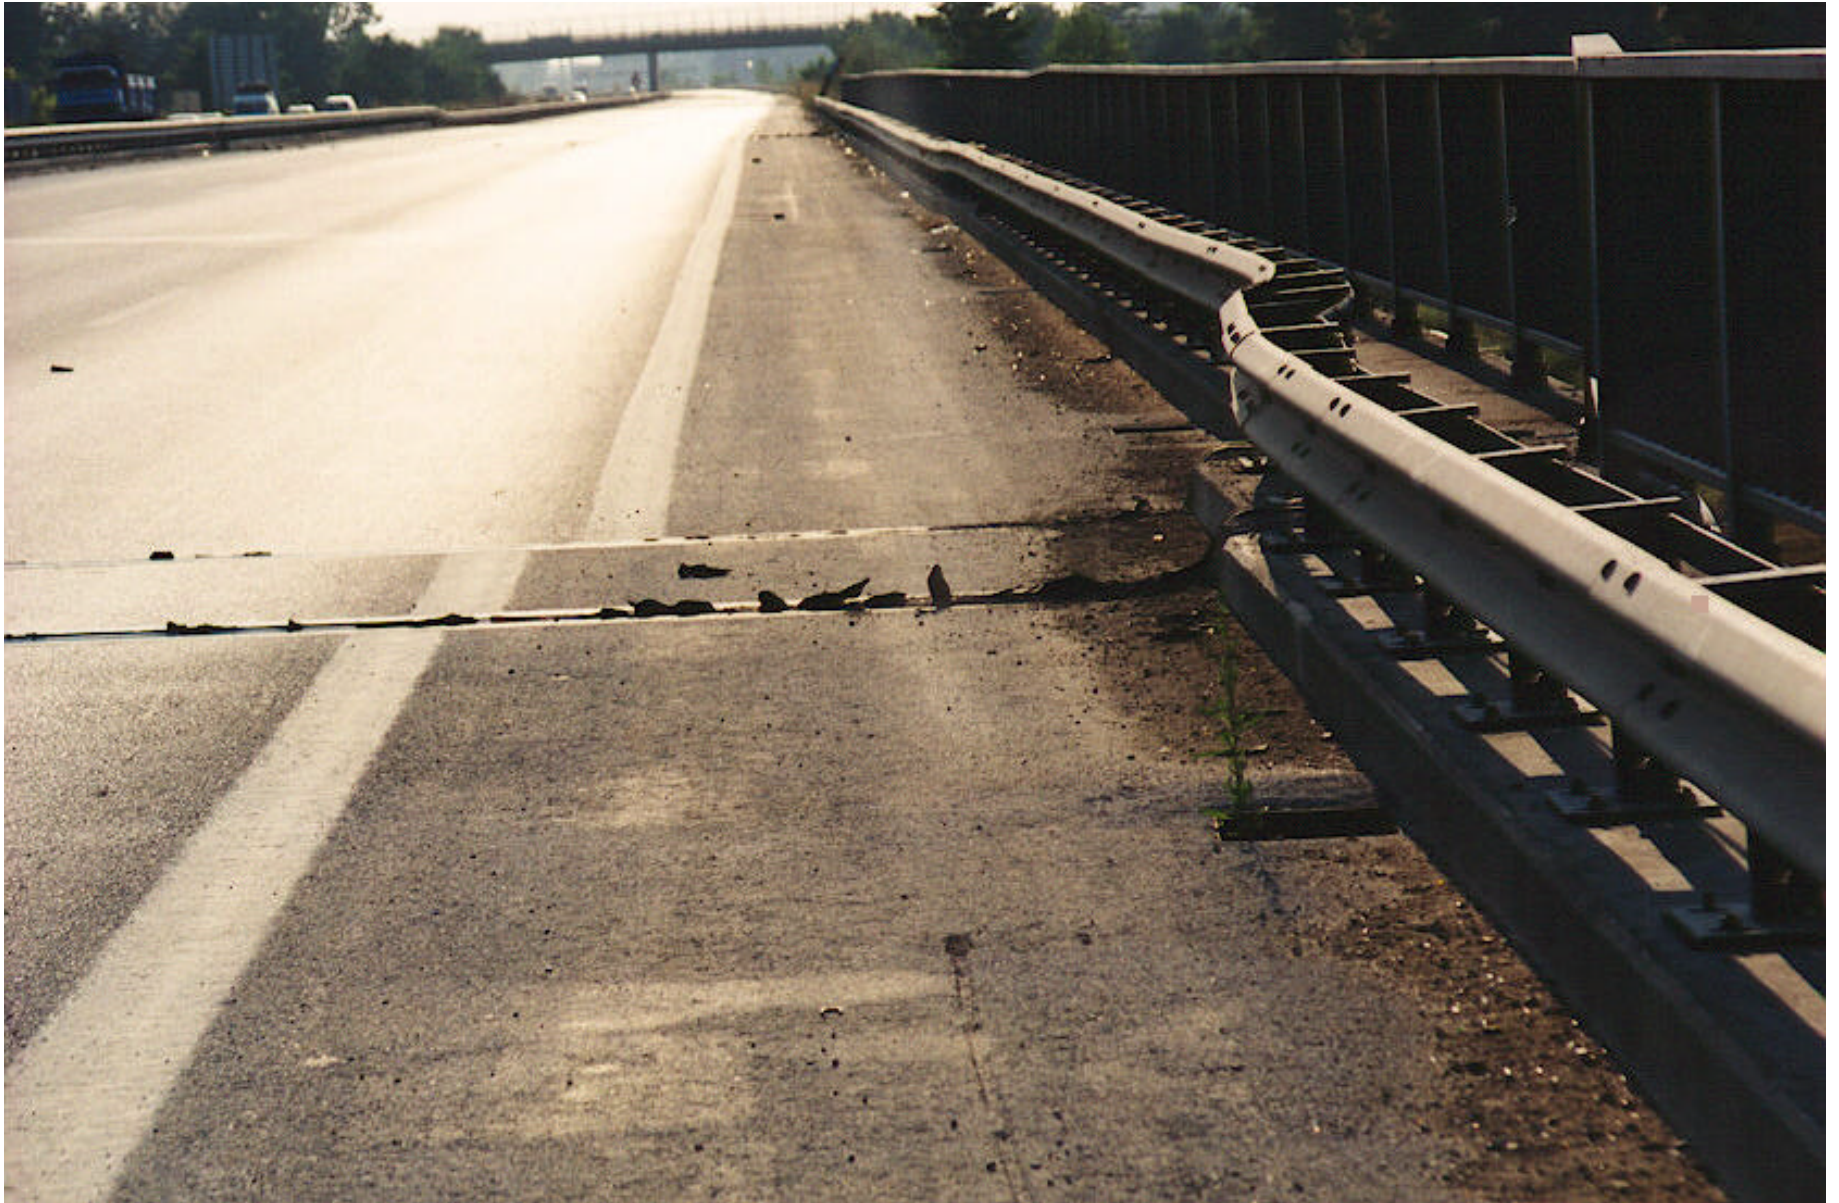
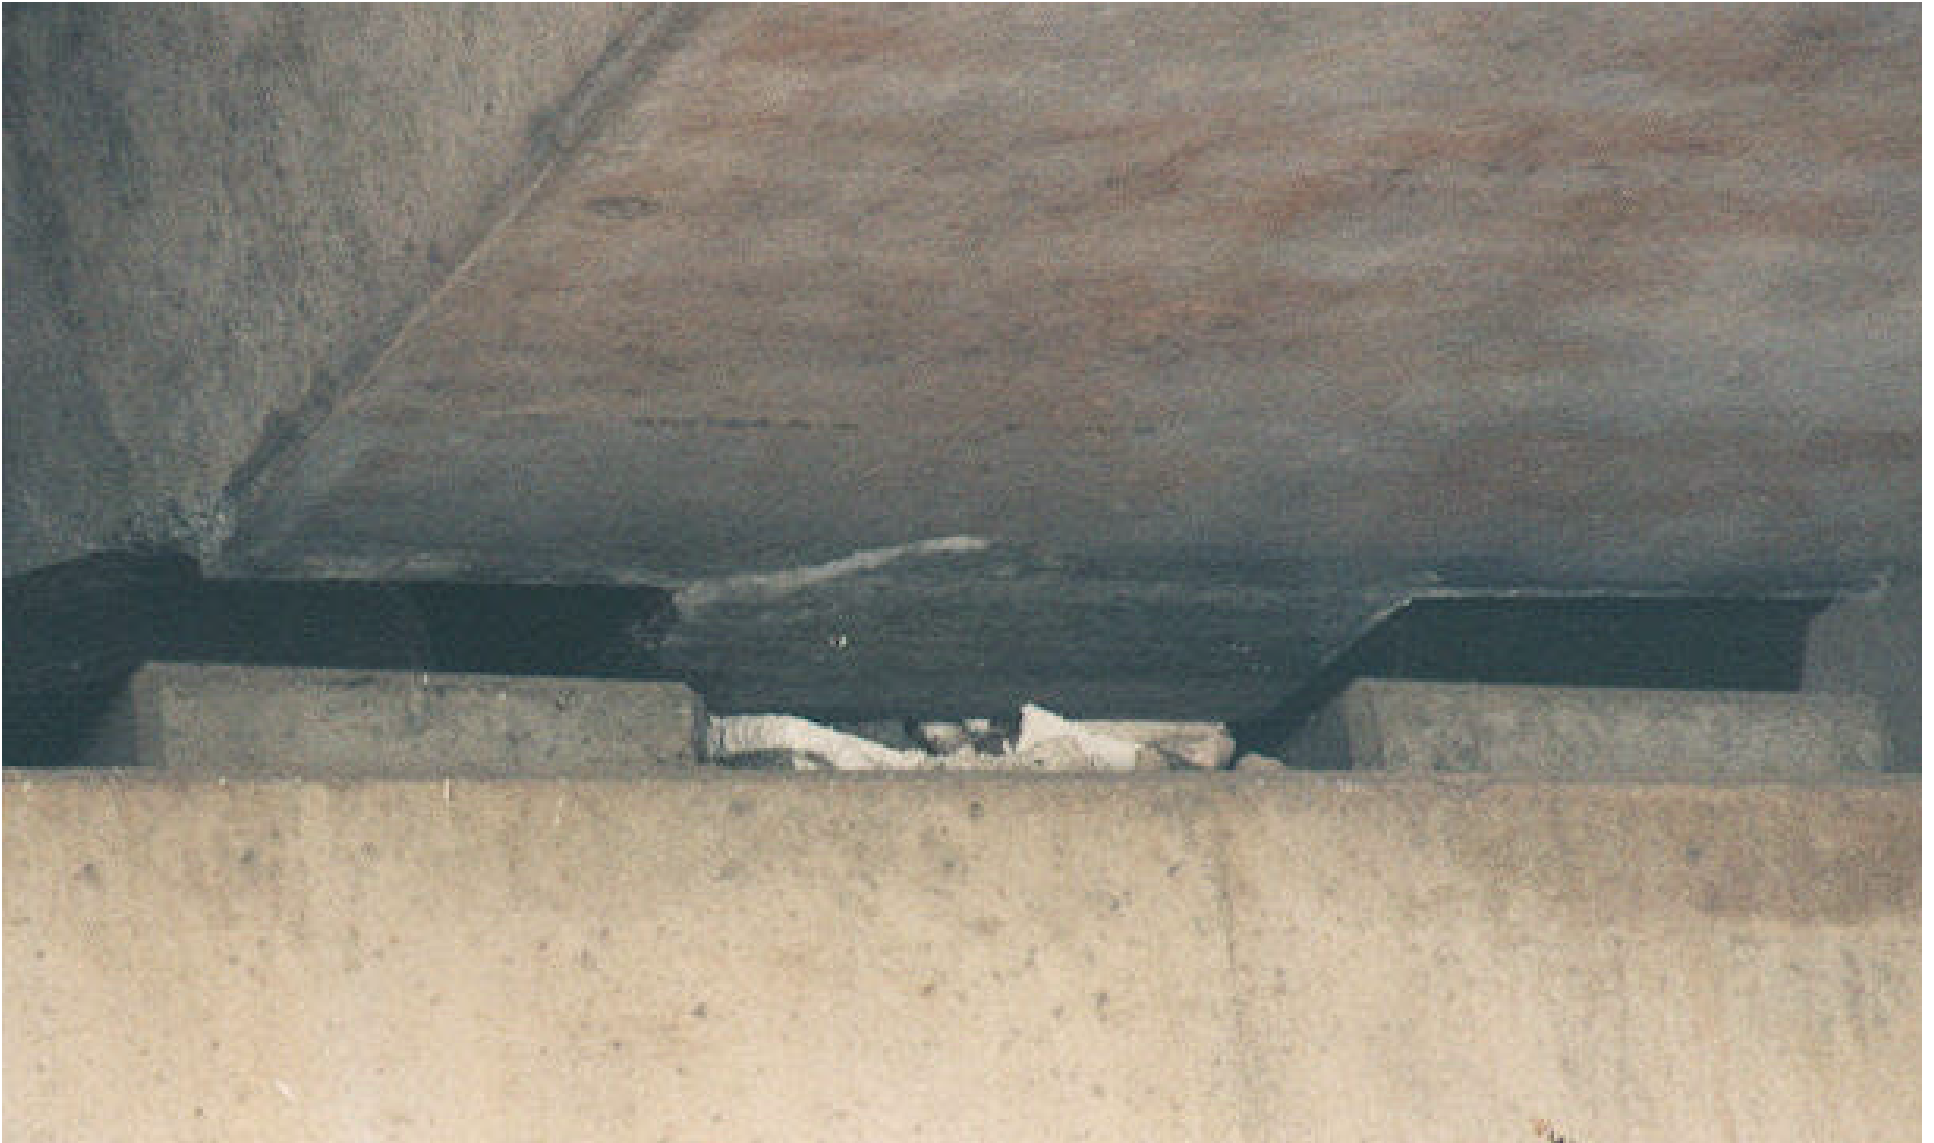
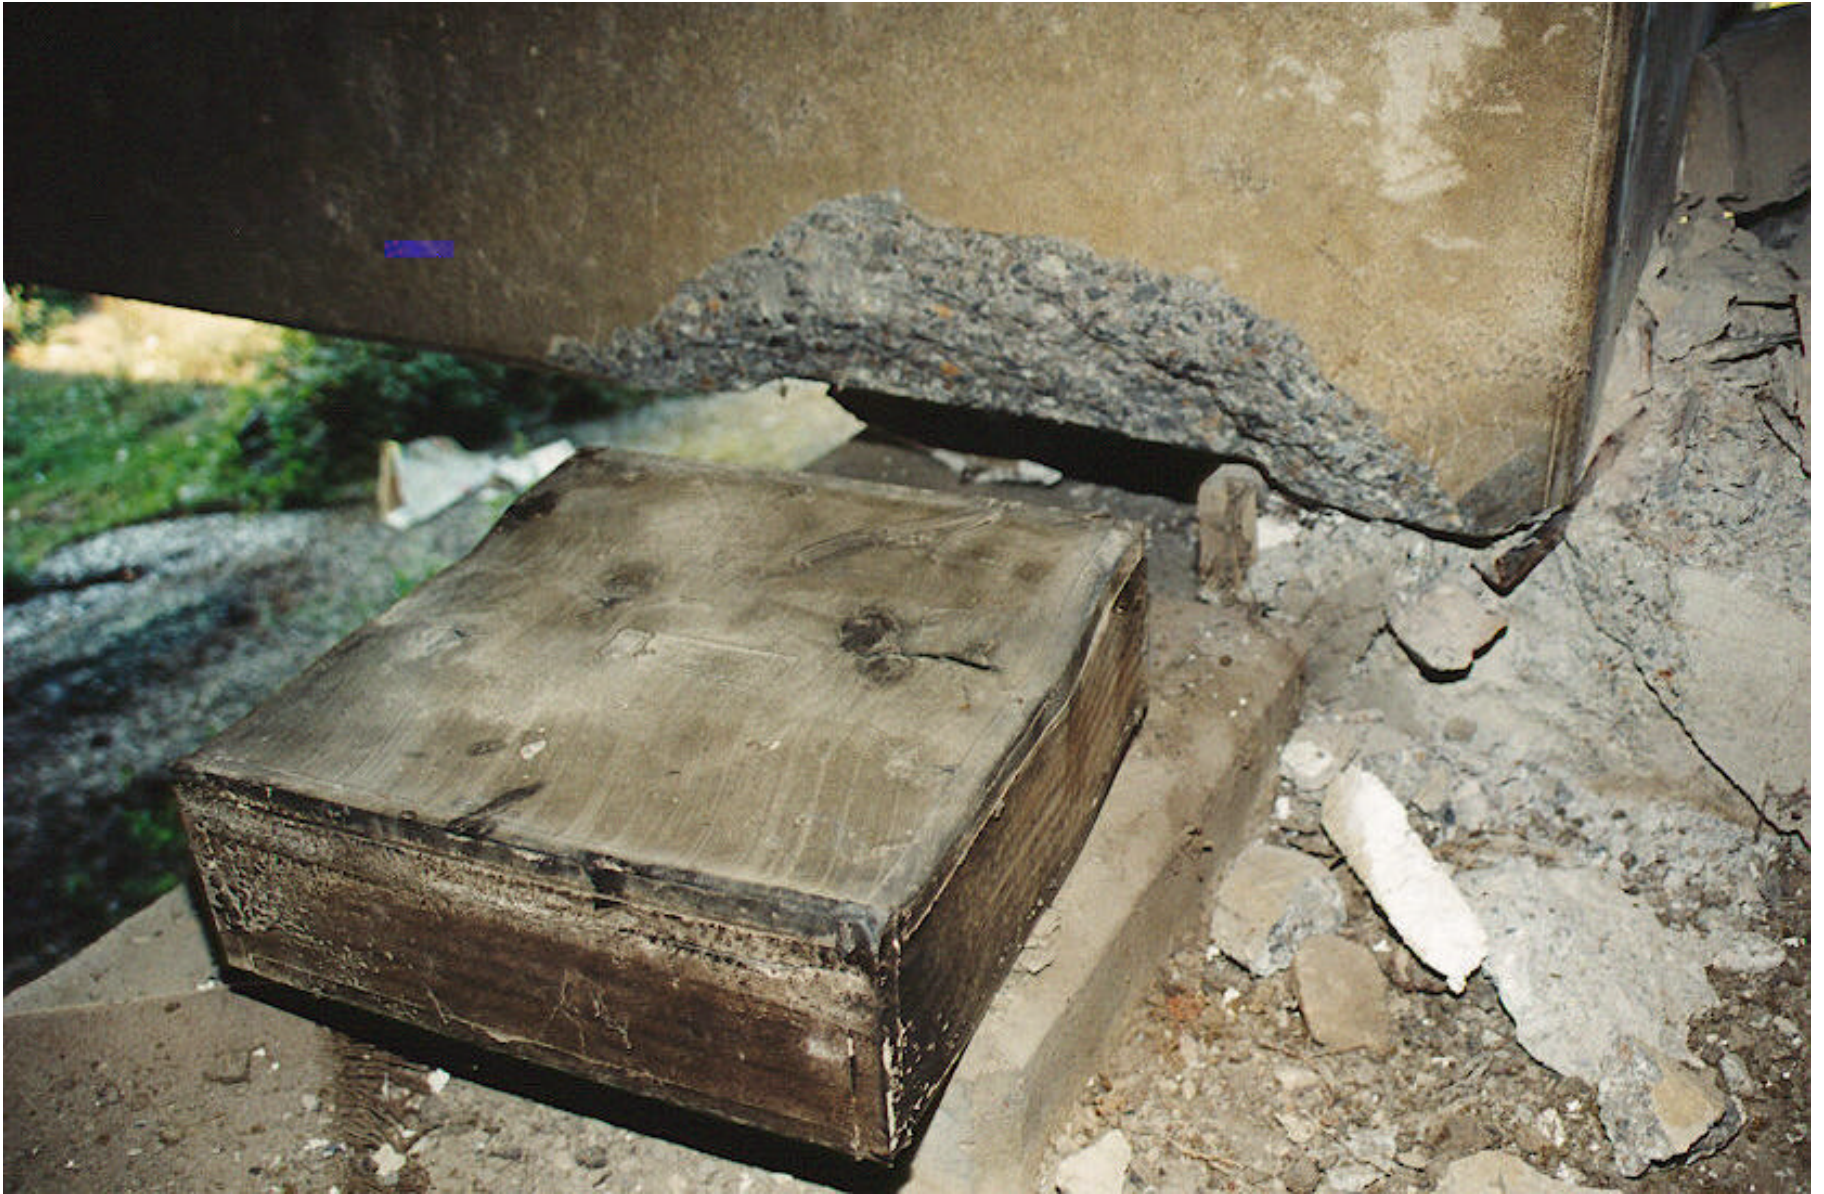
# Bearing Damage

Sakarya Viaduct, 1999 Kocaeli Eq. (KOERI)

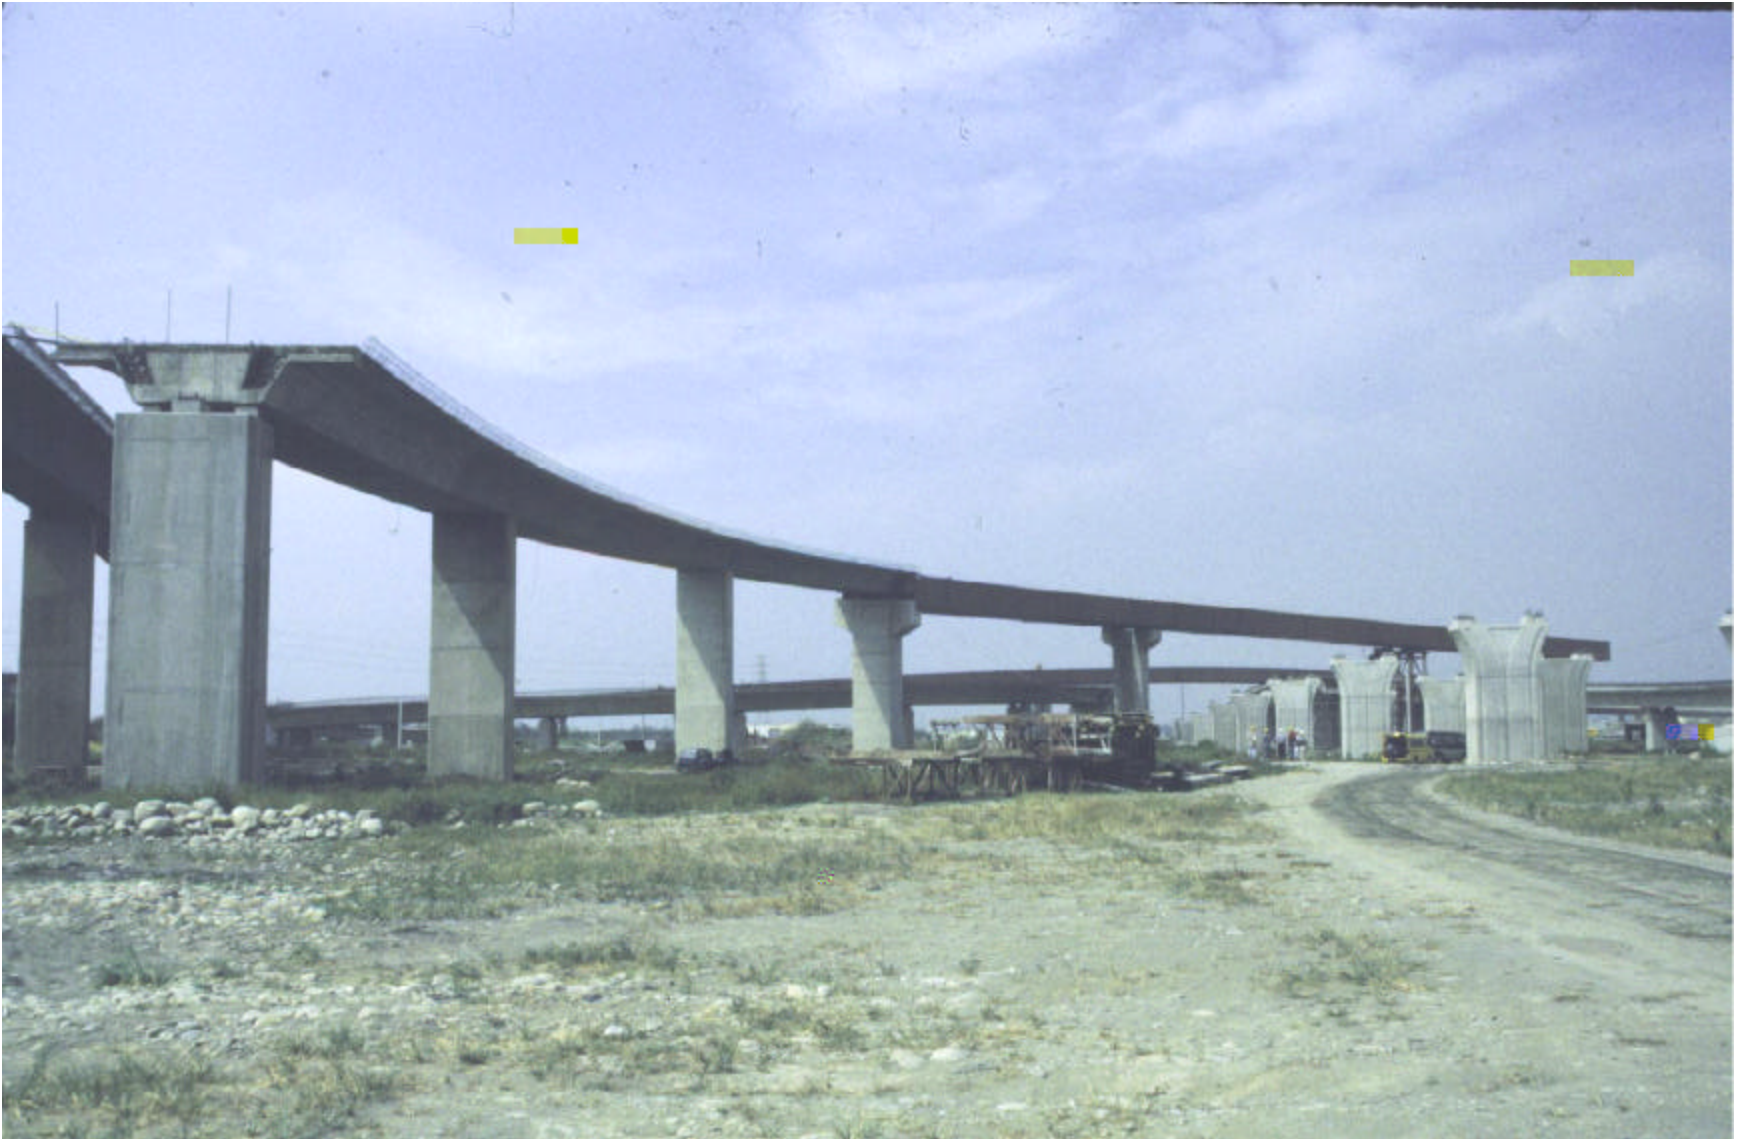
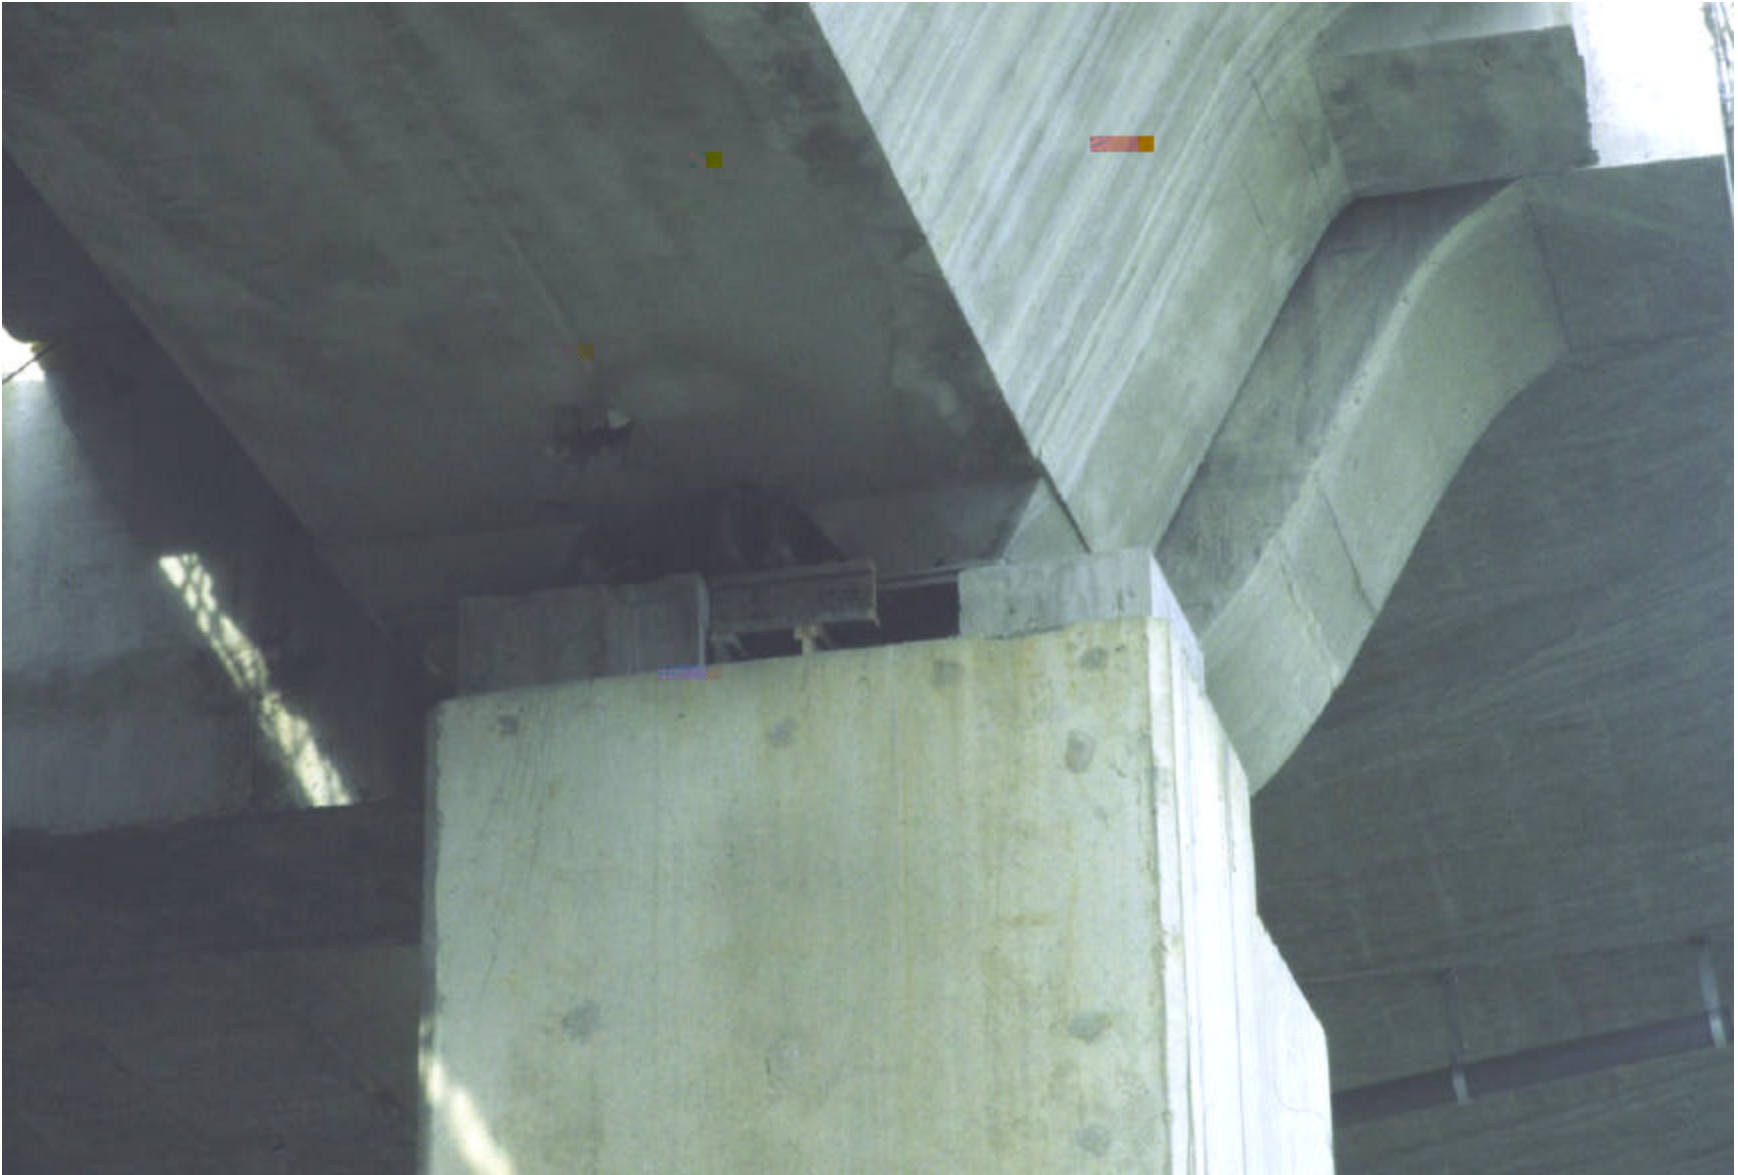
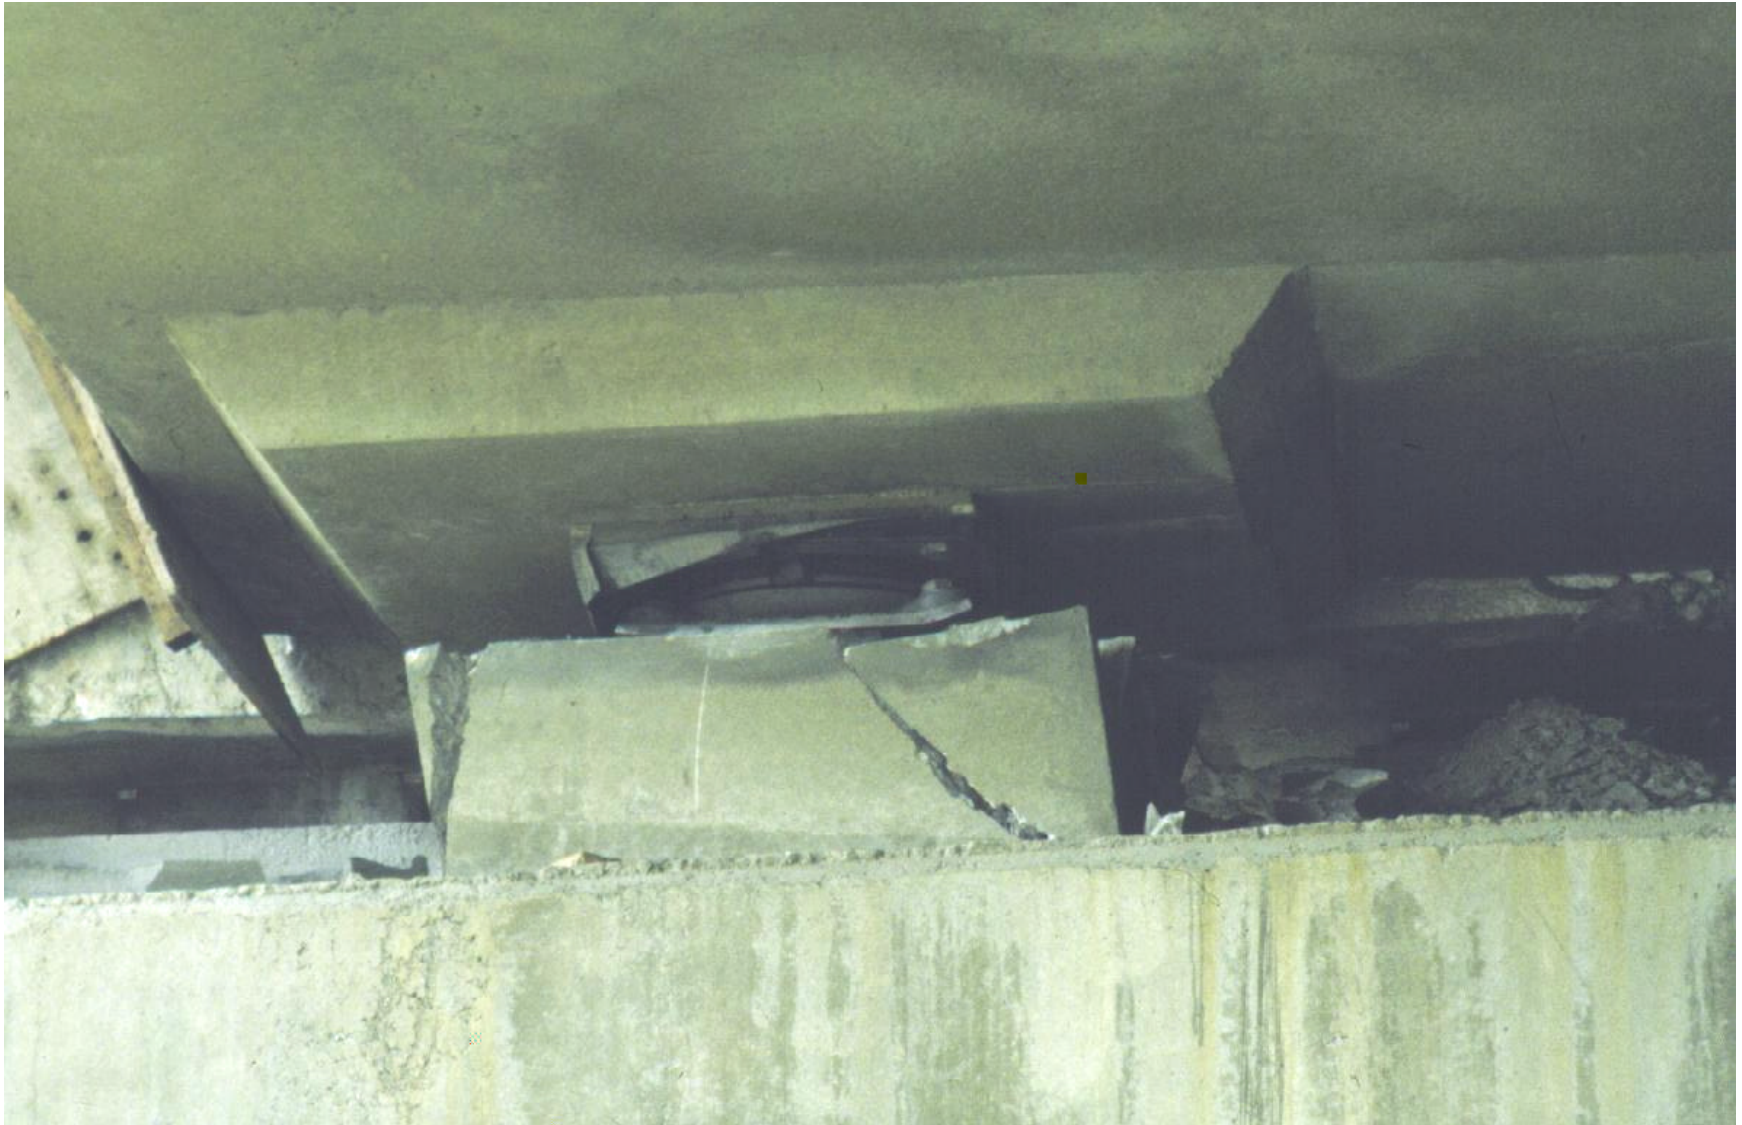
# Bearing Damage

1-3 Expressway Link, 1999 Chi-Chi Eq. (M.O. Eberhard)

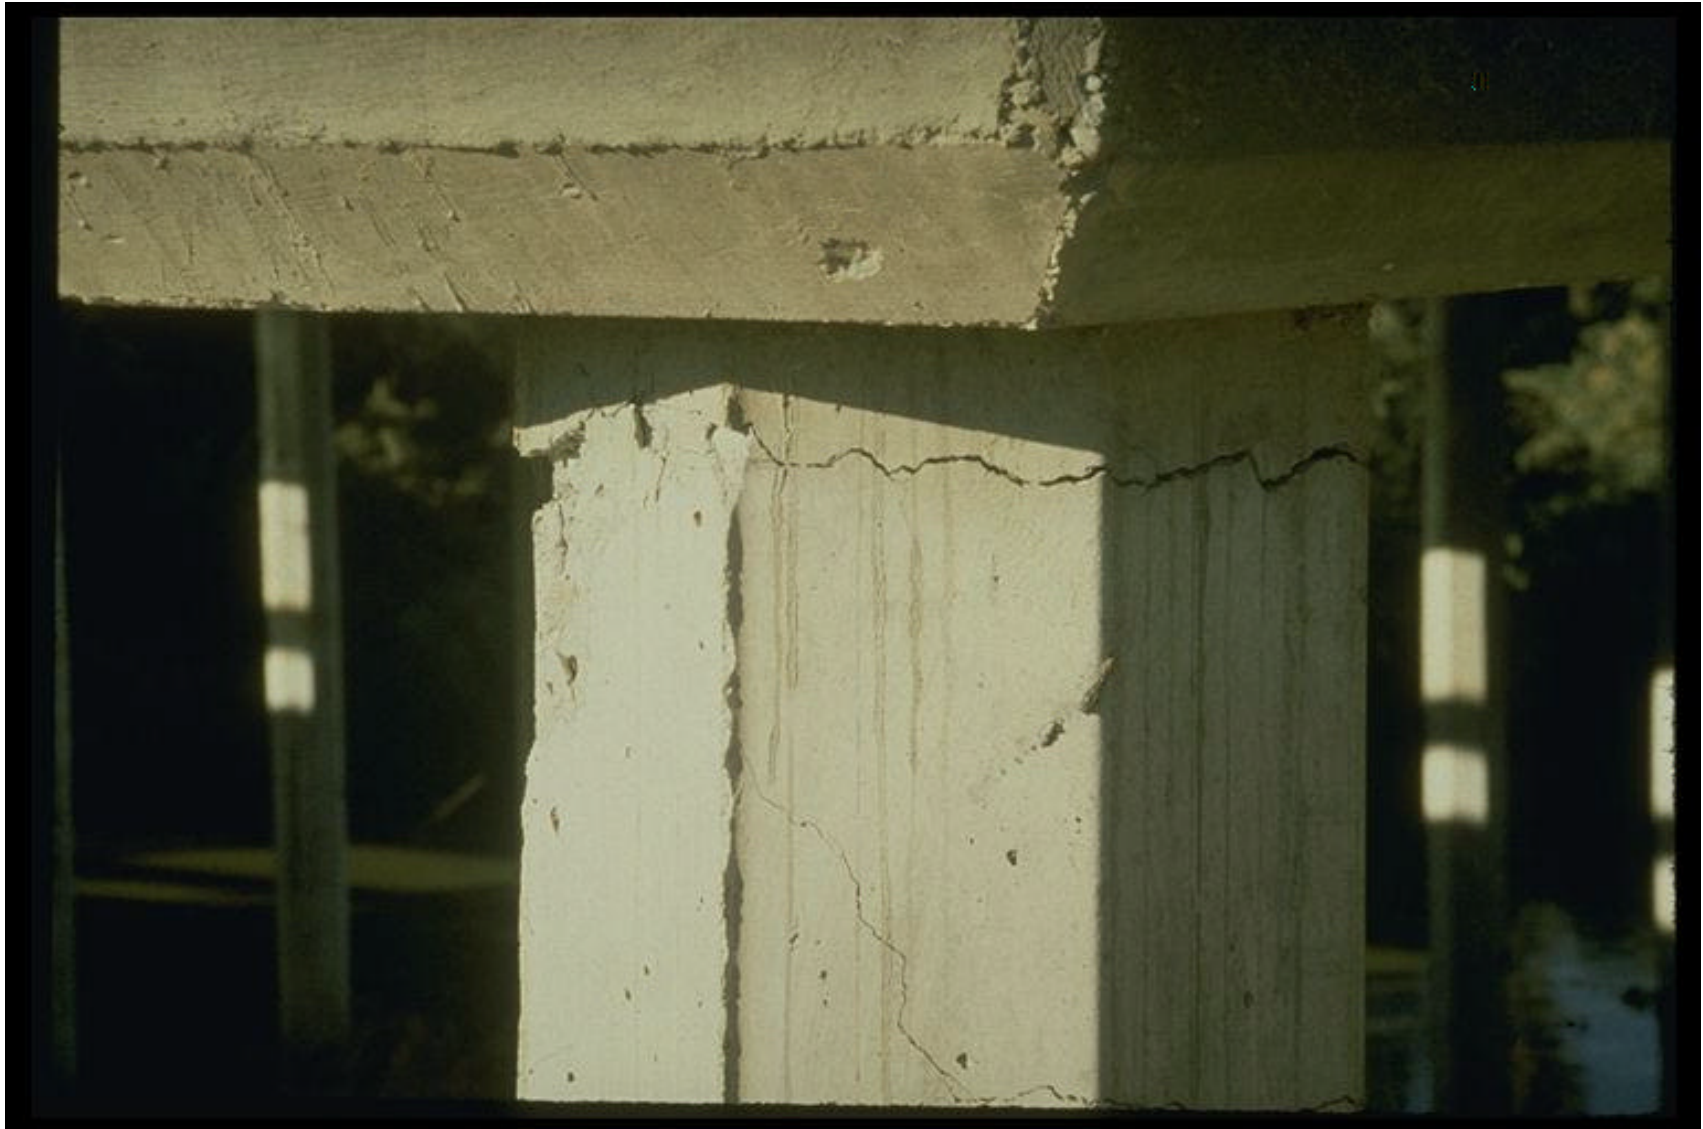
New River Bridge, 1979 Imperial Valley Eq.  
(Steinbrugge Collection, EERC)

# Columns: Flexural Damage

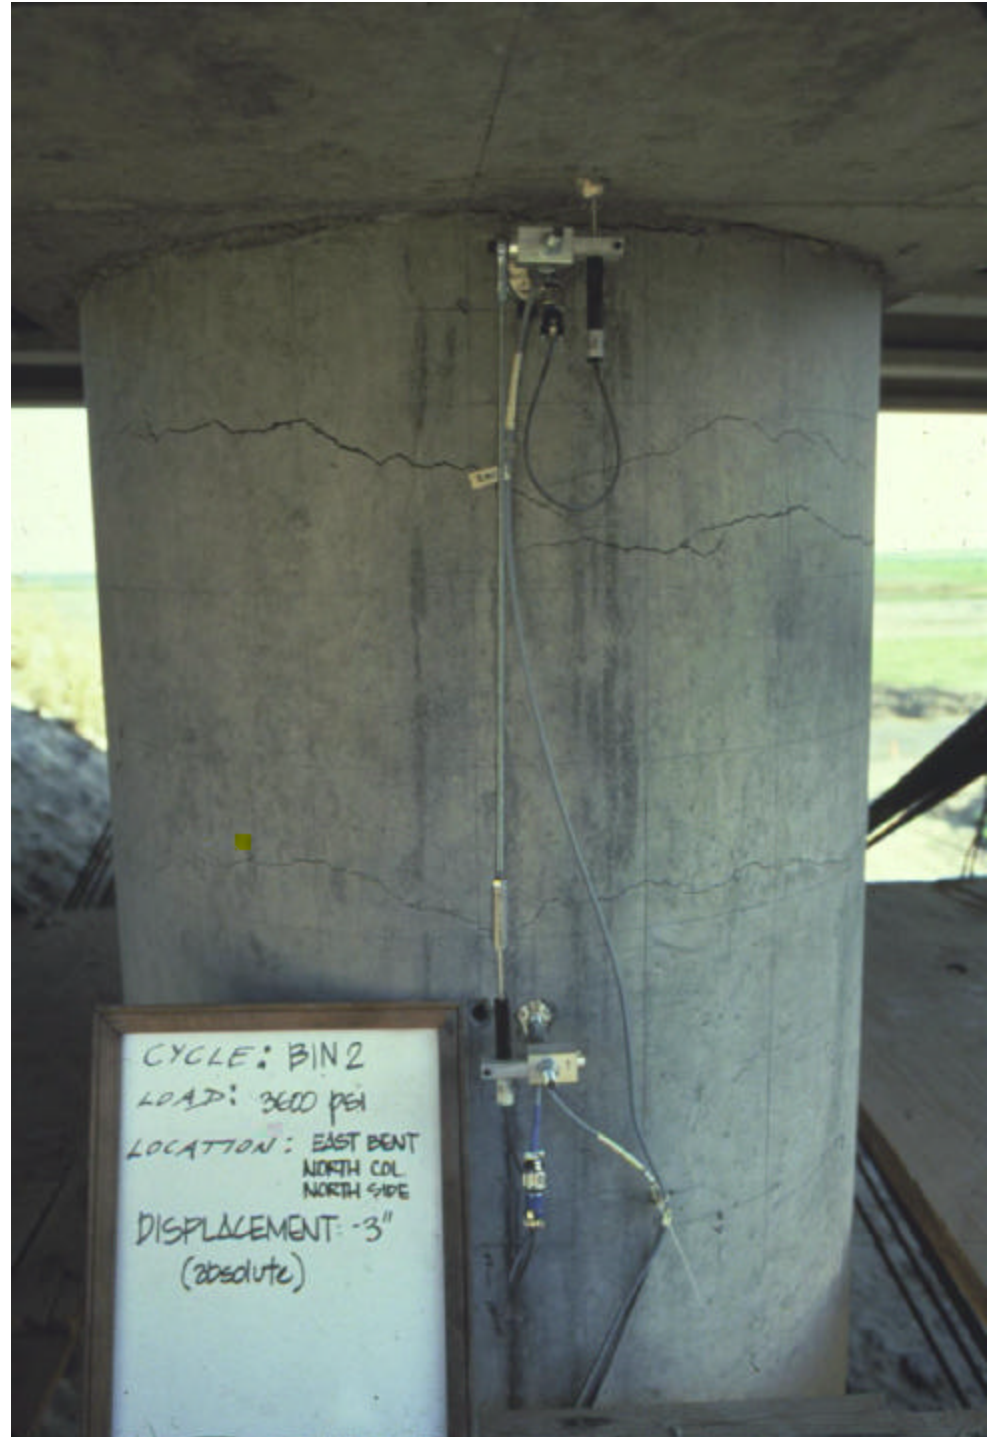
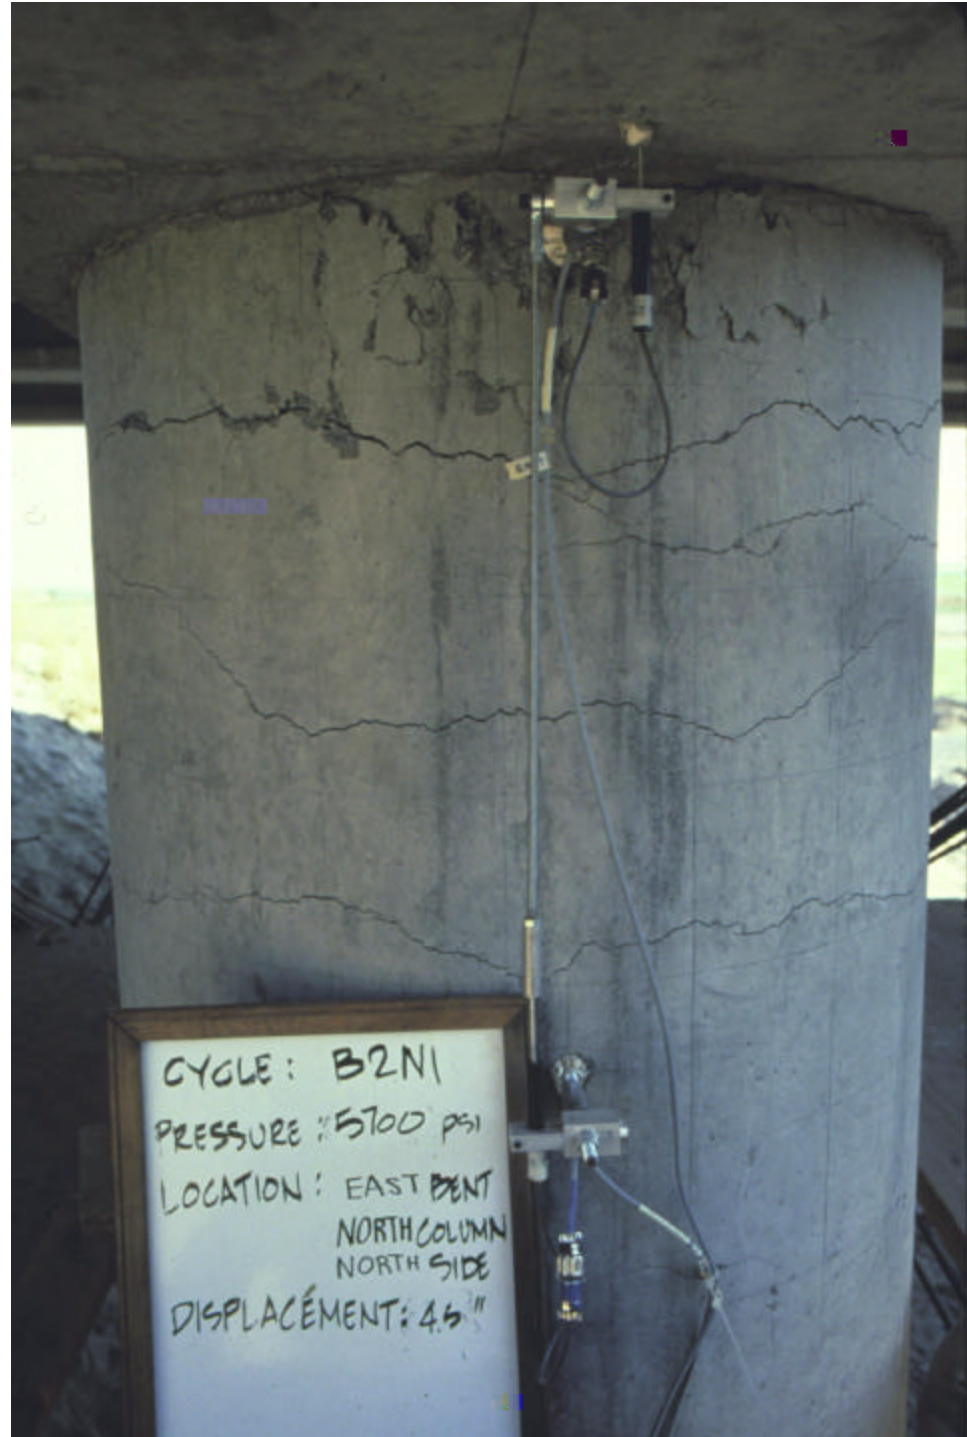
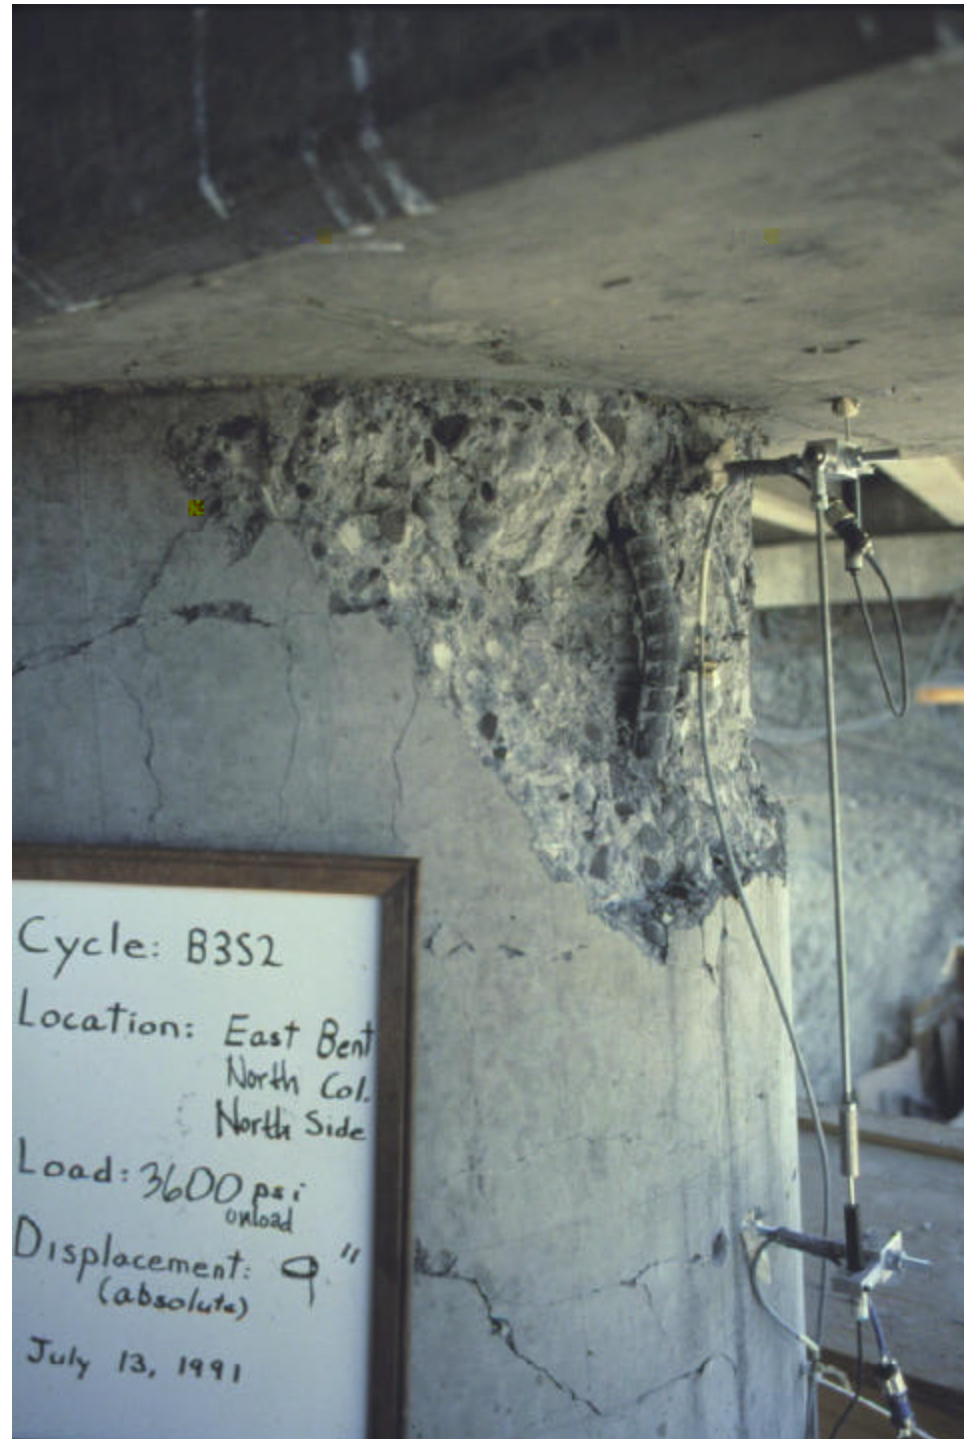
I-90 Bridge Test  
(Marc O. Eberhard )

# Columns: Flexural Damage

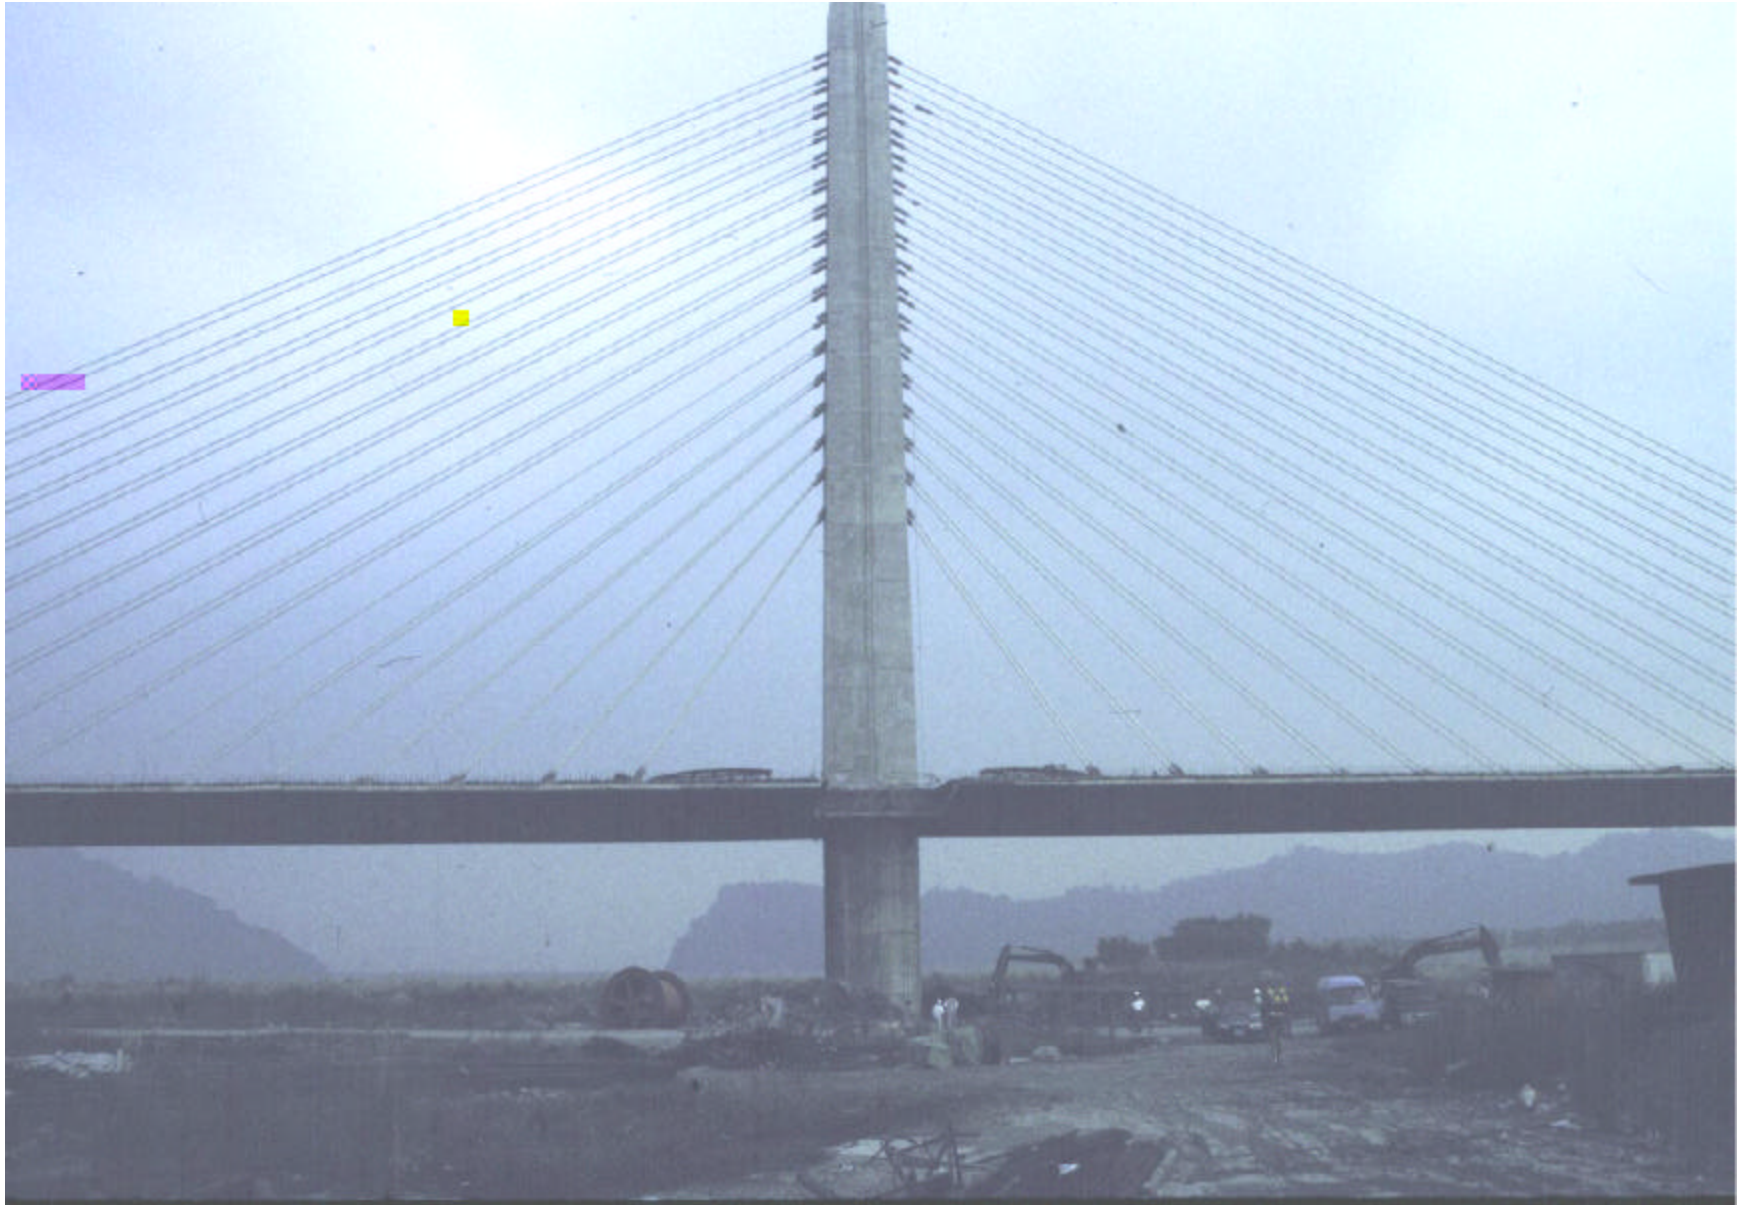
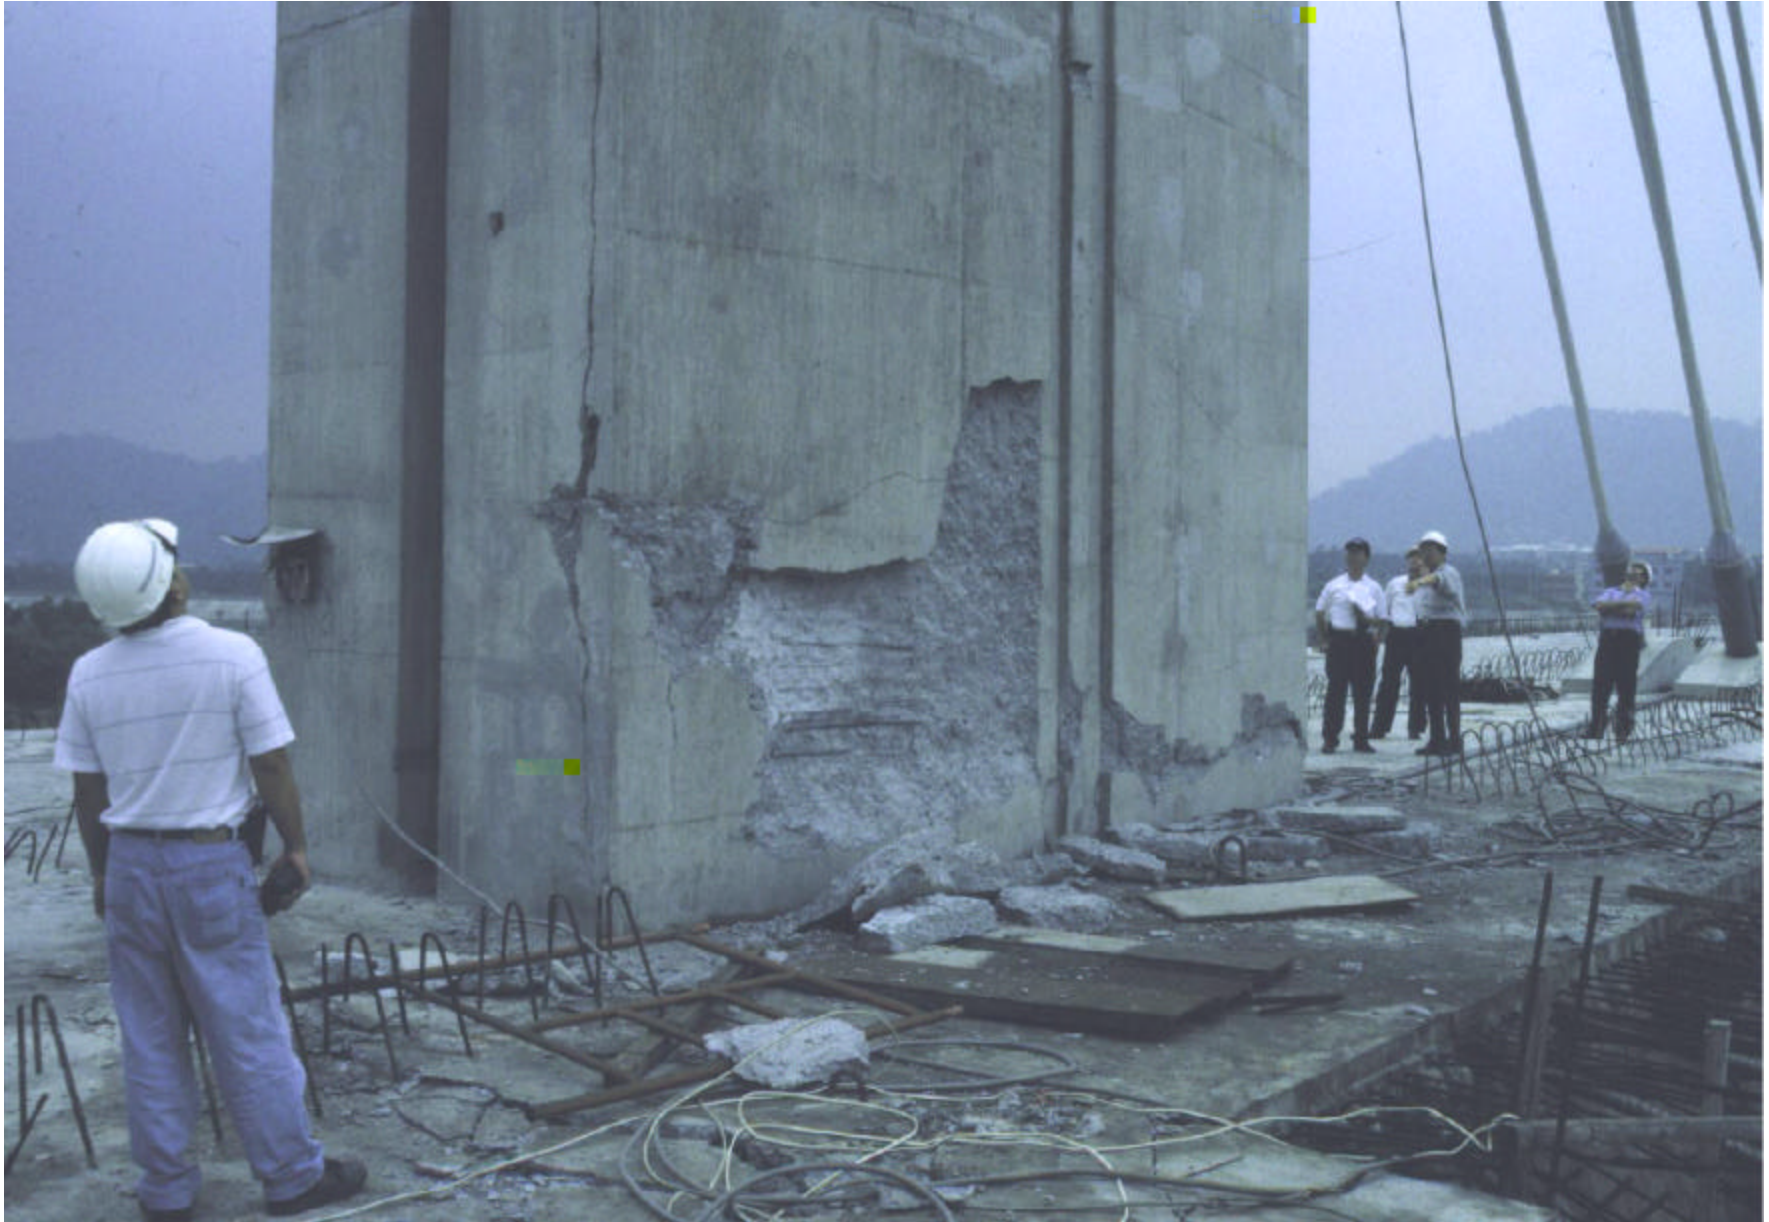
Cable-Stayed Bridge, 1999 Chi-Chi Eq. (M.O. Eberhard)

# Columns: Flexural Damage
