# POST-EARTHQUAKE SAFETY EVALUATION OF BRIDGES AND ROADS

Purdue University and  
Joint Transportation Research Board

Bridges and Damage Examples

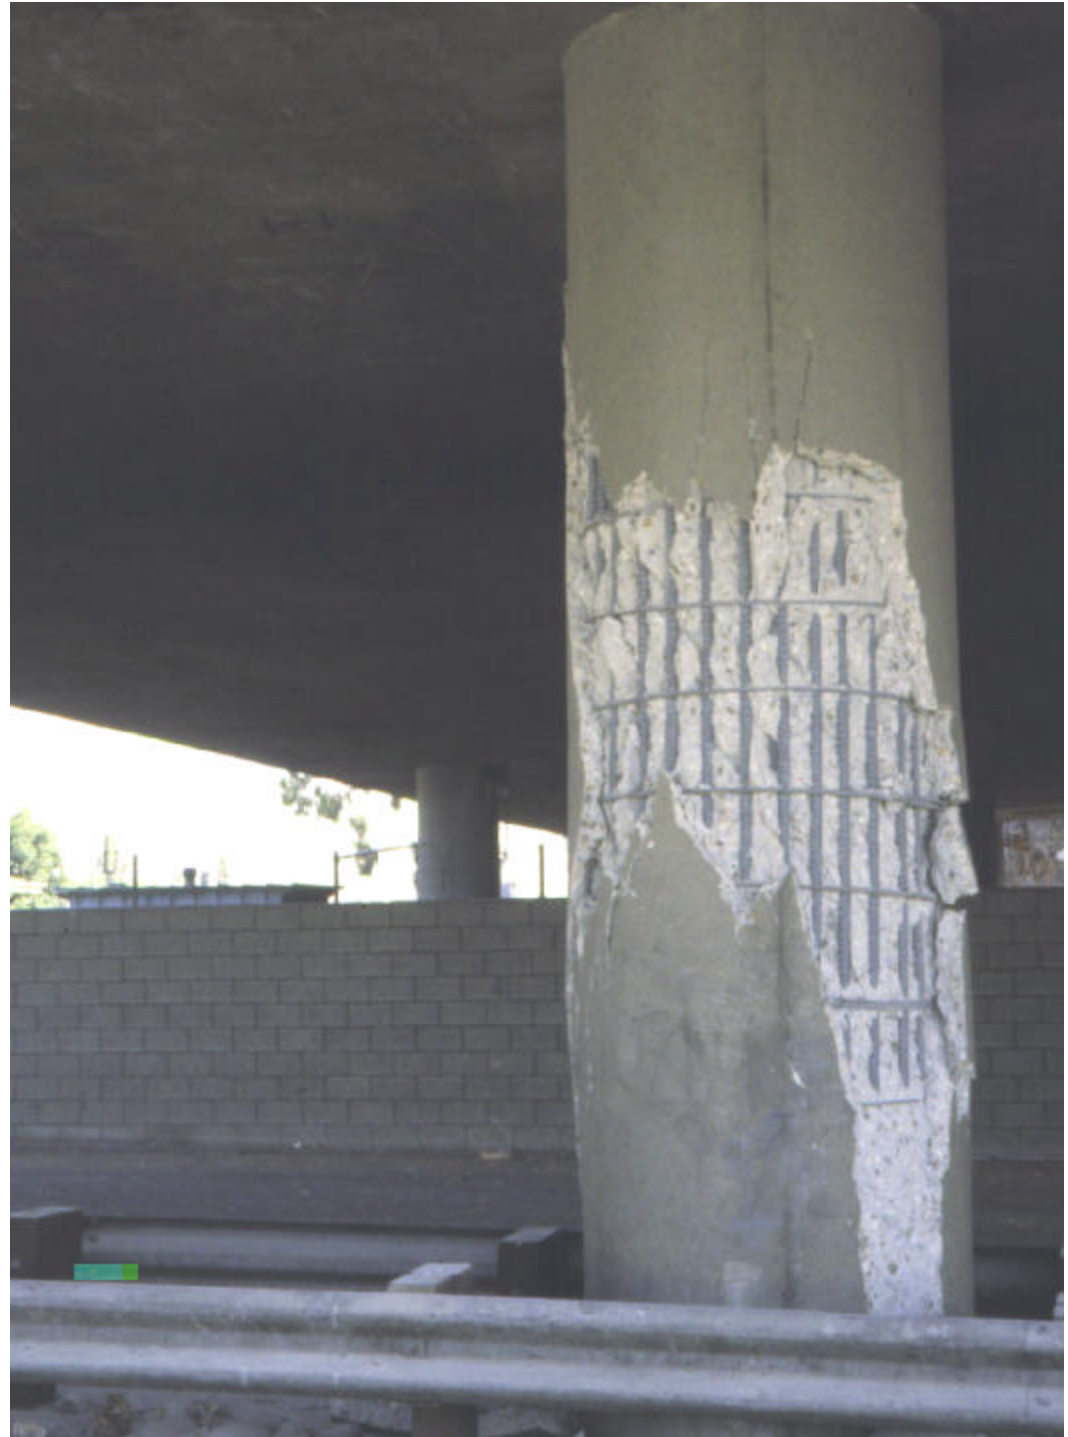
I10 at Fairfax Ave.,  
1994 Northridge Eq.  
(M.O. Eberhard)

# Columns: Shear Failure

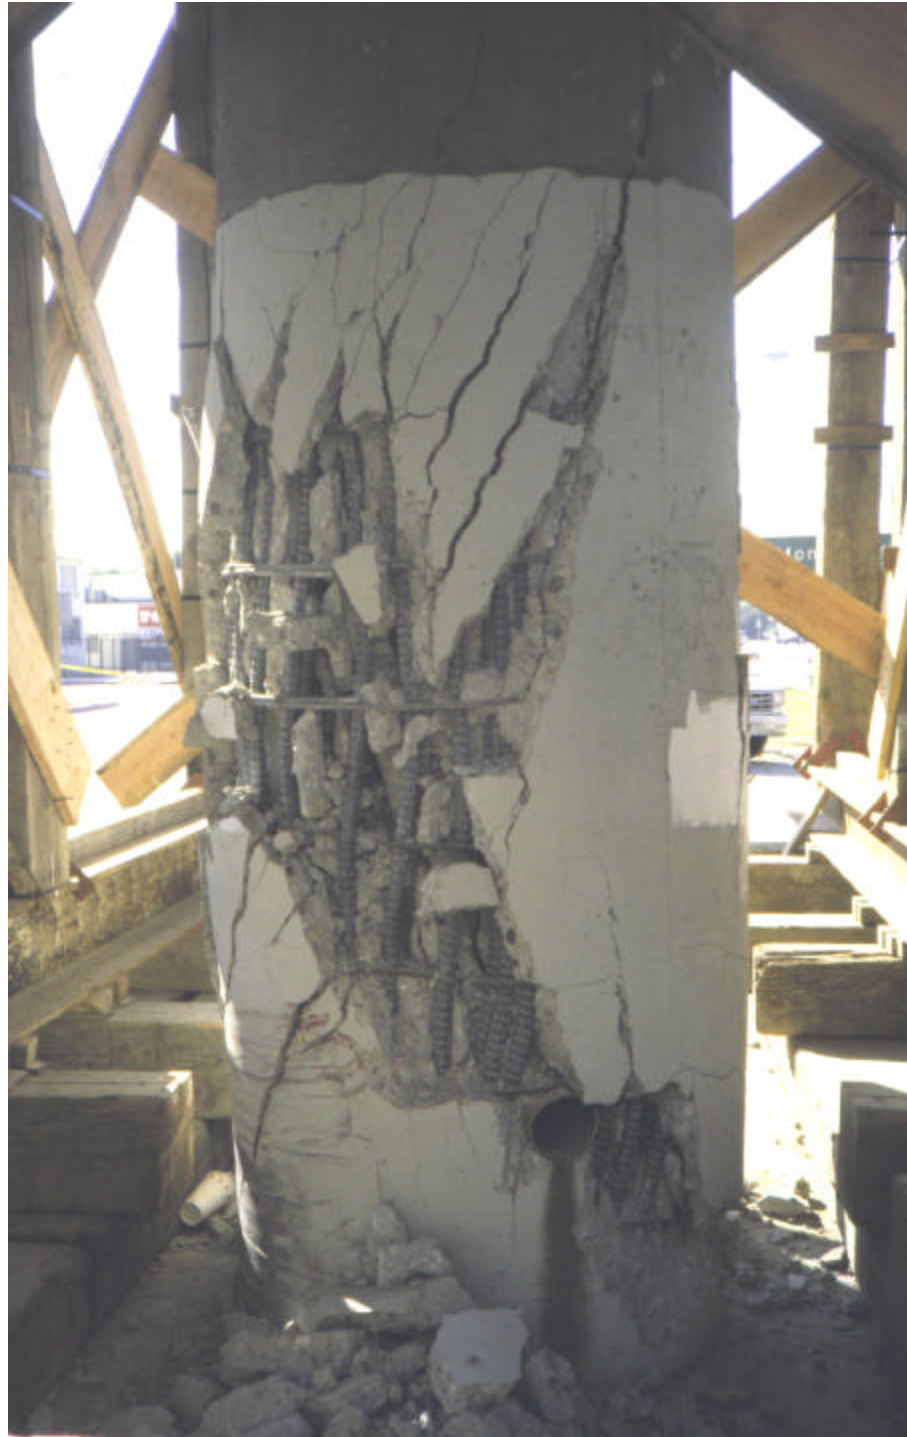
I10 at Venice/La  
Cienega Ave.,  
1994 Northridge Eq.  
(M.O. Eberhard)

# Columns: Shear Failure

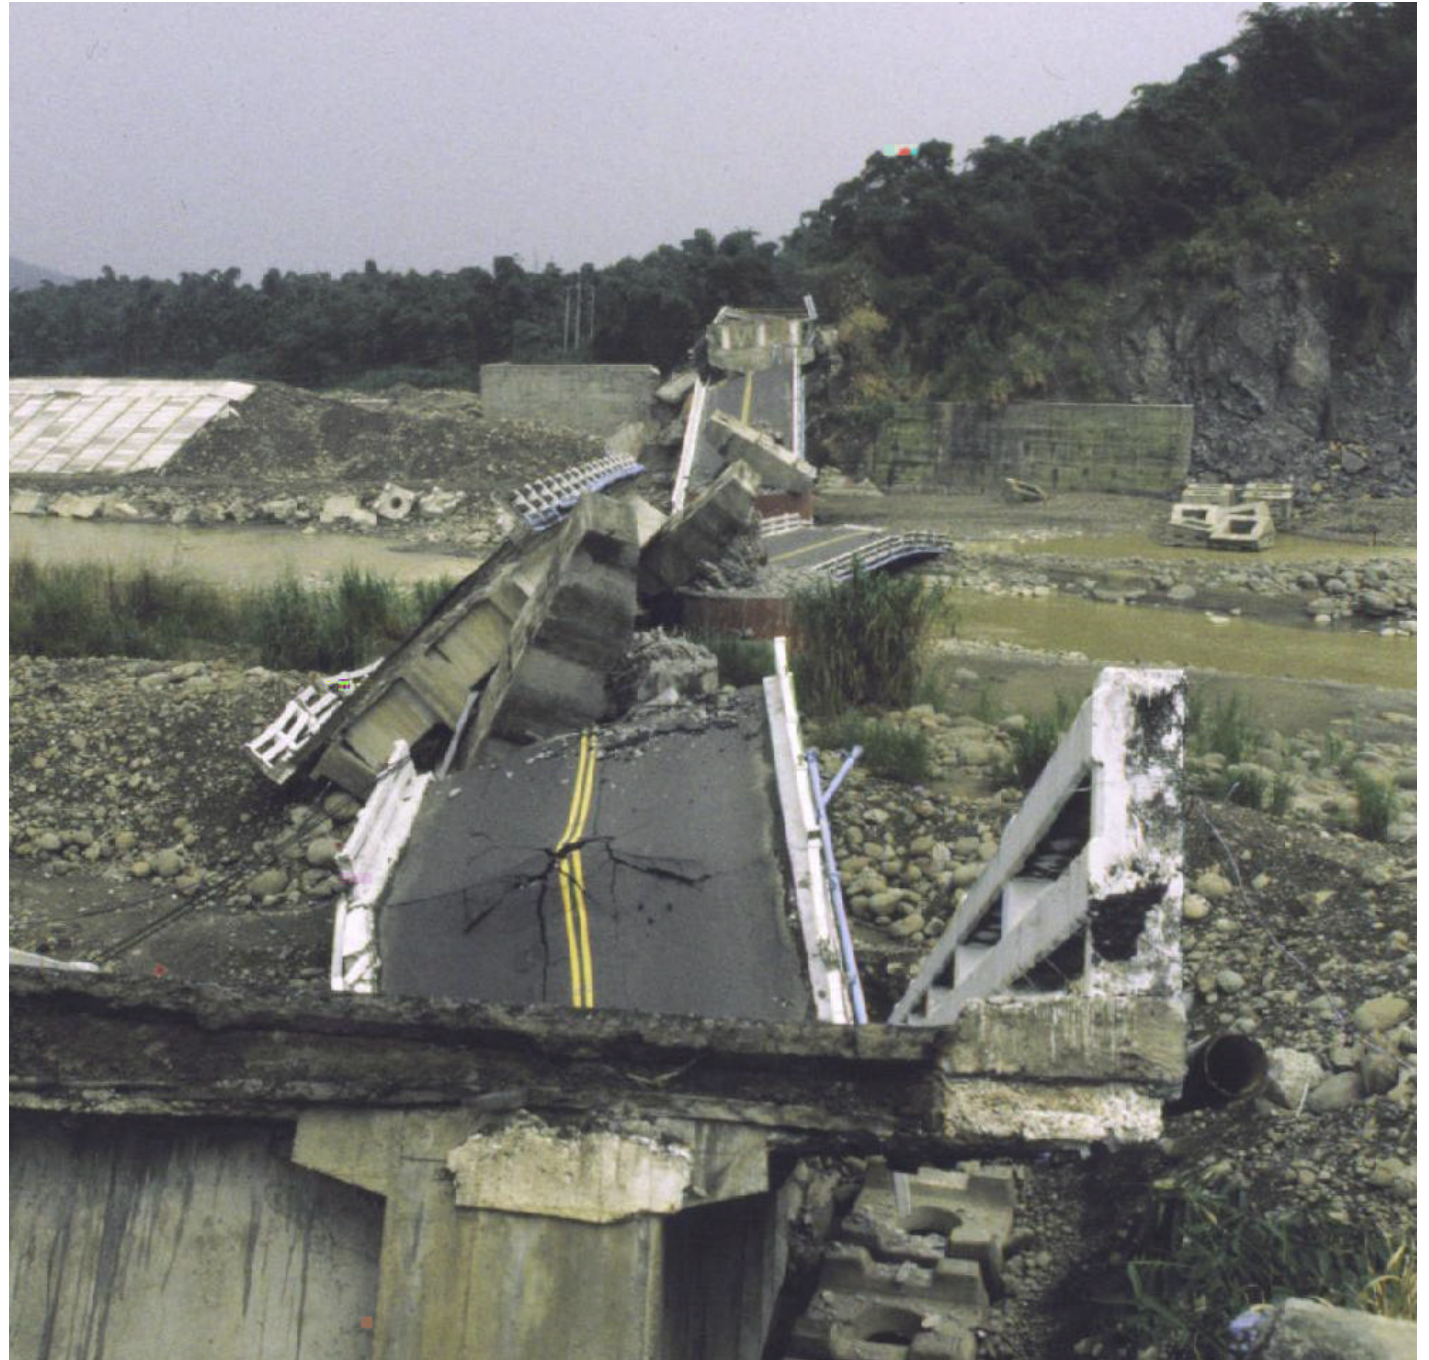
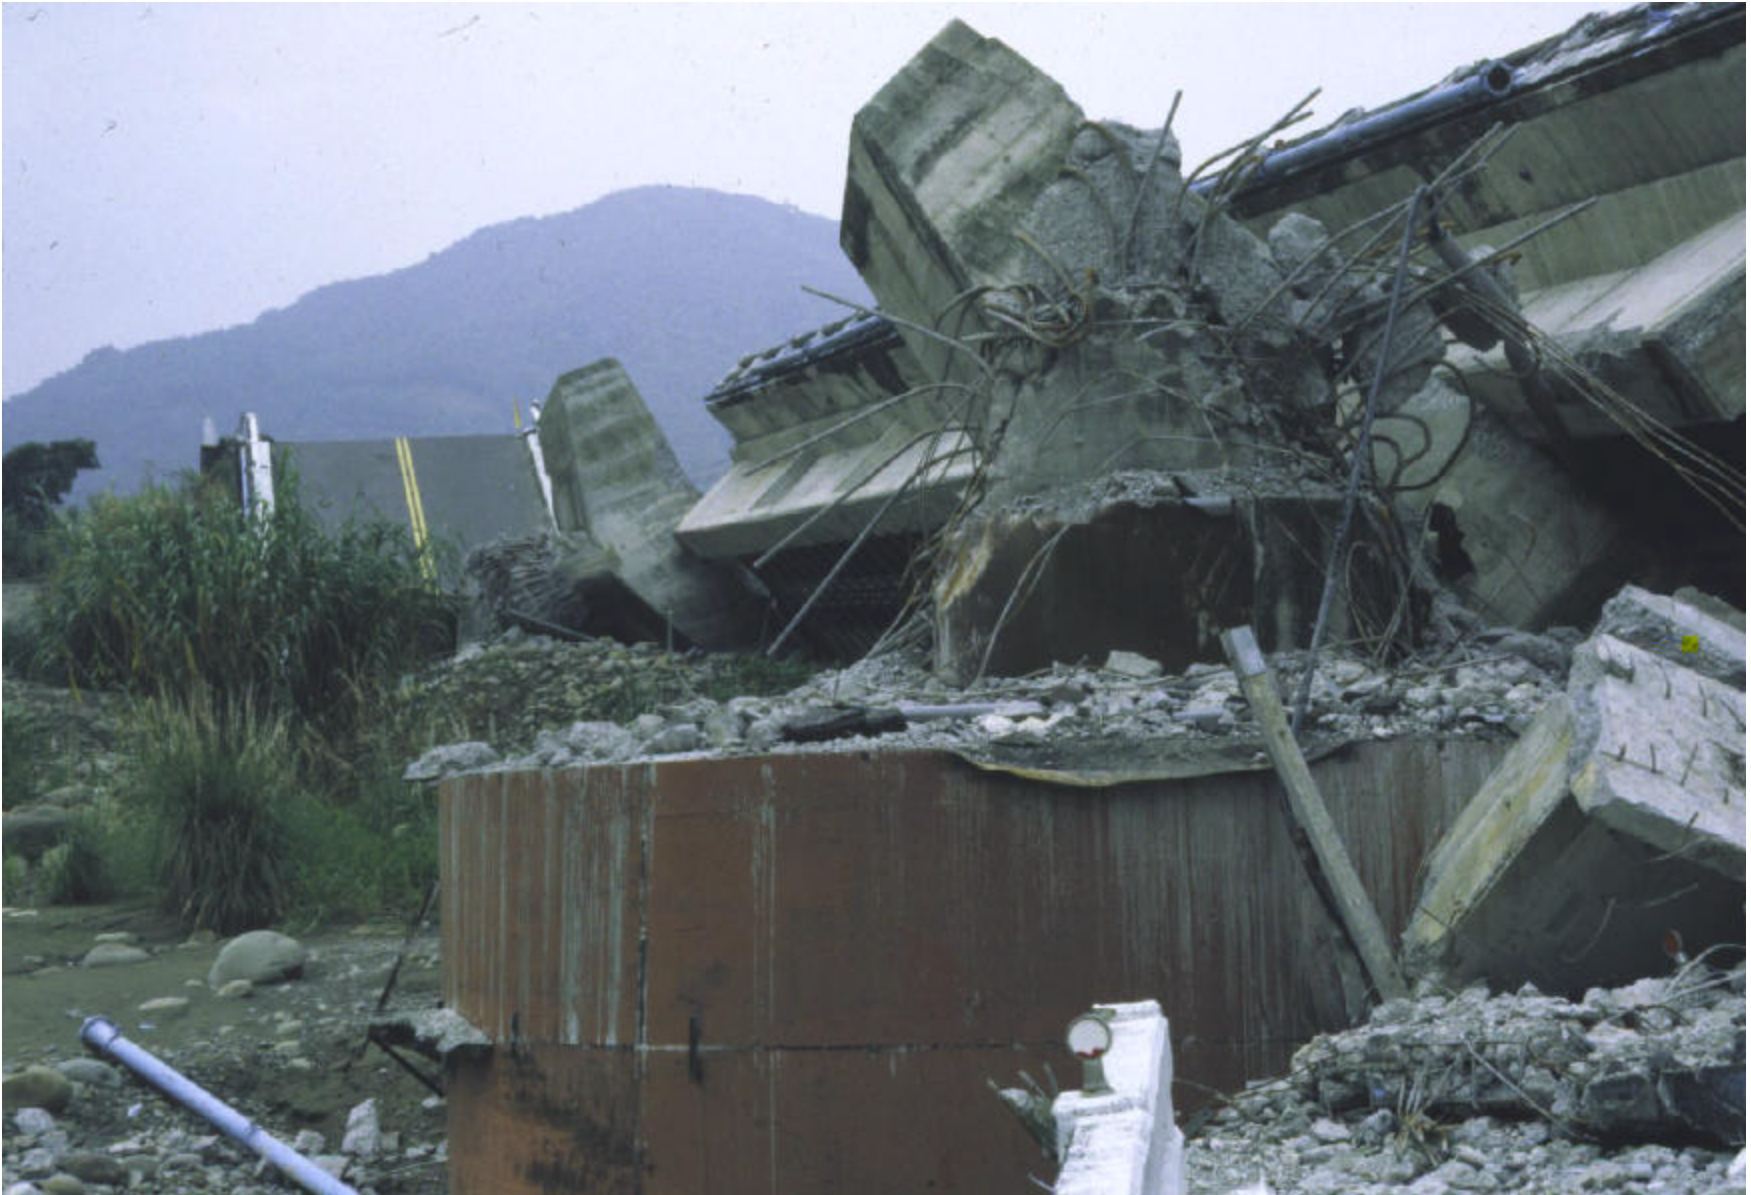
Toong-Tour Bridge, 921 Taiwan Eq. (1999) (M.O. Eberhard)

# Columns: Shear Failure

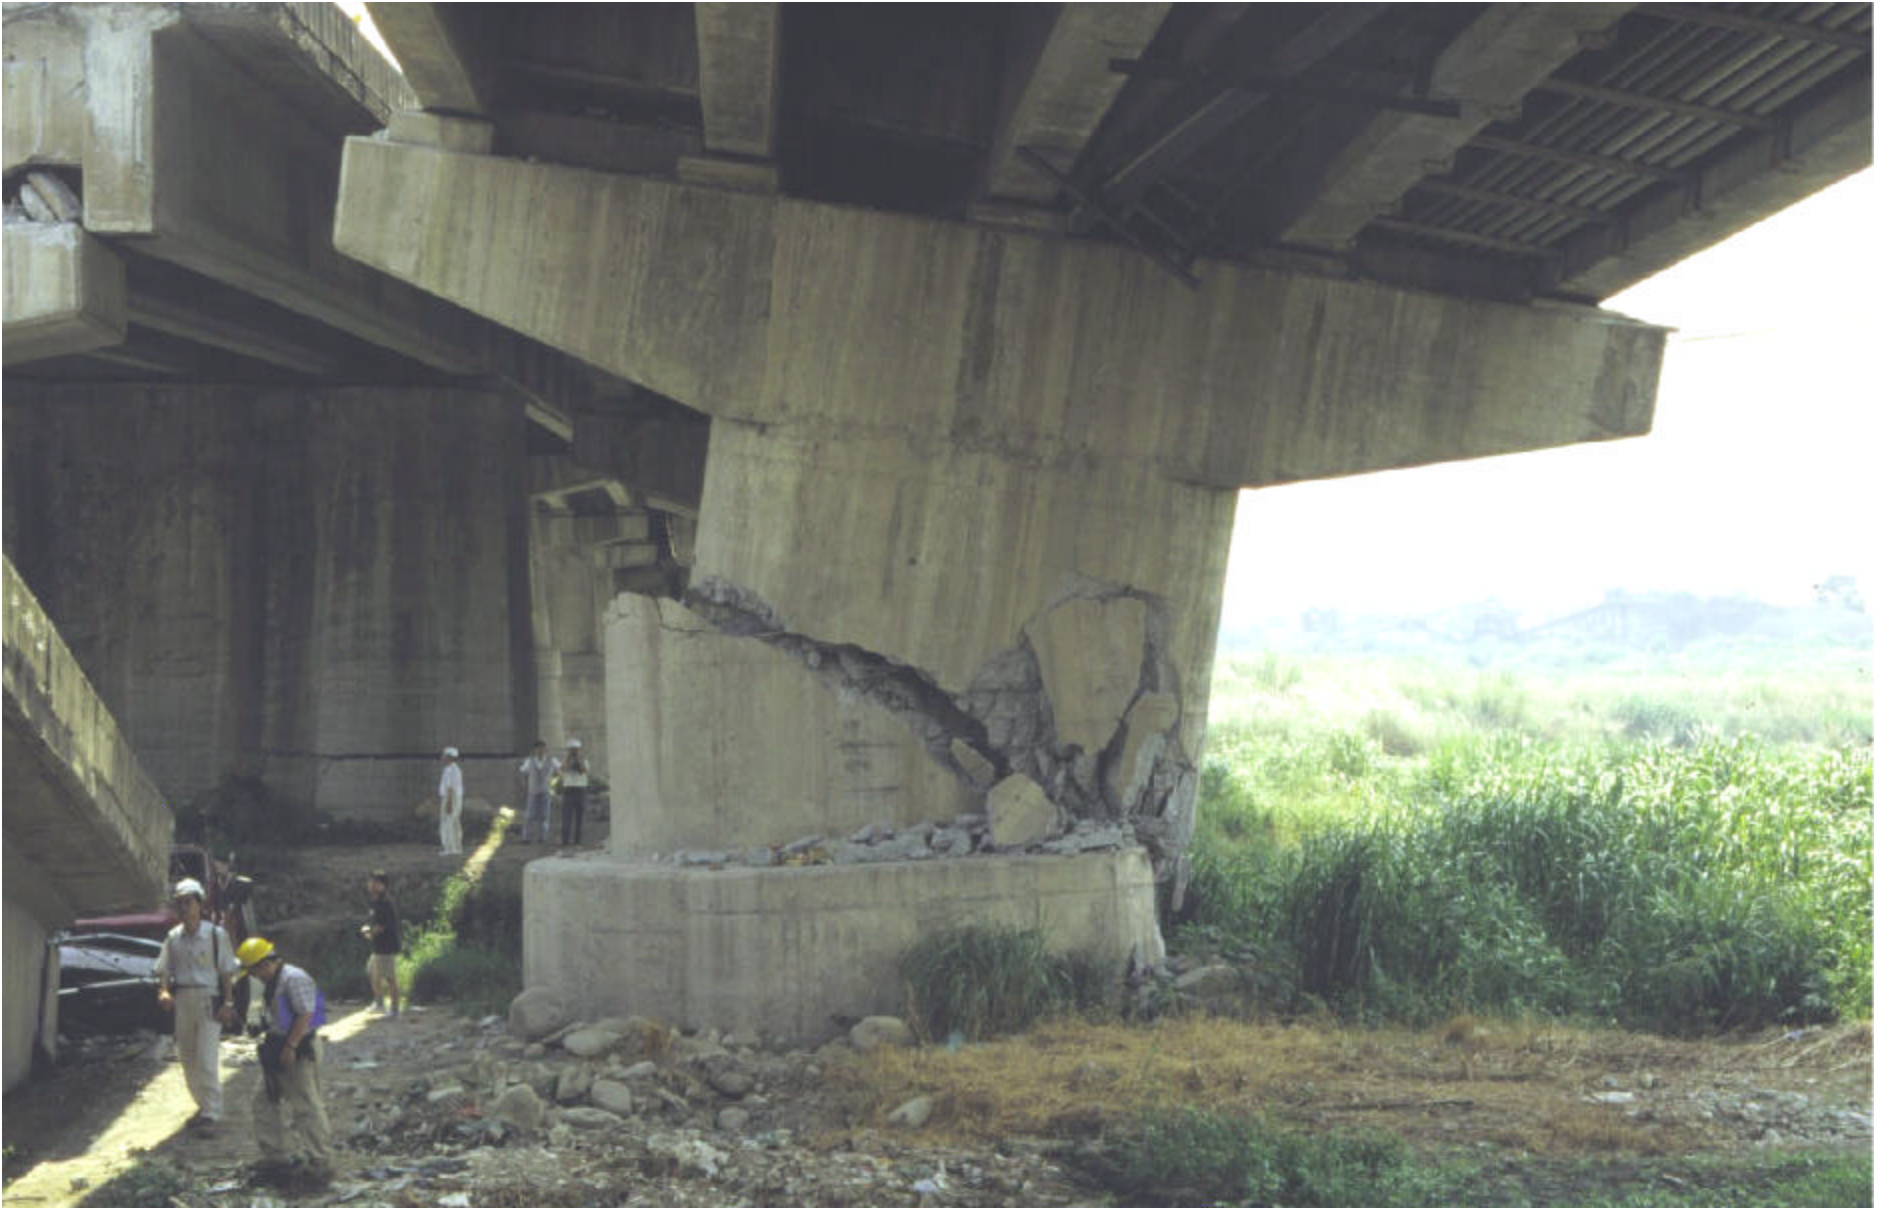
U-Shi Bridge, 1999 Chi-Chi Eq. (M.O. Eberhard)

# Piers: Shear Failure

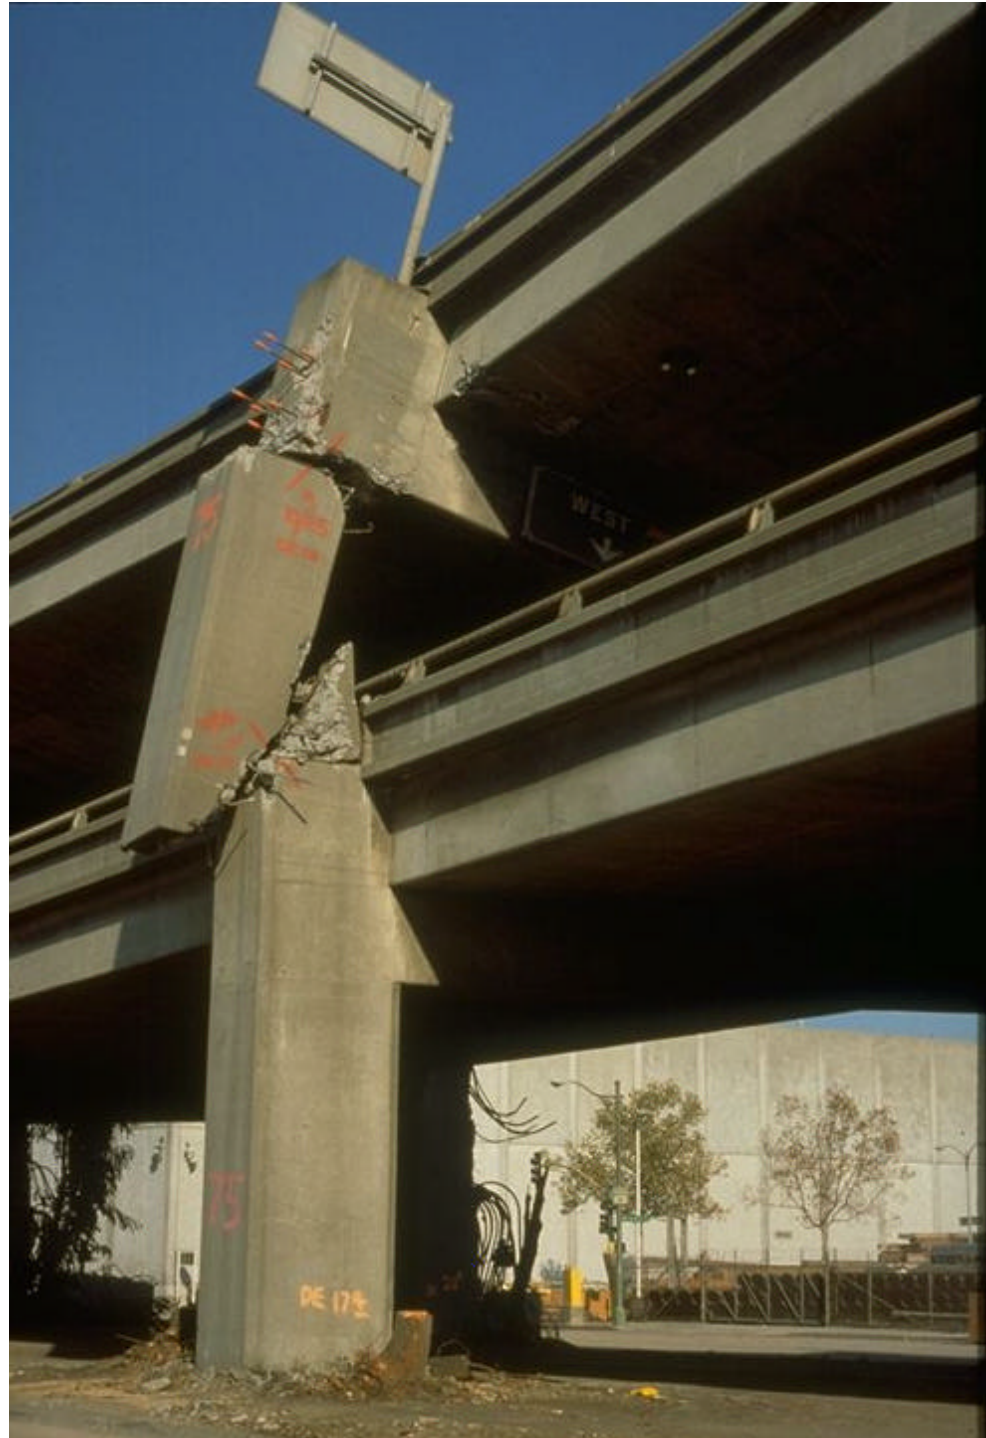
Cypress Structure  
1989 Loma Prieta  
Earthquake  
(Loma Prieta  
Collection, EERC  
Library)

# Joints

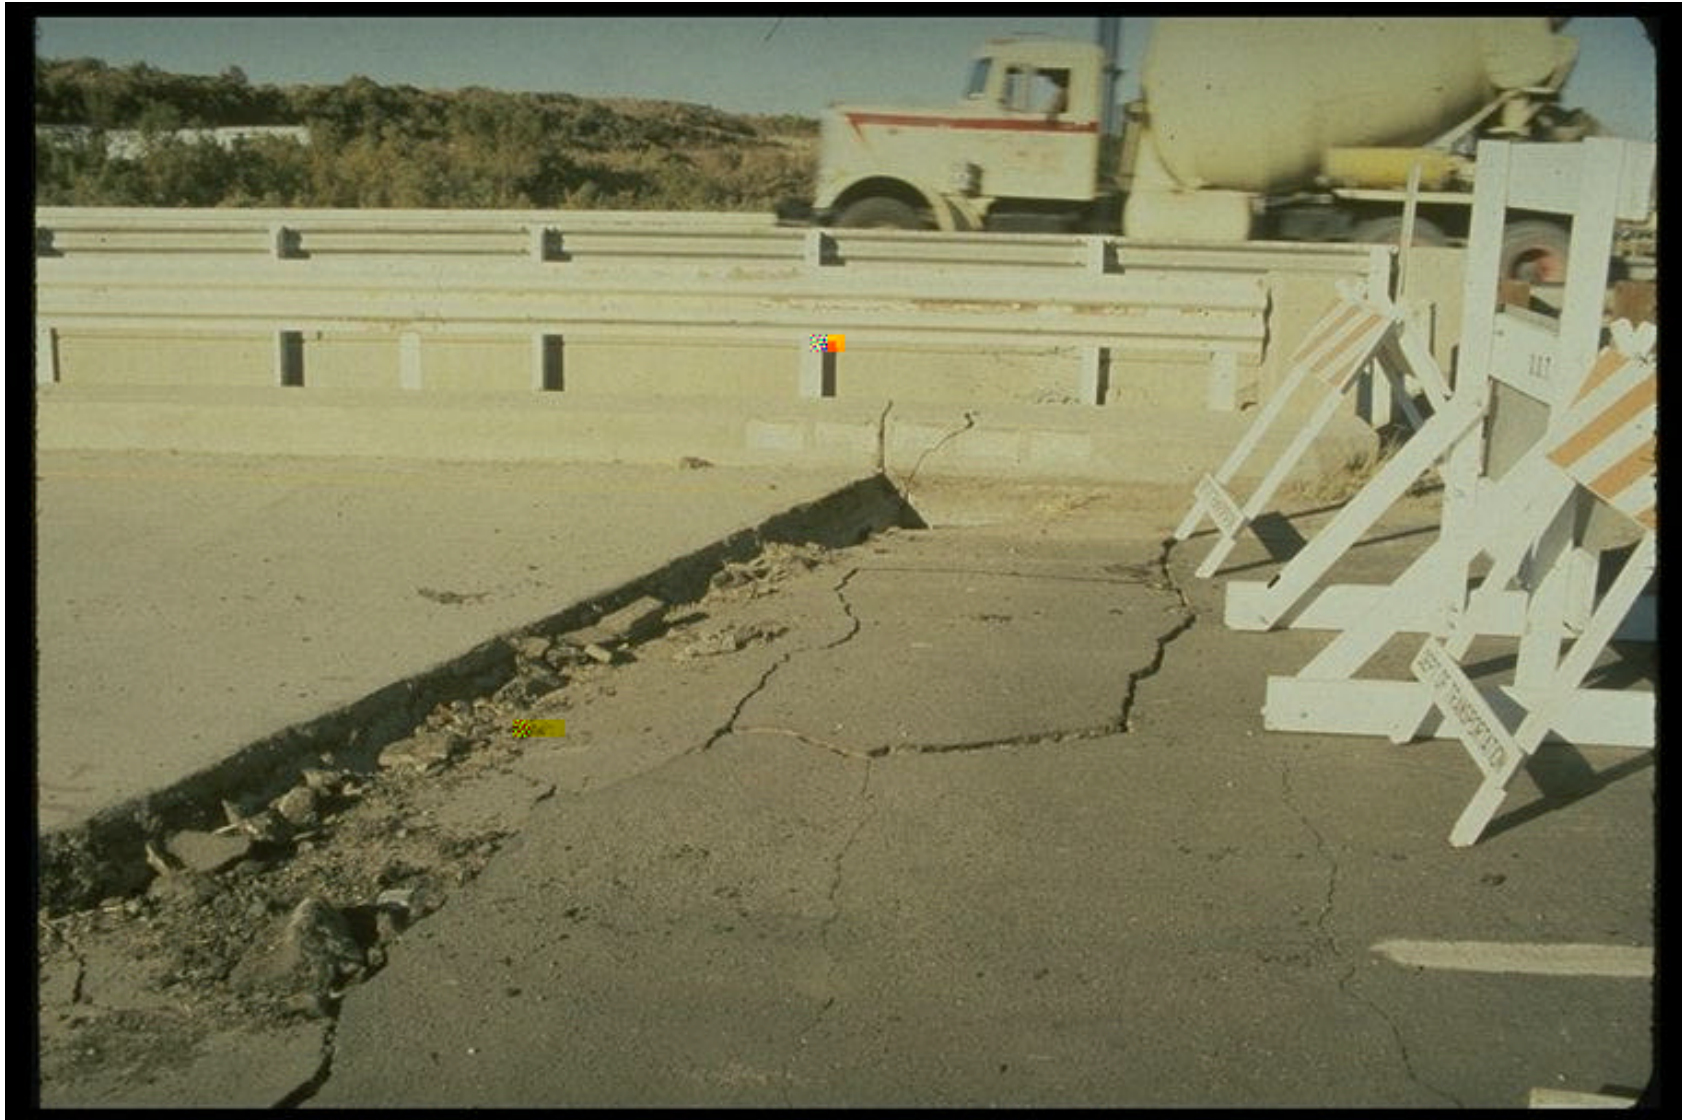
New River Bridge, 1979 Imperial Valley Eq.  
(Steinbrugge Collection, EERC)

# Approaches

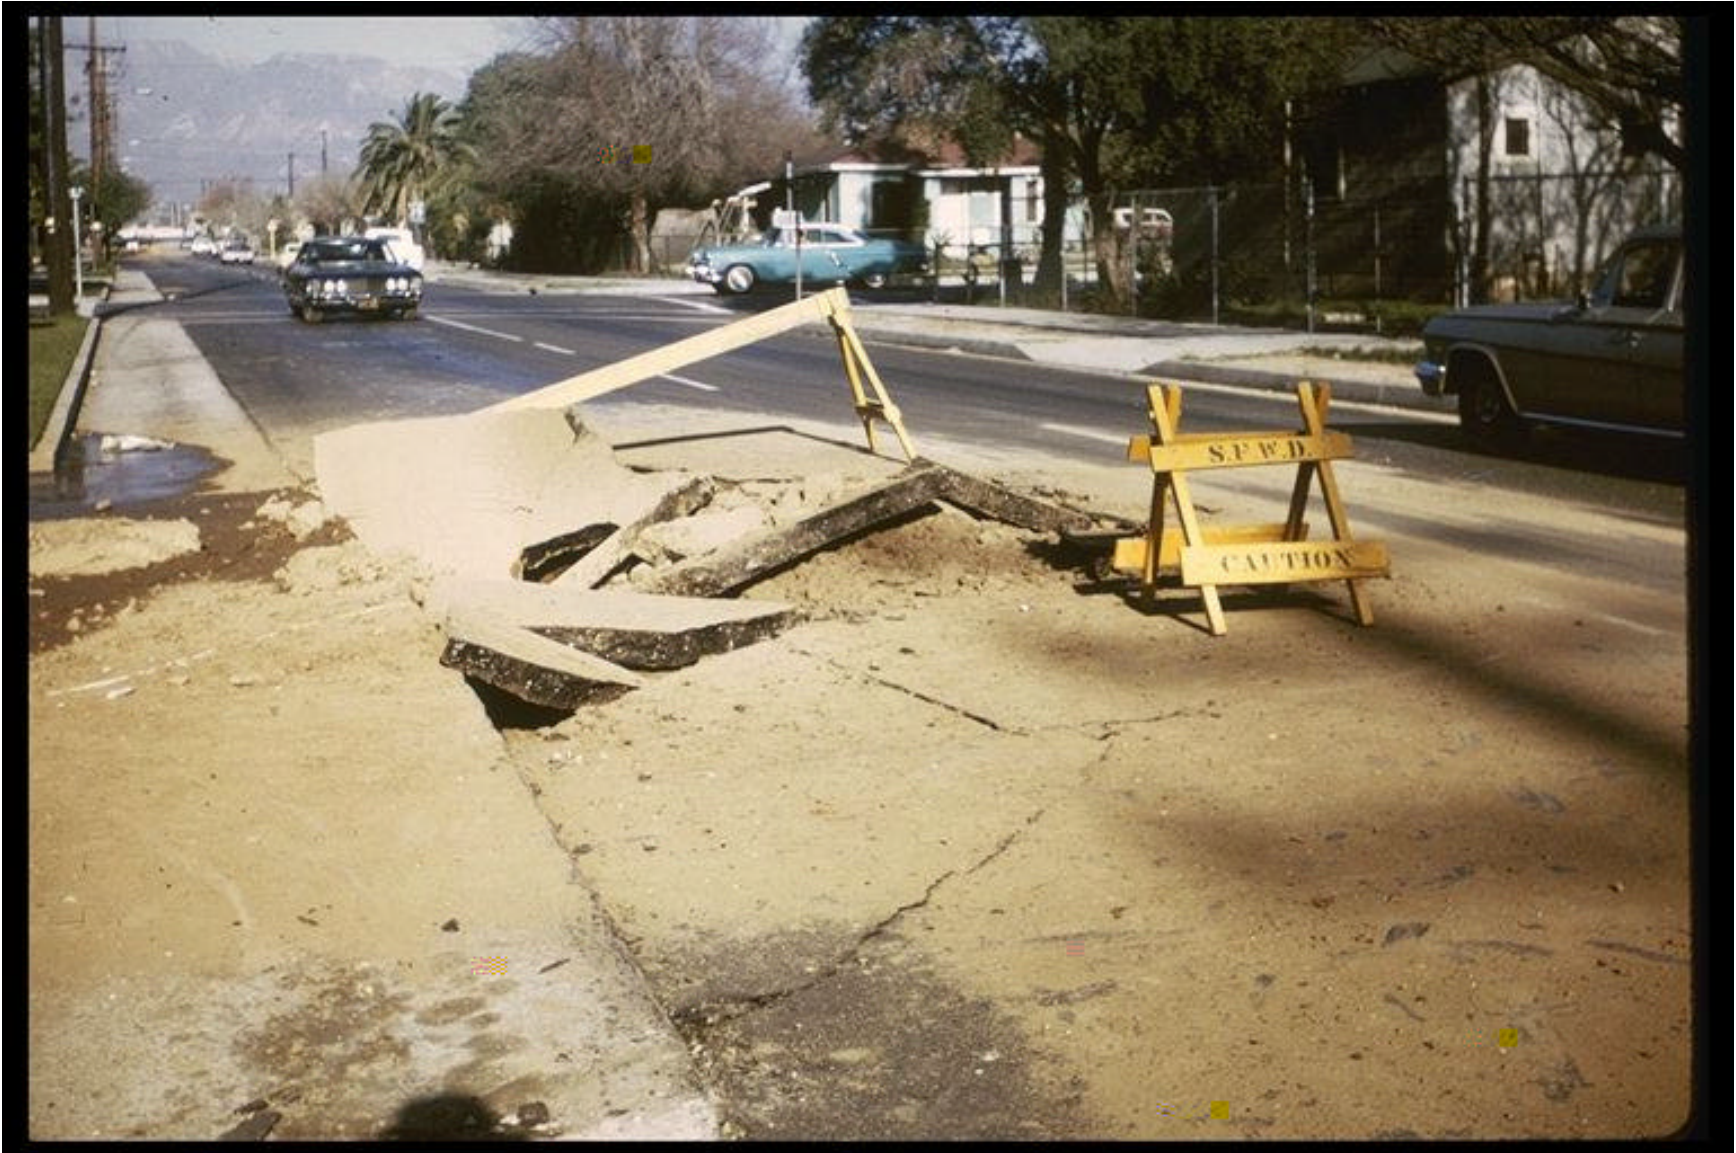
1971 San Fernando Eq. (Steinbrugge Collection, EERC)

# Roadways: (pipe failure)

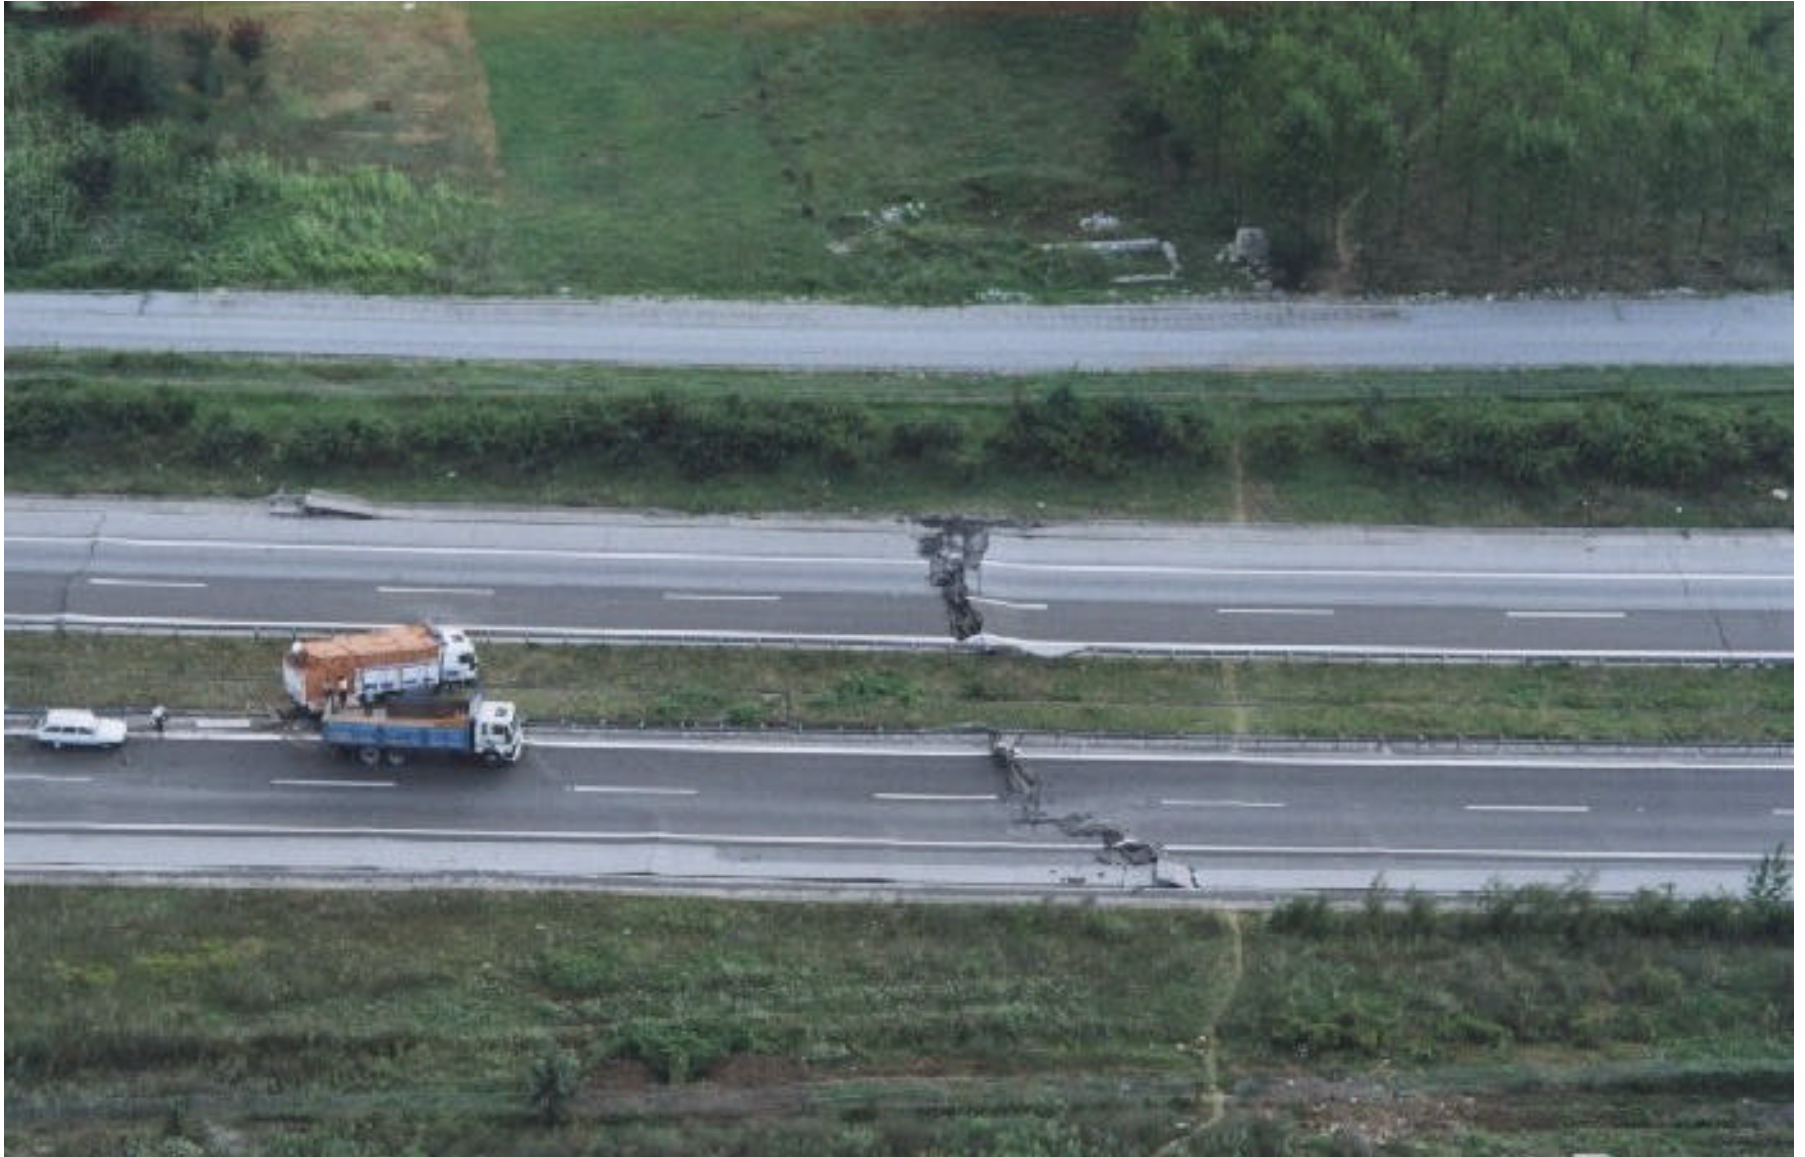
Roadway, 1999 Kocaeli Eq. (KOERI)

# Roadways: (Surface Rupture)

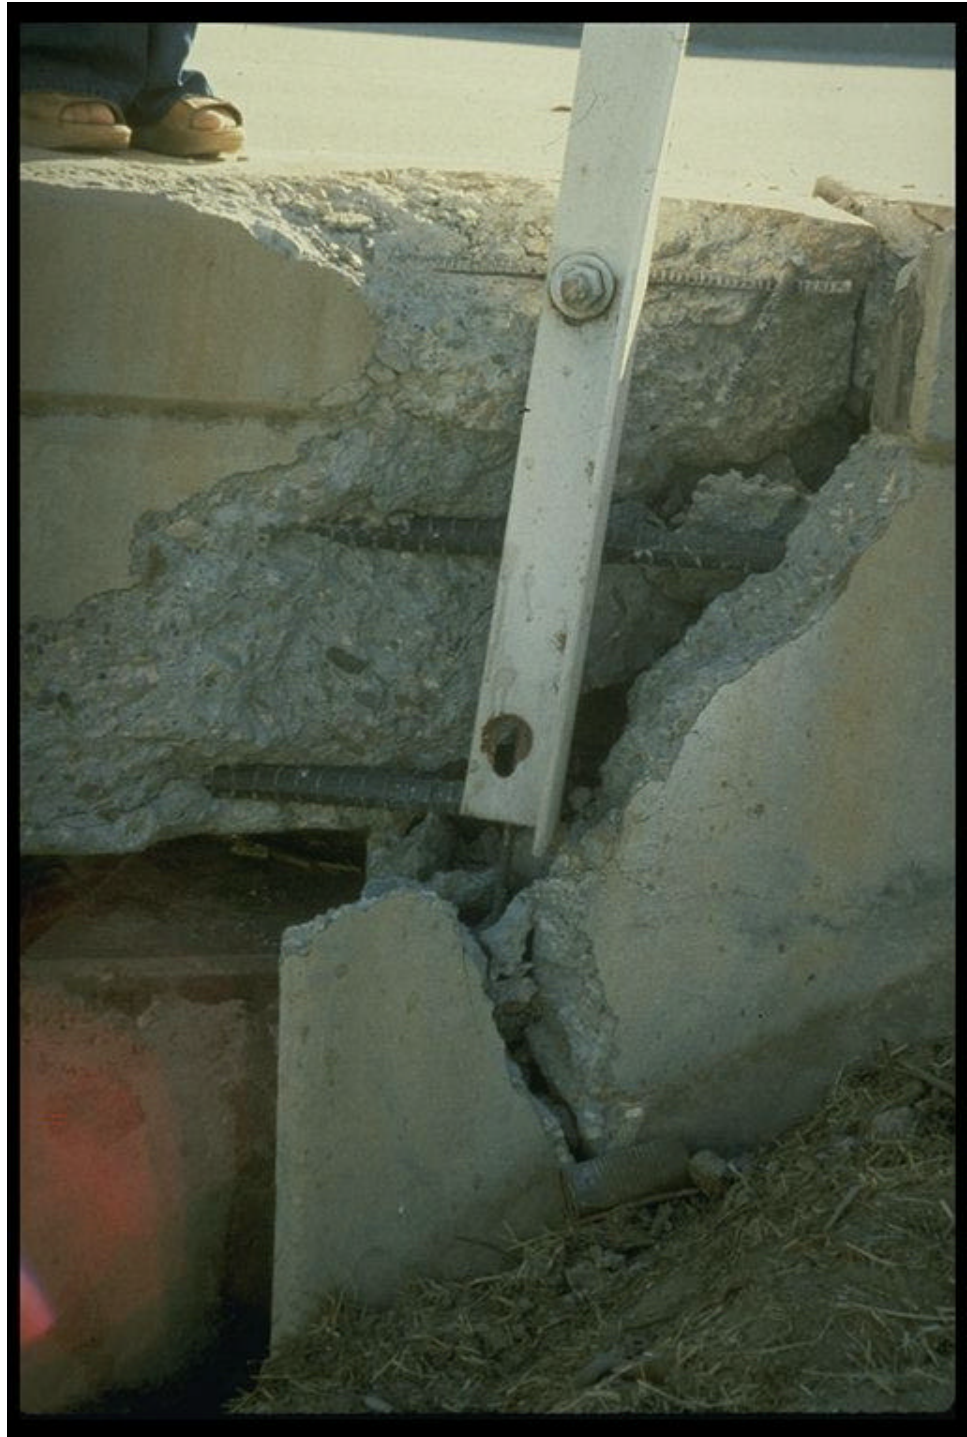
New River Bridge,  
1979 Imperial  
Valley Eq.  
(Steinbrugge  
Collection, EERC)

# Abutments

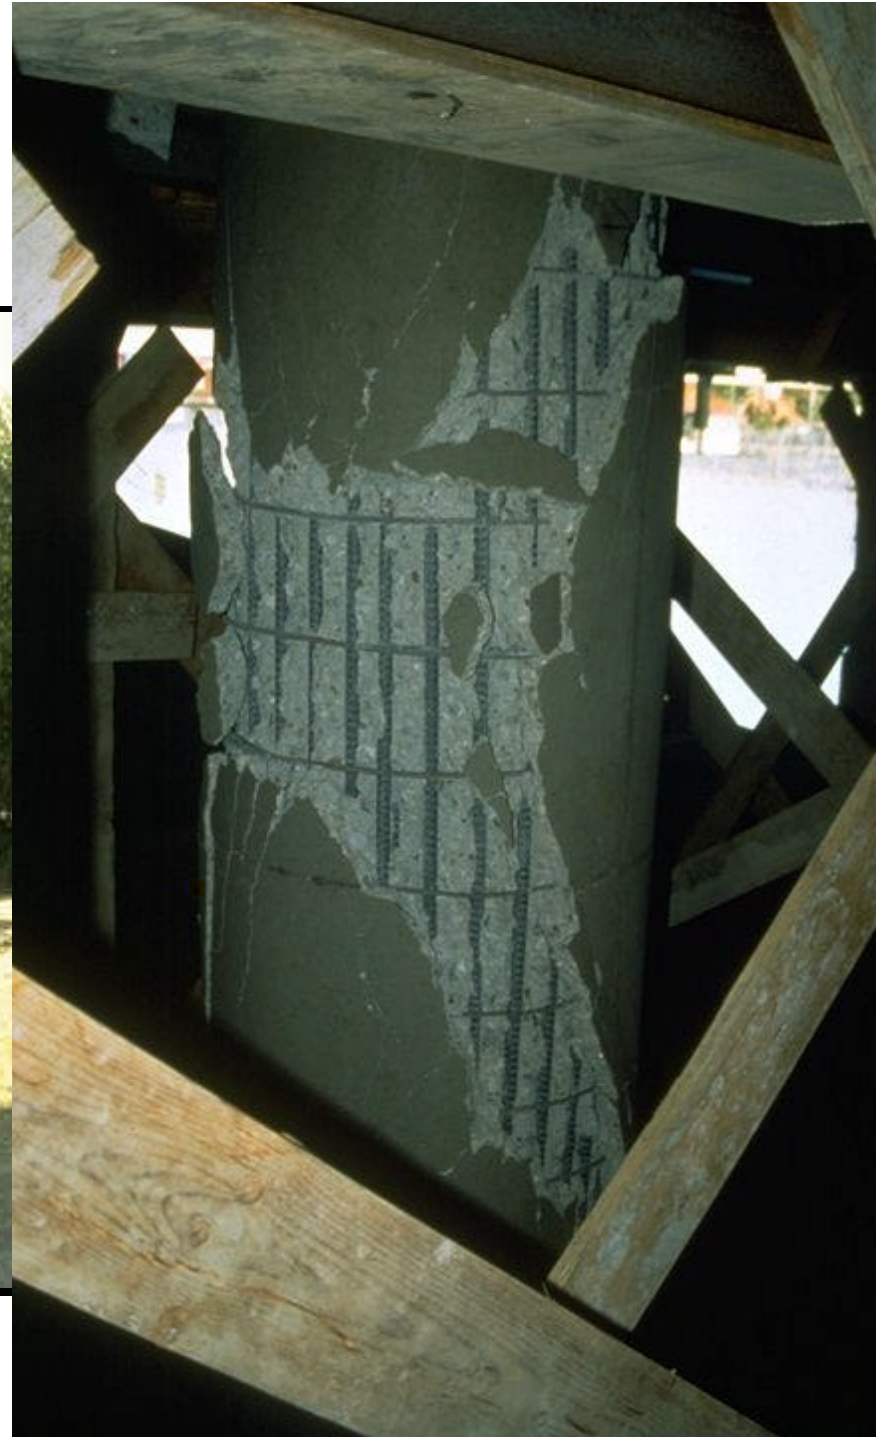
- Examine Flexural and Shear Cracks
  - Possible Complications
    - Spalled Concrete
    - Exposed Reinforcing Steel
- Mark Cracks
- Record Crack Path and Location
  - Make Sketch
  - Note Crack Width

# Mark Cracks

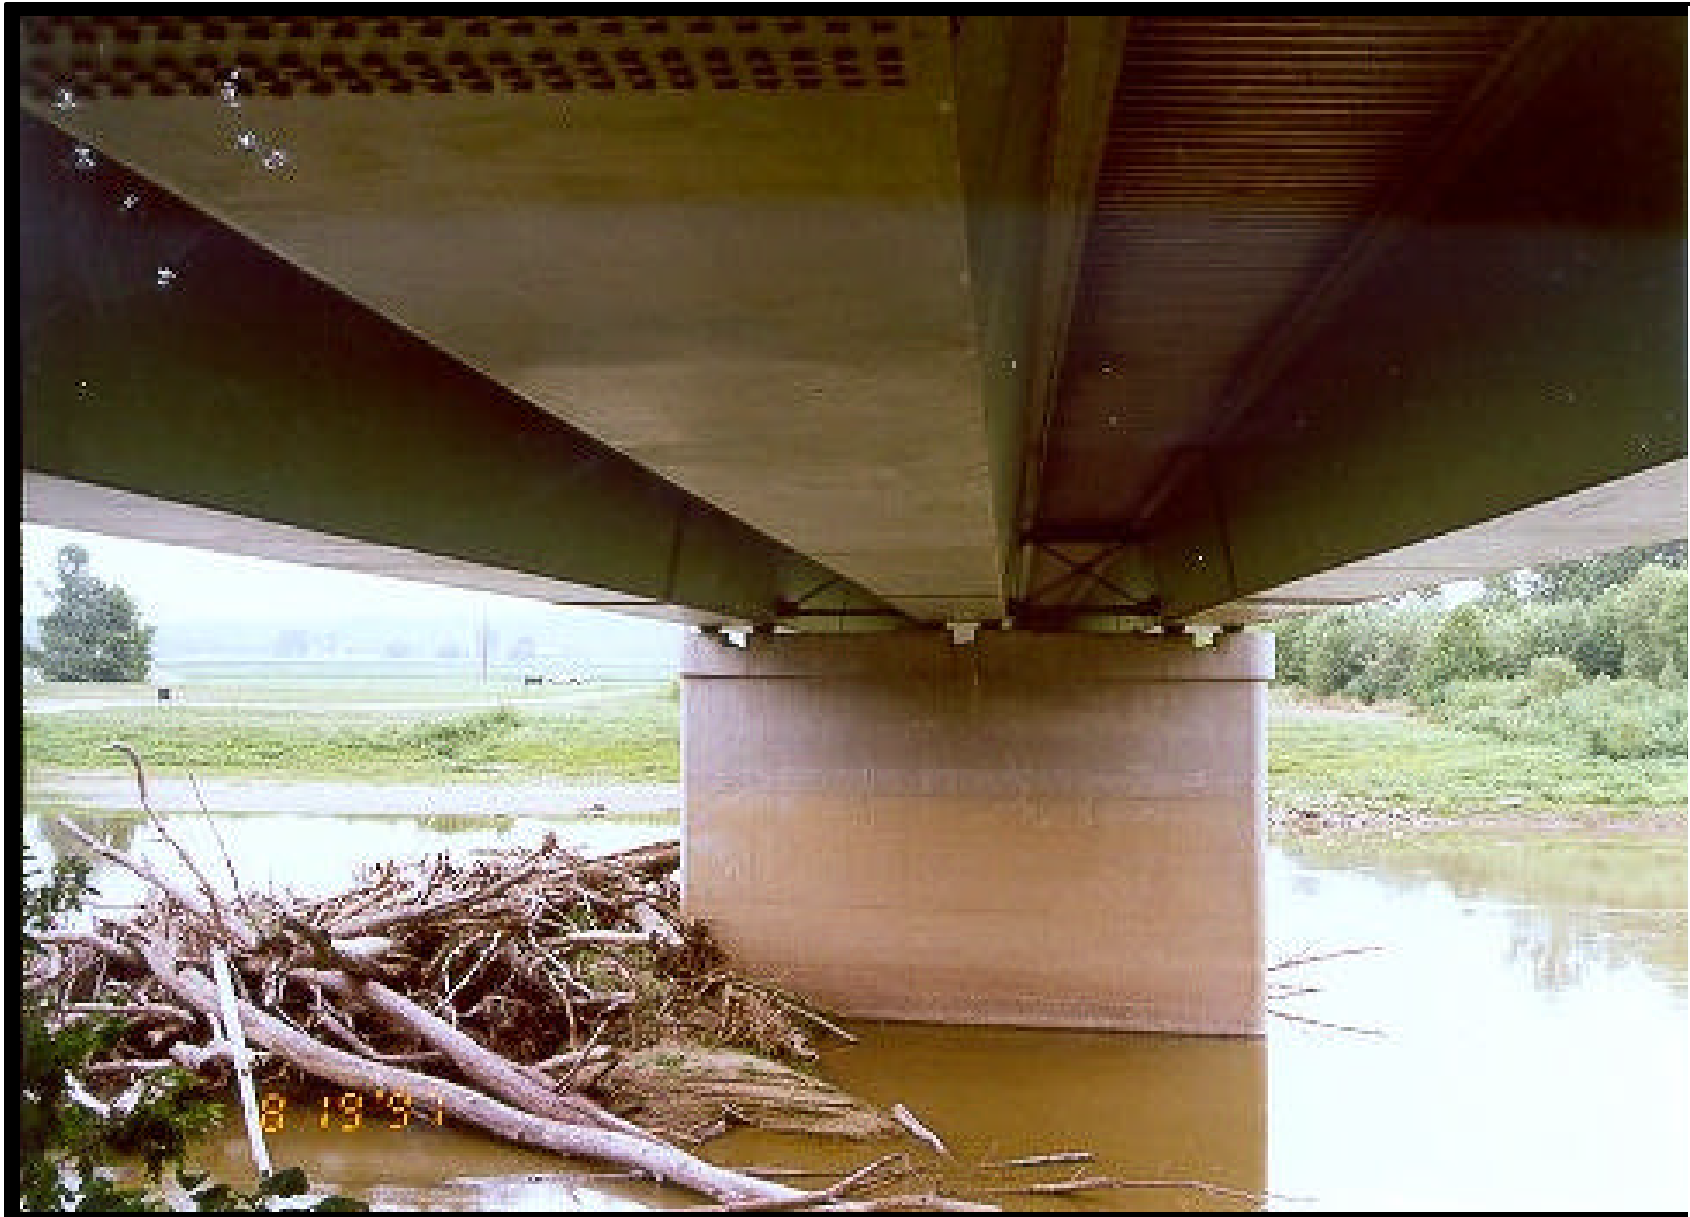
- Elements Not Readily Inspected
  - Box Girders
  - Piles
- Provide Access
  - Open Box Girder Holes
  - Excavate Soil around Footings

# Box Girders
