# POST-EARTHQUAKE SAFETY EVALUATION OF BRIDGES AND ROADS

Purdue University and  
Joint Transportation Research Board

Bridges and Damage Examples

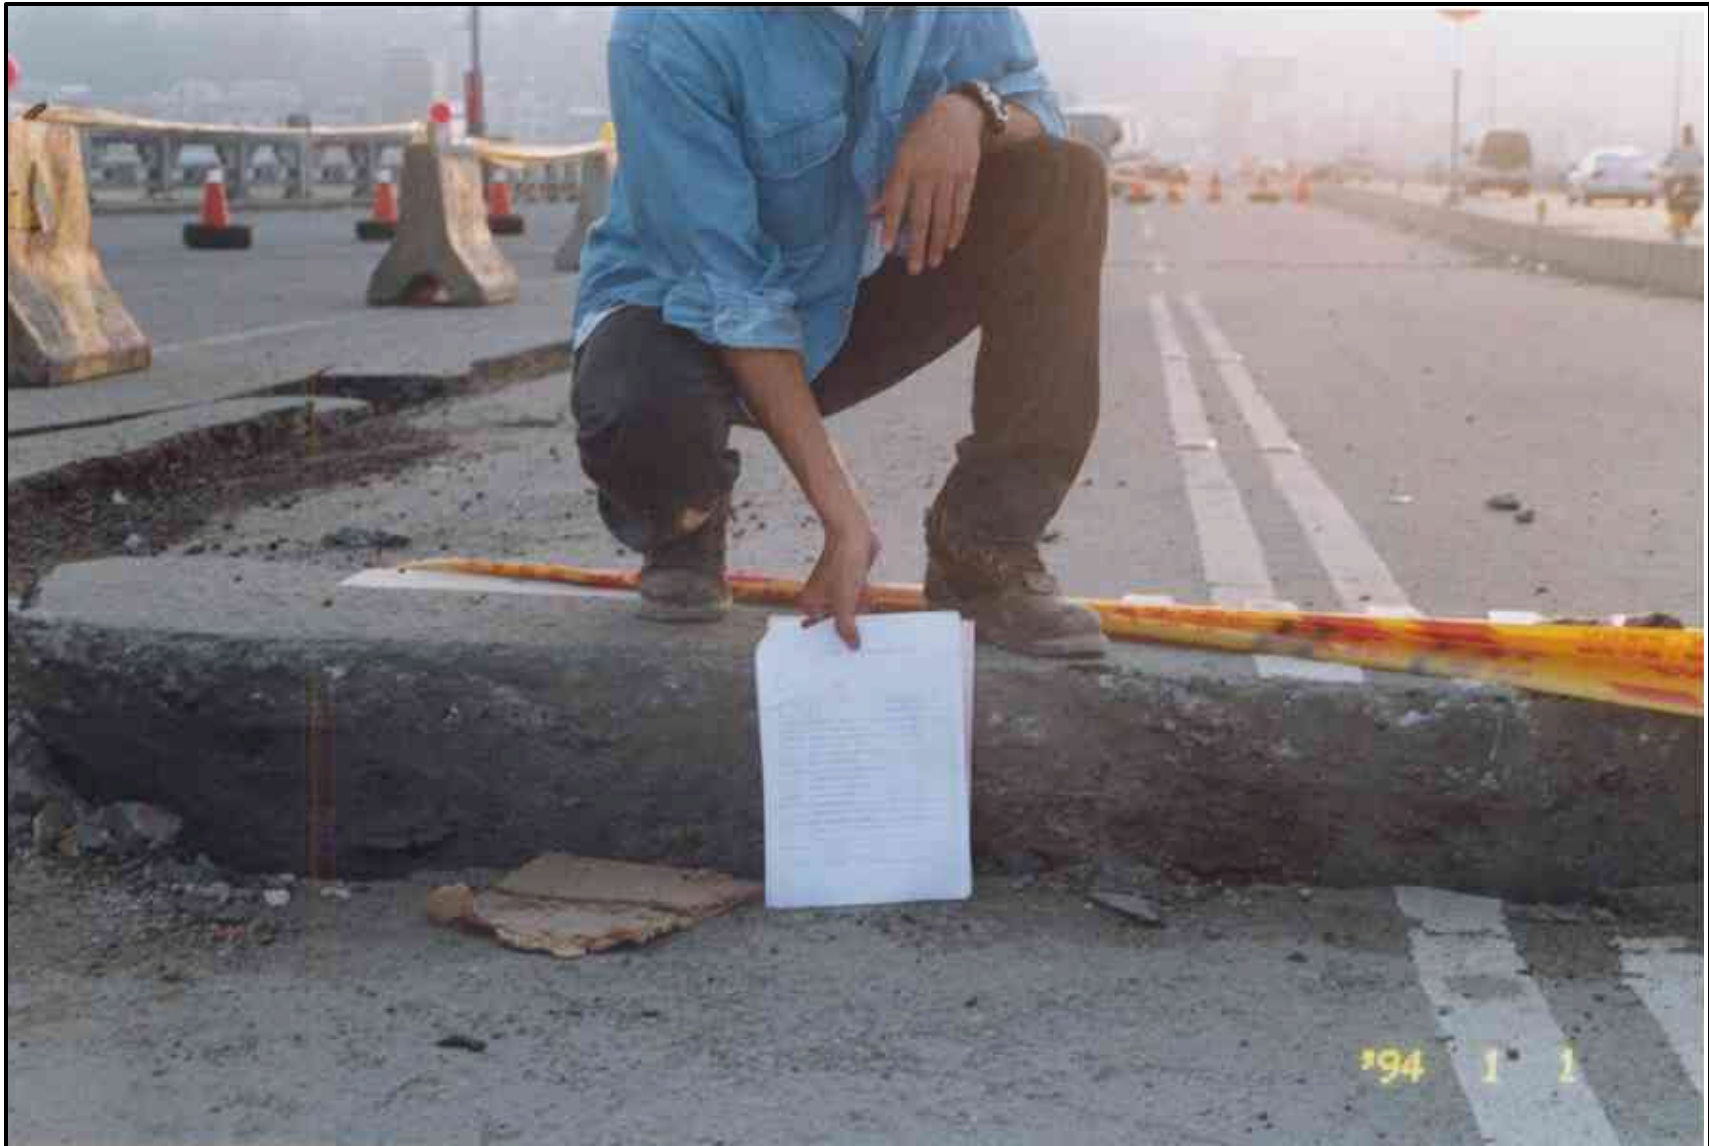
- Local
  - Risks to Users
  - No Risk to Structure
  - Temporary Repair Possible
- Global
  - Risks to Safety of Users
  - Stability of Structure
  - Temporary Repair Not Possible

# Local Damage (Coursery of UCSD)

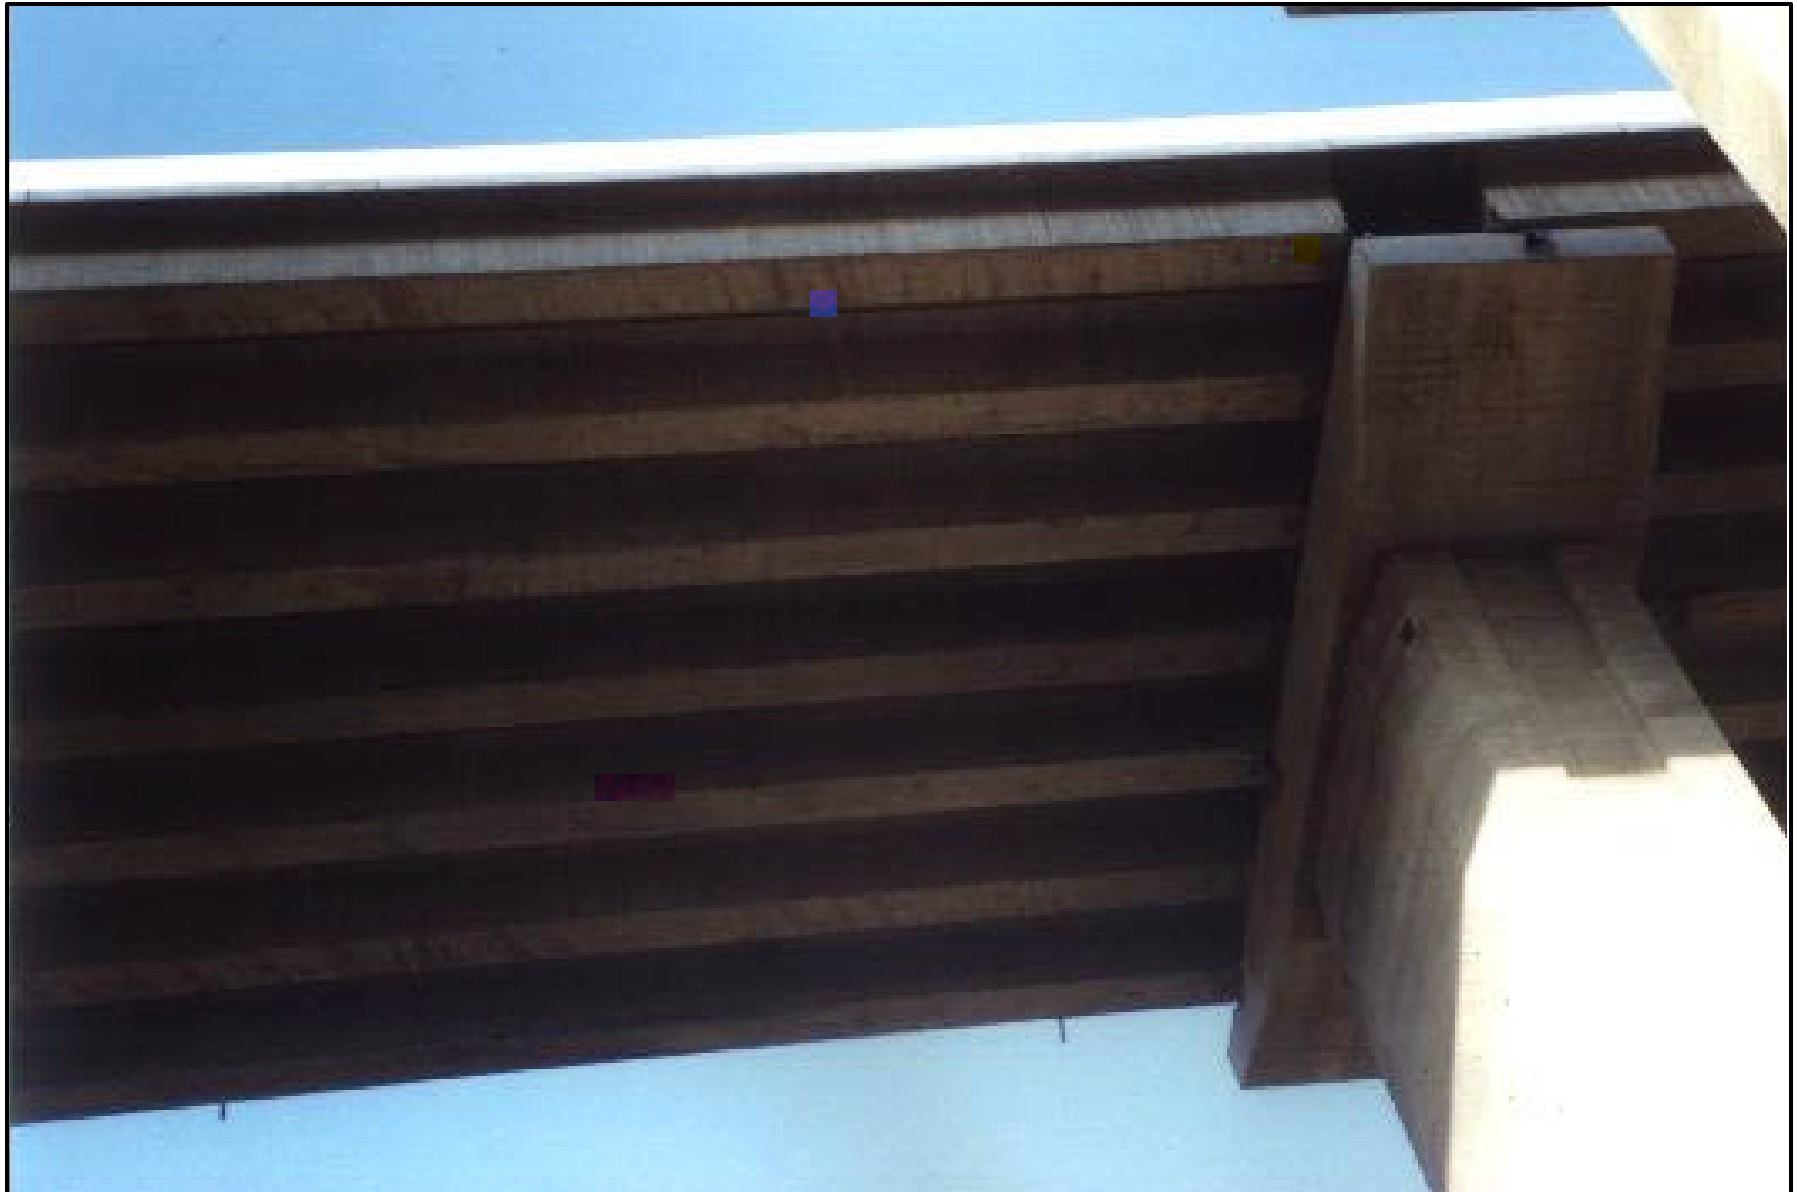
# Global Damage (Courtesy of KOERI)

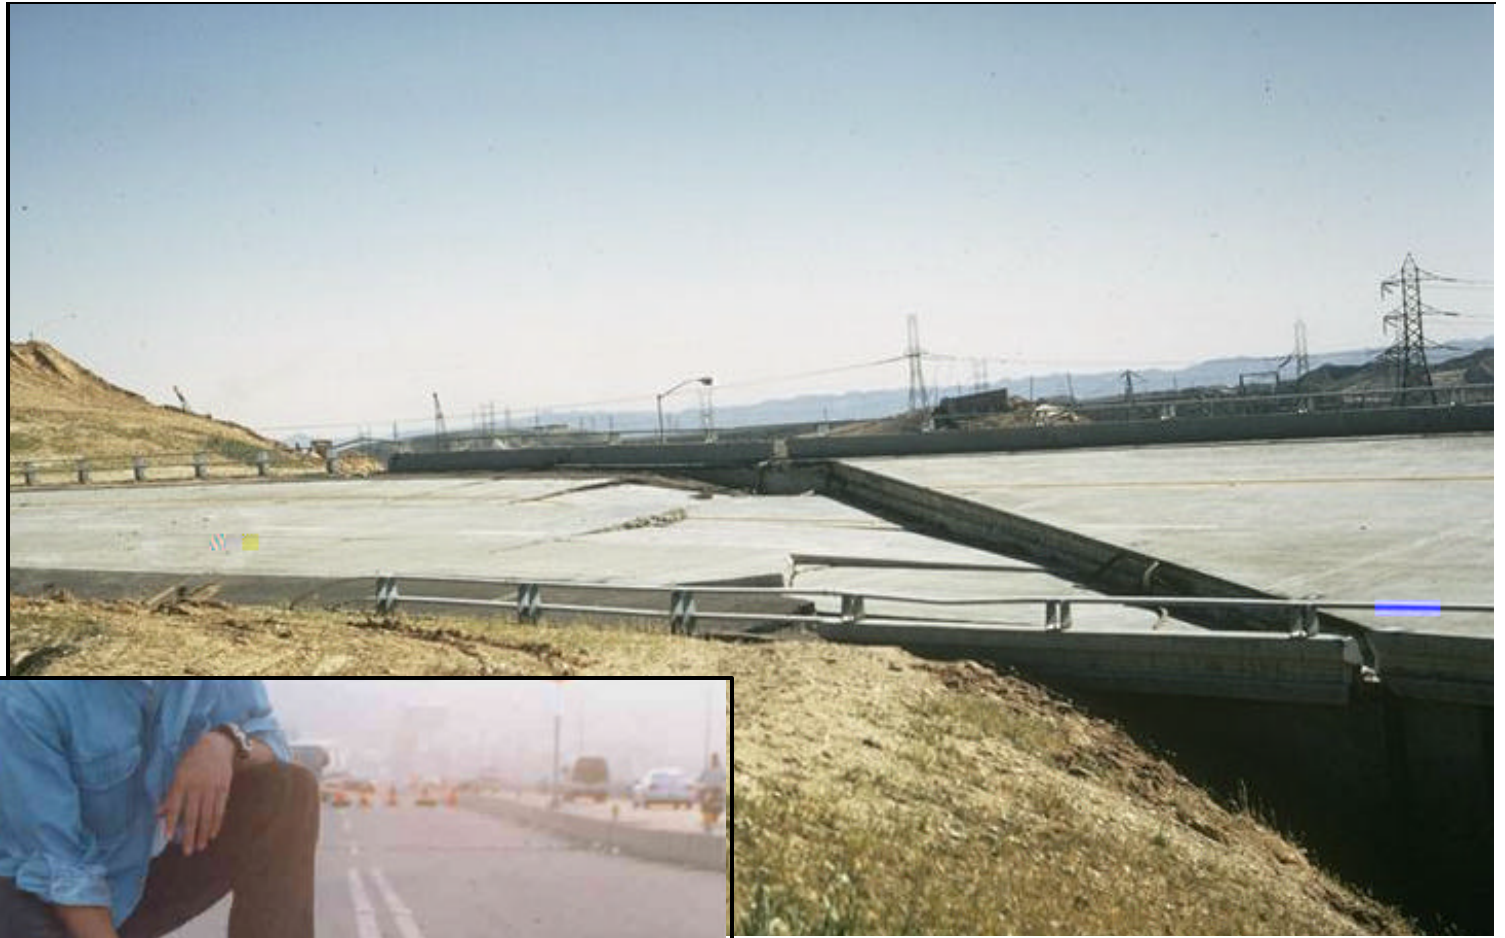
# Transition Repair

- Superstructures Displaced Vertically
  - Approach Settlement
  - Bearing Damage
- Damaged Roadways
  - Discontinuous Riding Surface

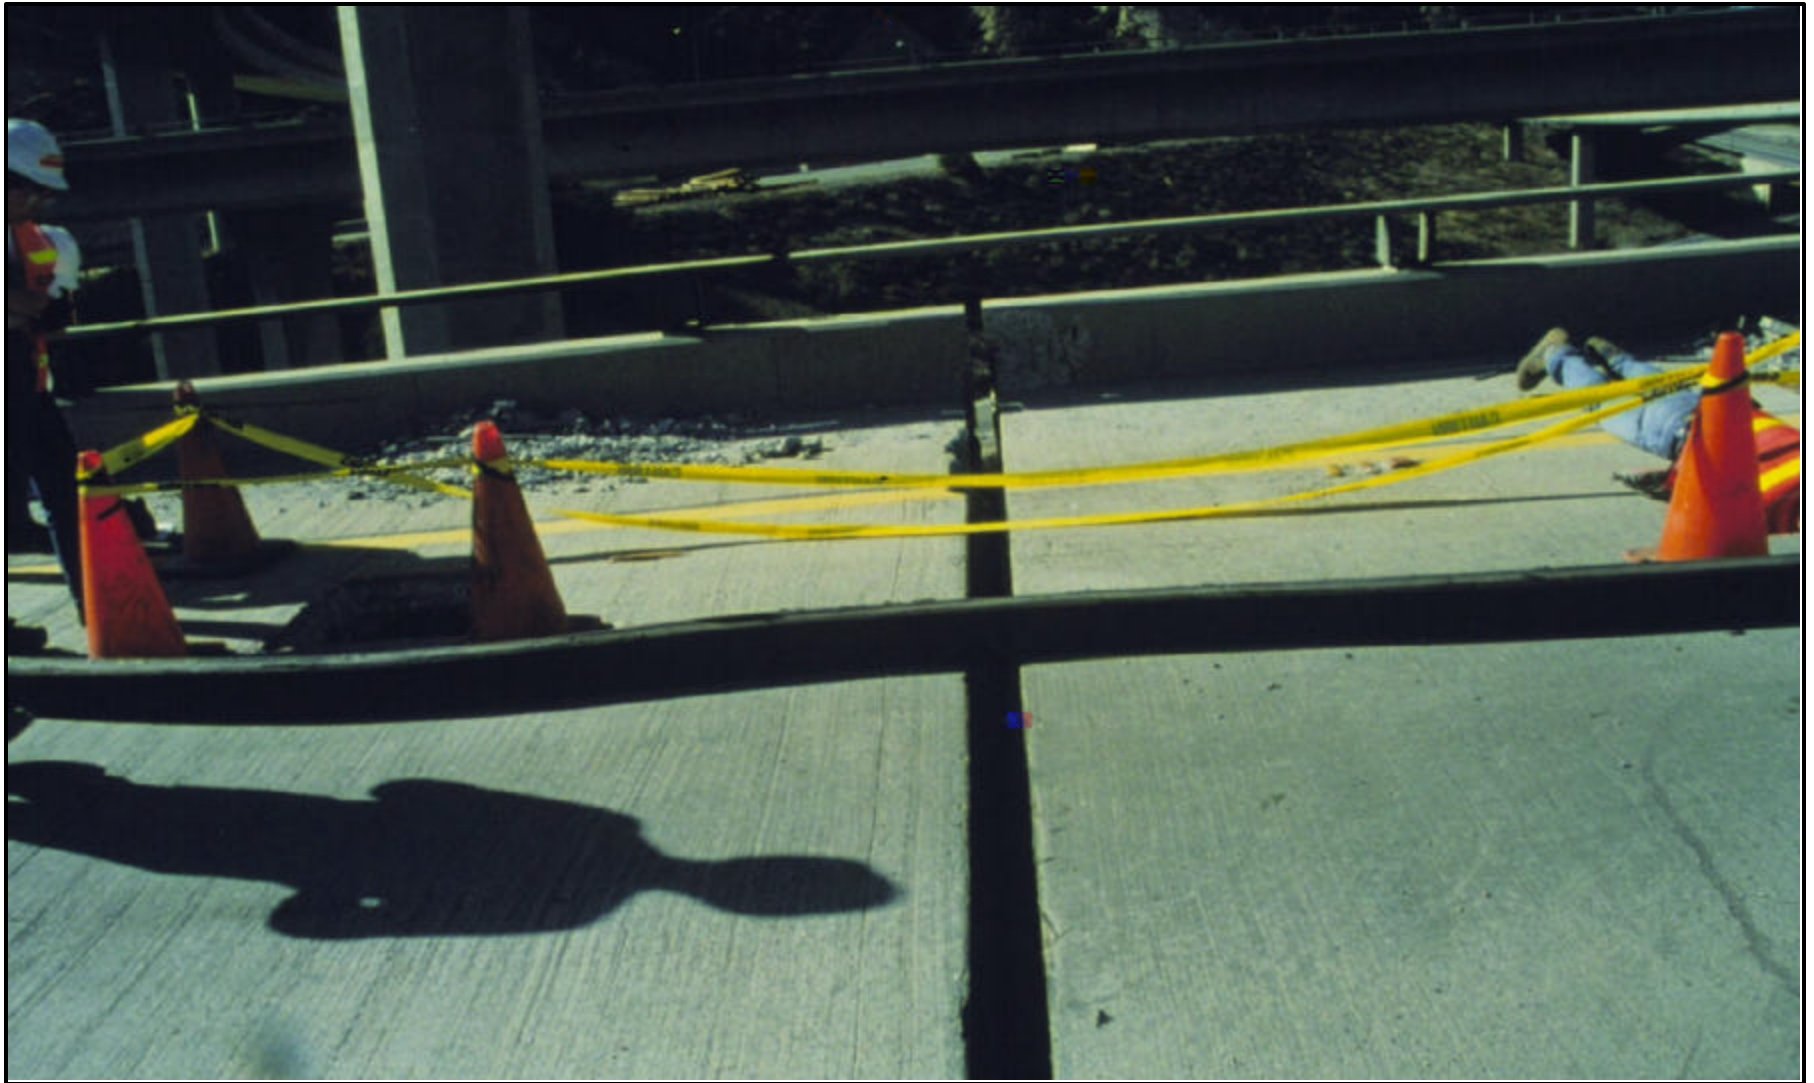
- Steel Plates
  - Bridge Gaps
  - Vertical Offsets
- Fill
  - Roadways
  - Vertical Offsets
- Jacking
  - Reset/Replace Bearings

# Steel Plates

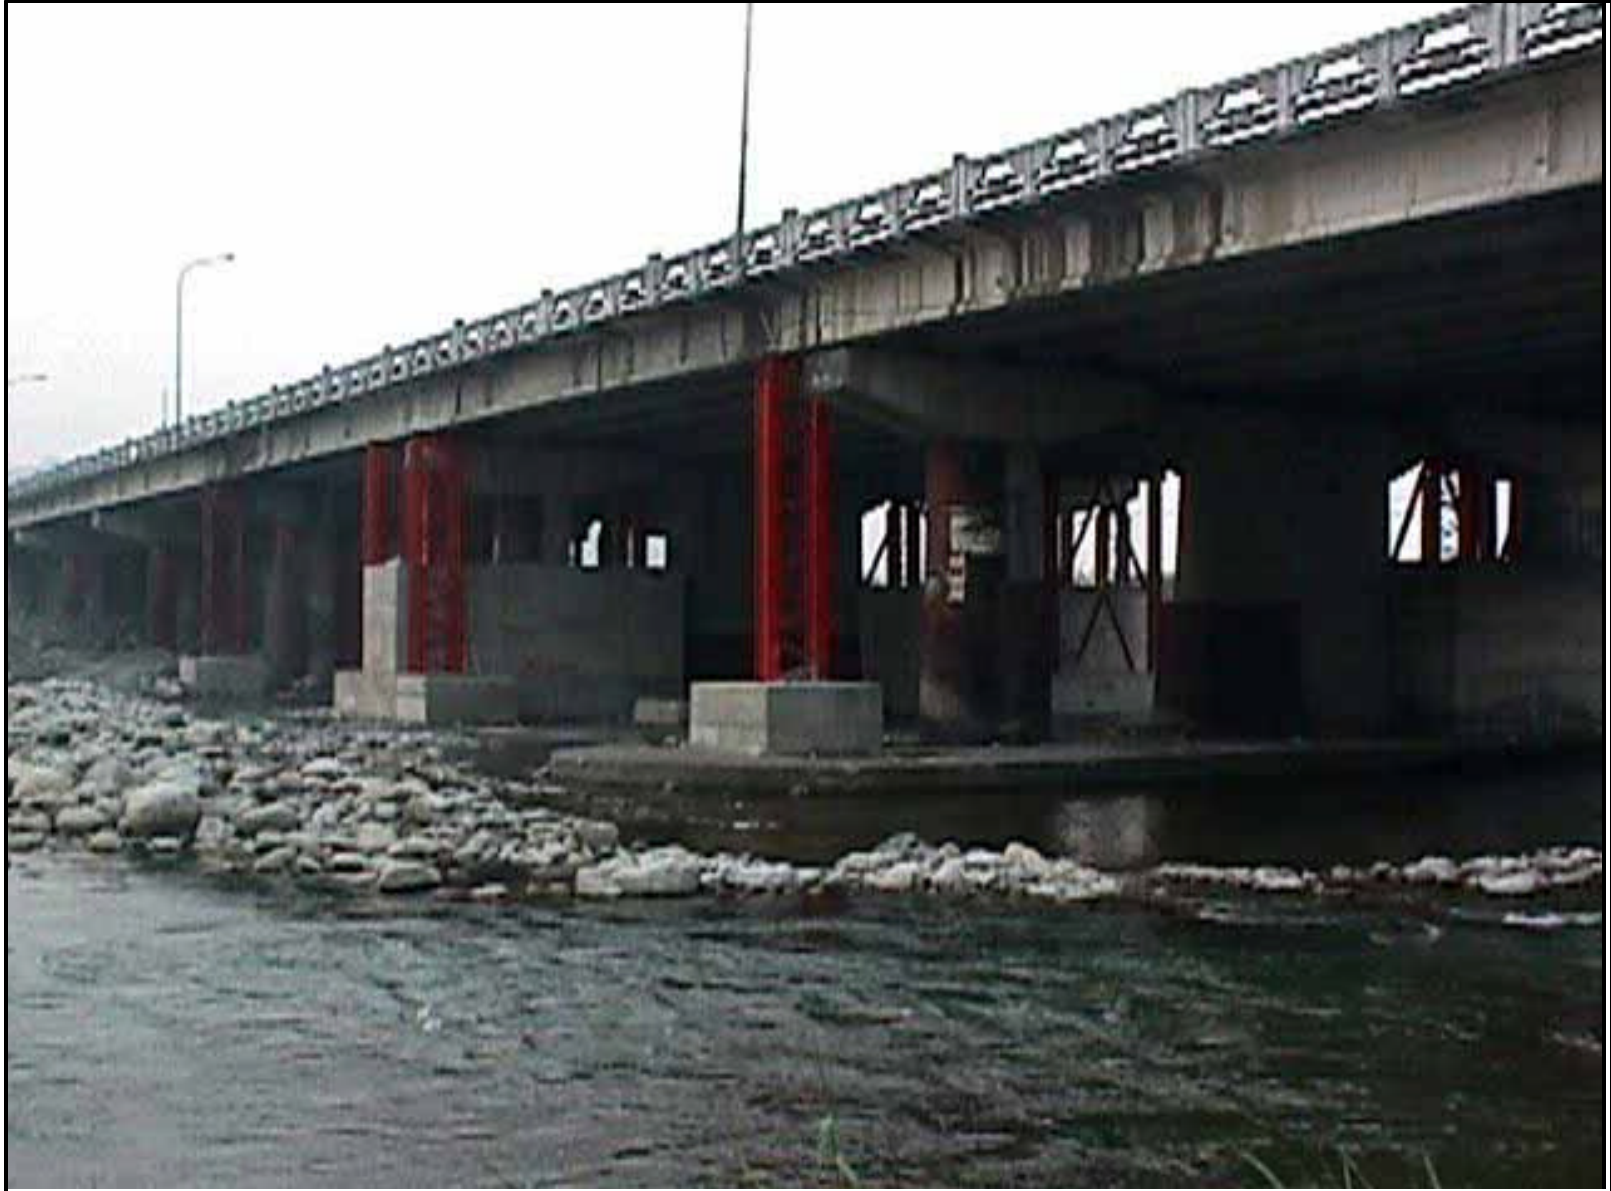
- Open Structure to Operation
  - Severe Damage
  - Support Loading
- Prevent Collapse
  - Maintain Access
    - Underlying Roadway

# Open Structure to Operation
