POST-EARTHQUAKE SAFETY EVALUATION OF BRIDGES AND ROADS

Purdue University and
Joint Transportation Research Board

Goal

- Develop an effective system to train INDOT personnel of various backgrounds in the safety evaluation of roads and bridges after a major earthquake

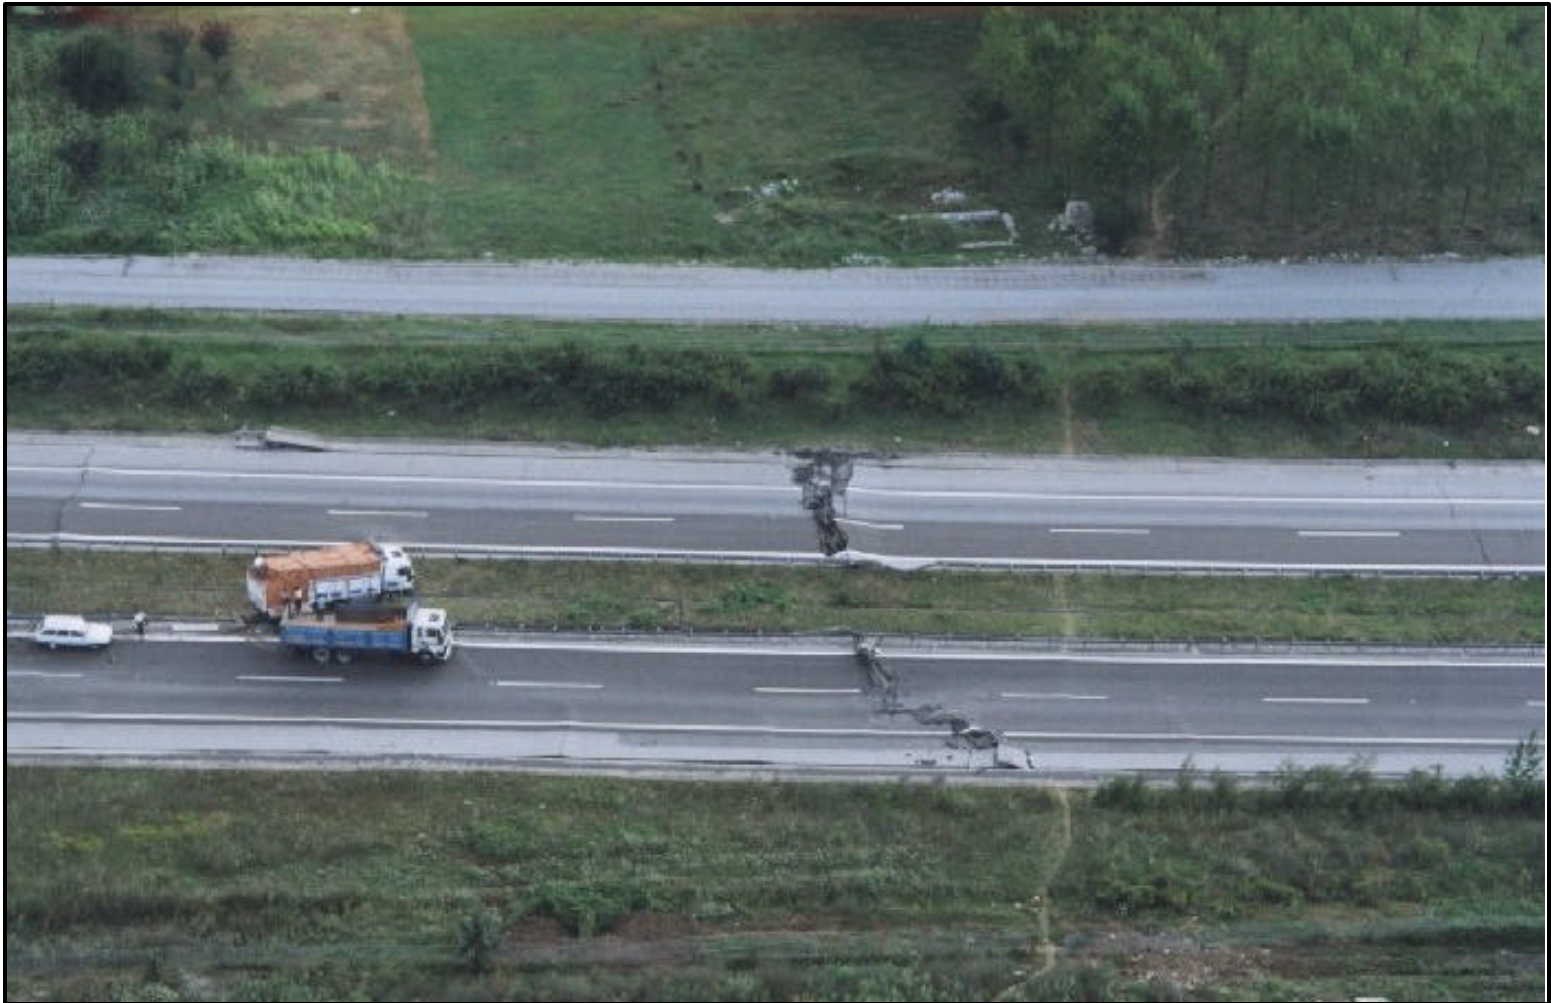
Roadway closure/fault rupture after Izmit EQ 8/17/1999 (KOERI) Red Tag

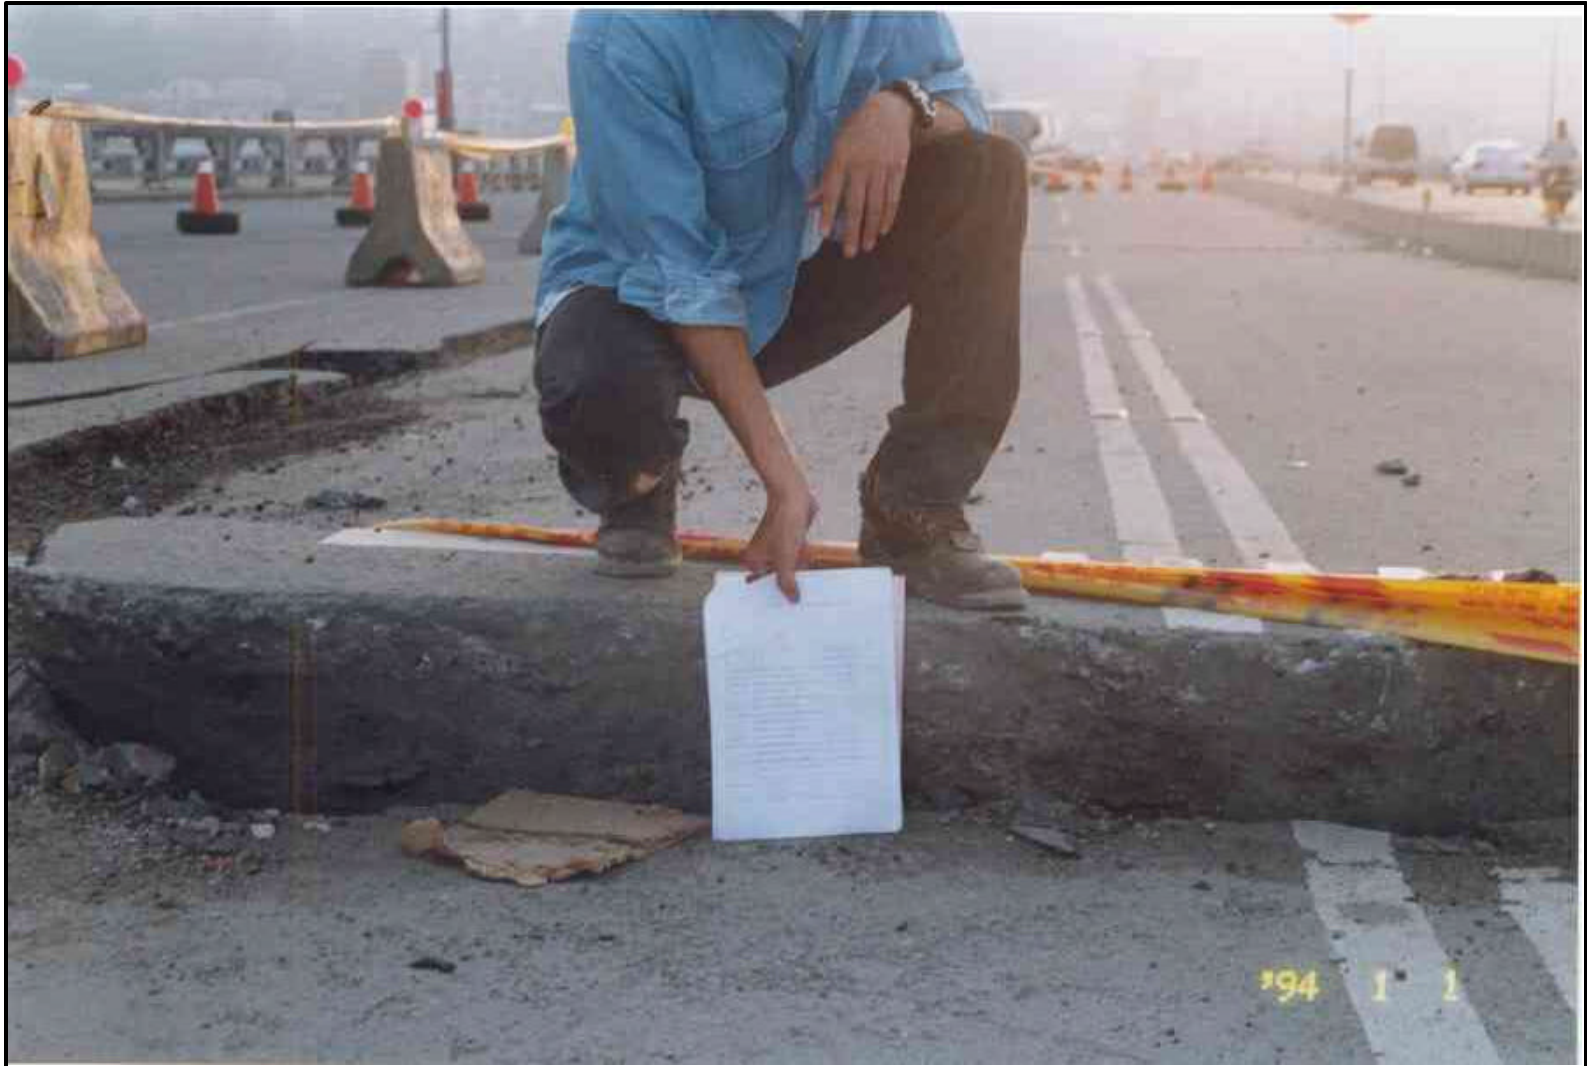
Deck settlement > 6" (UCSD) Red Tag

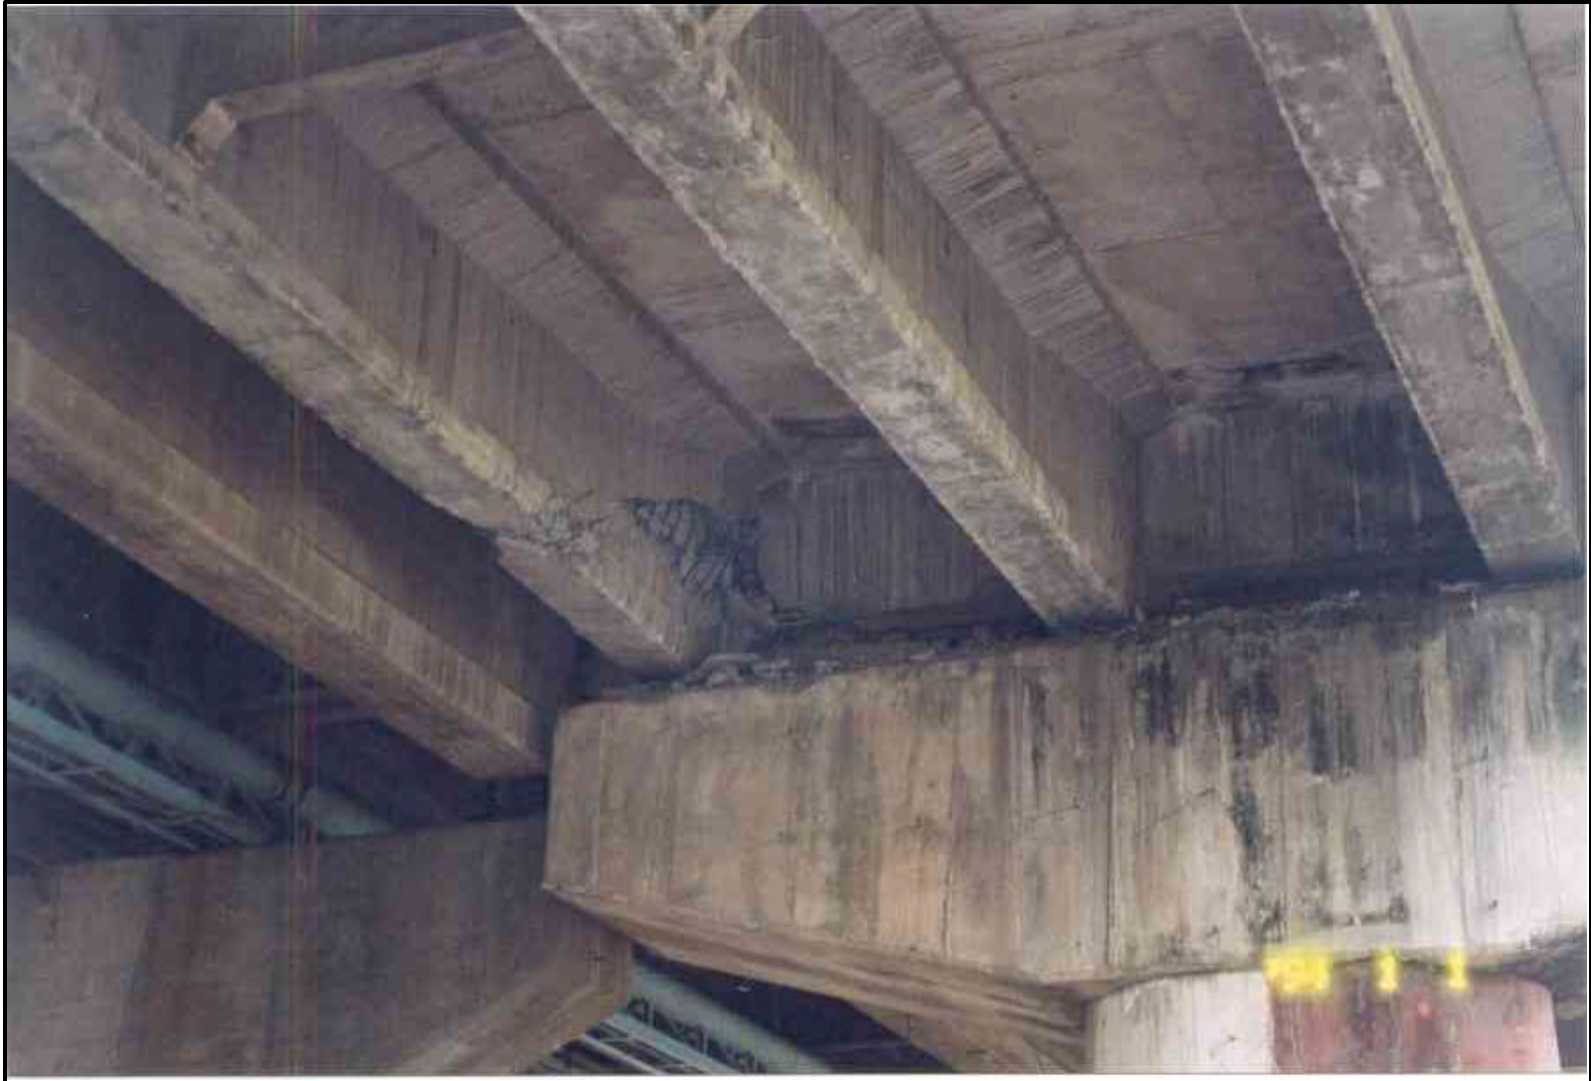
Shear cracks RC girder near support (UCSD)- Red Tag

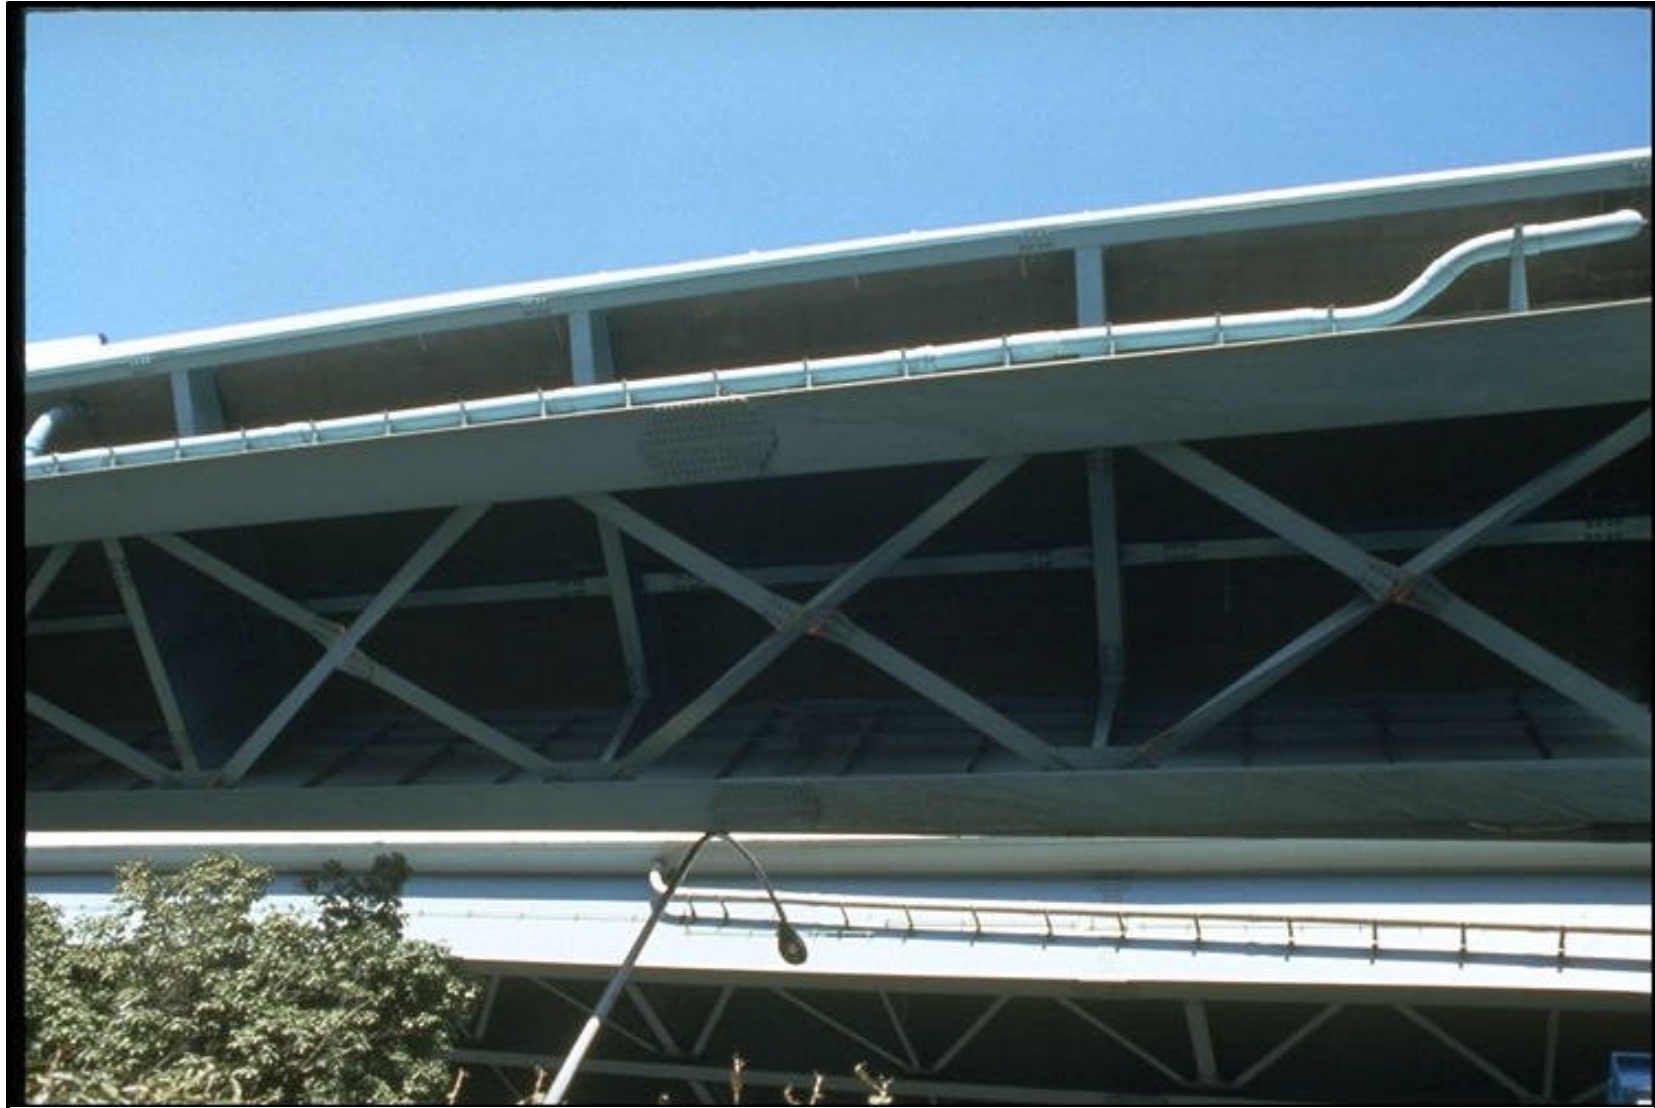
Twisted steel bracing (EERC)- Yellow Tag

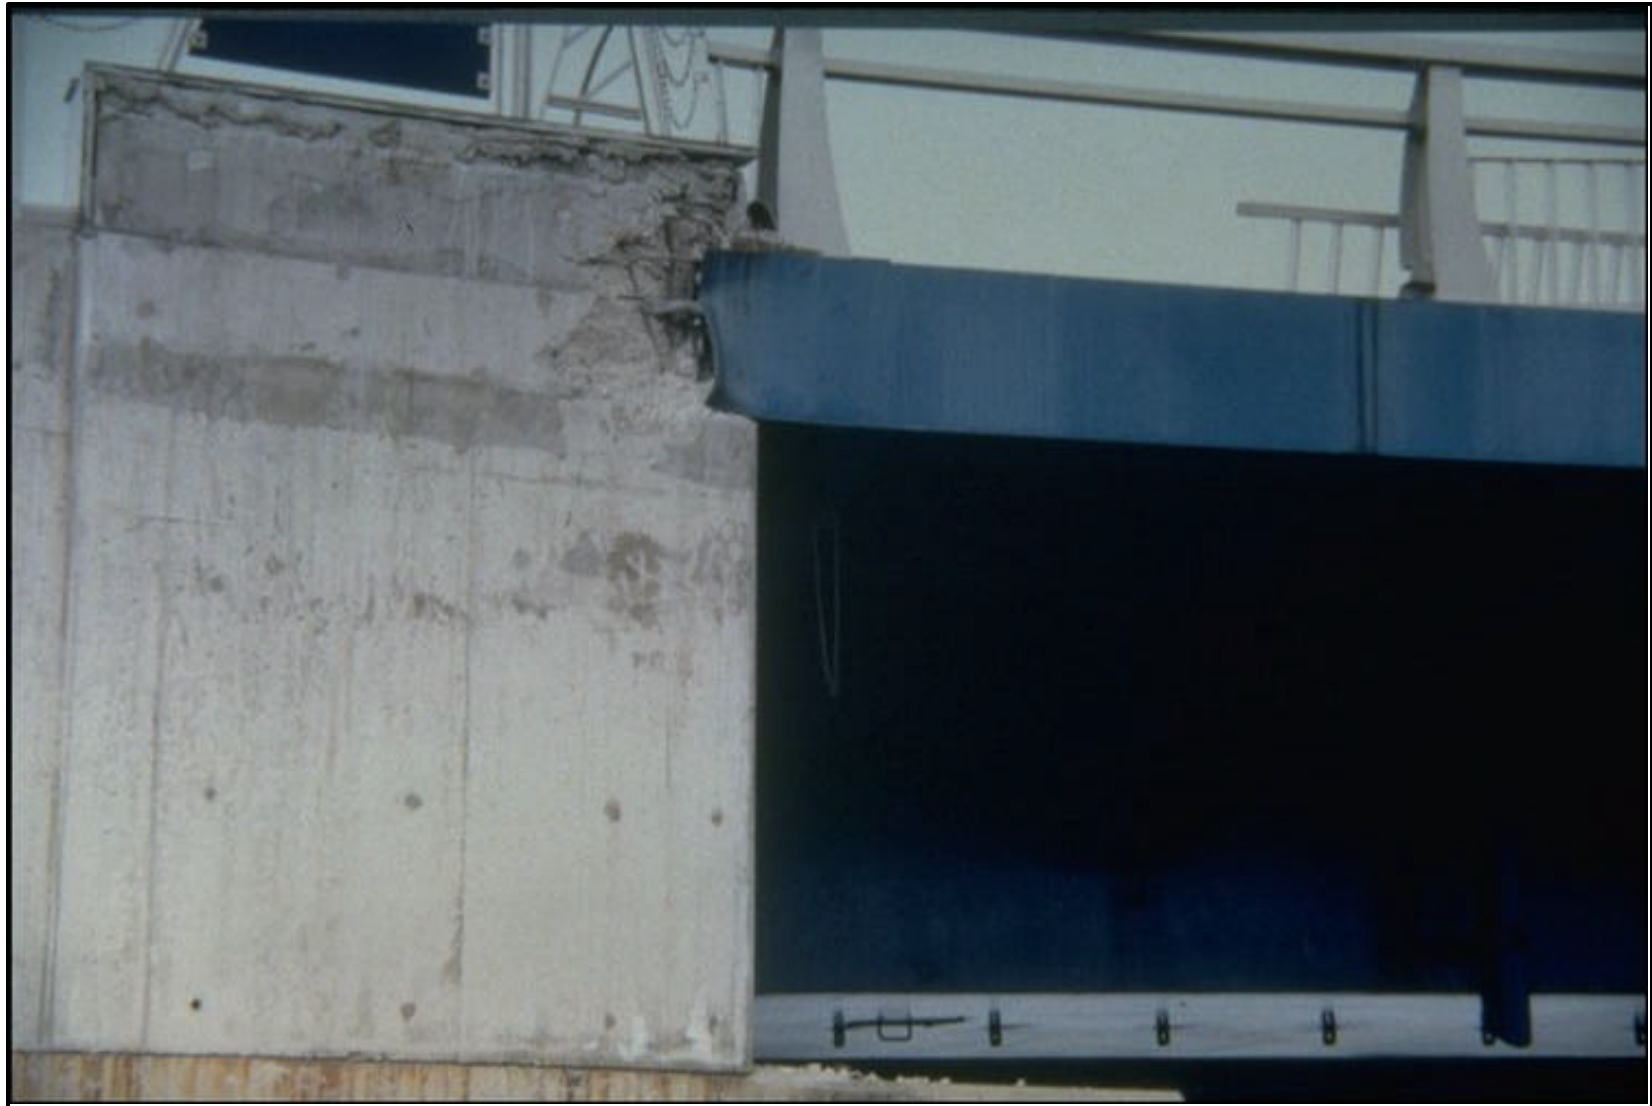
Pounding damage at abutment (EERC) Yellow Tag

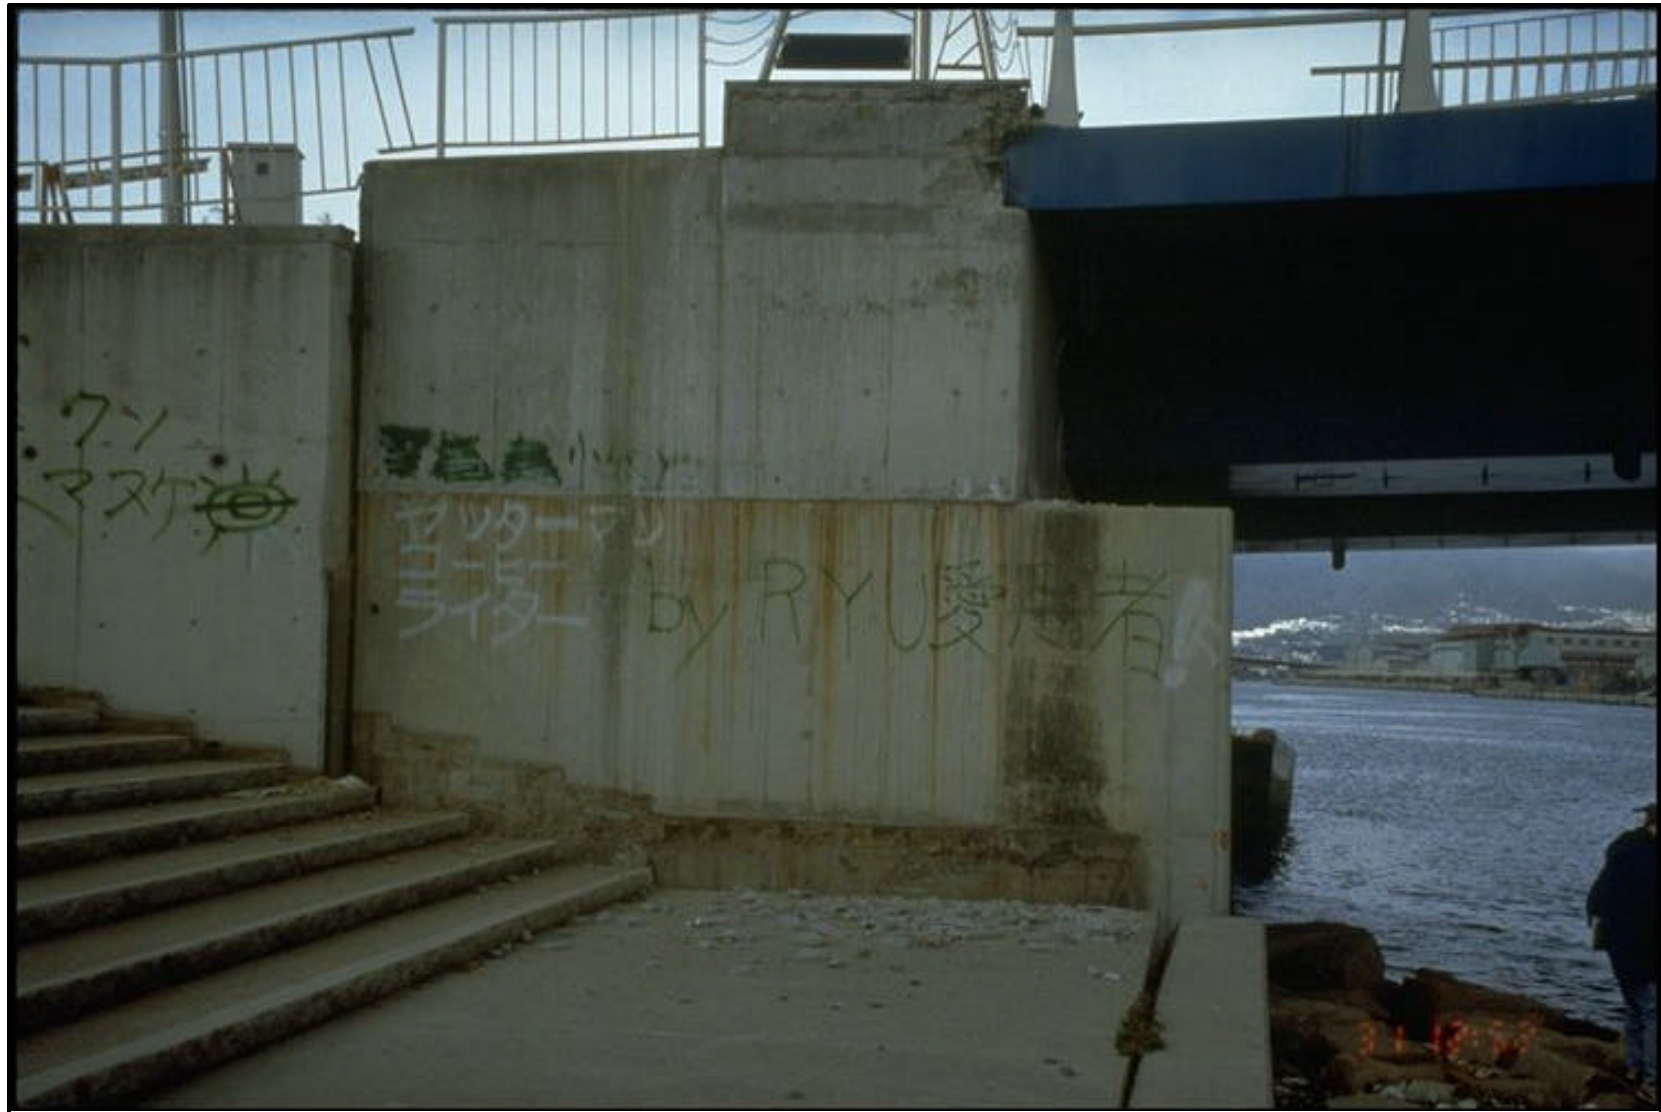
Transverse movement of abutment (EERC)- Yellow Tag

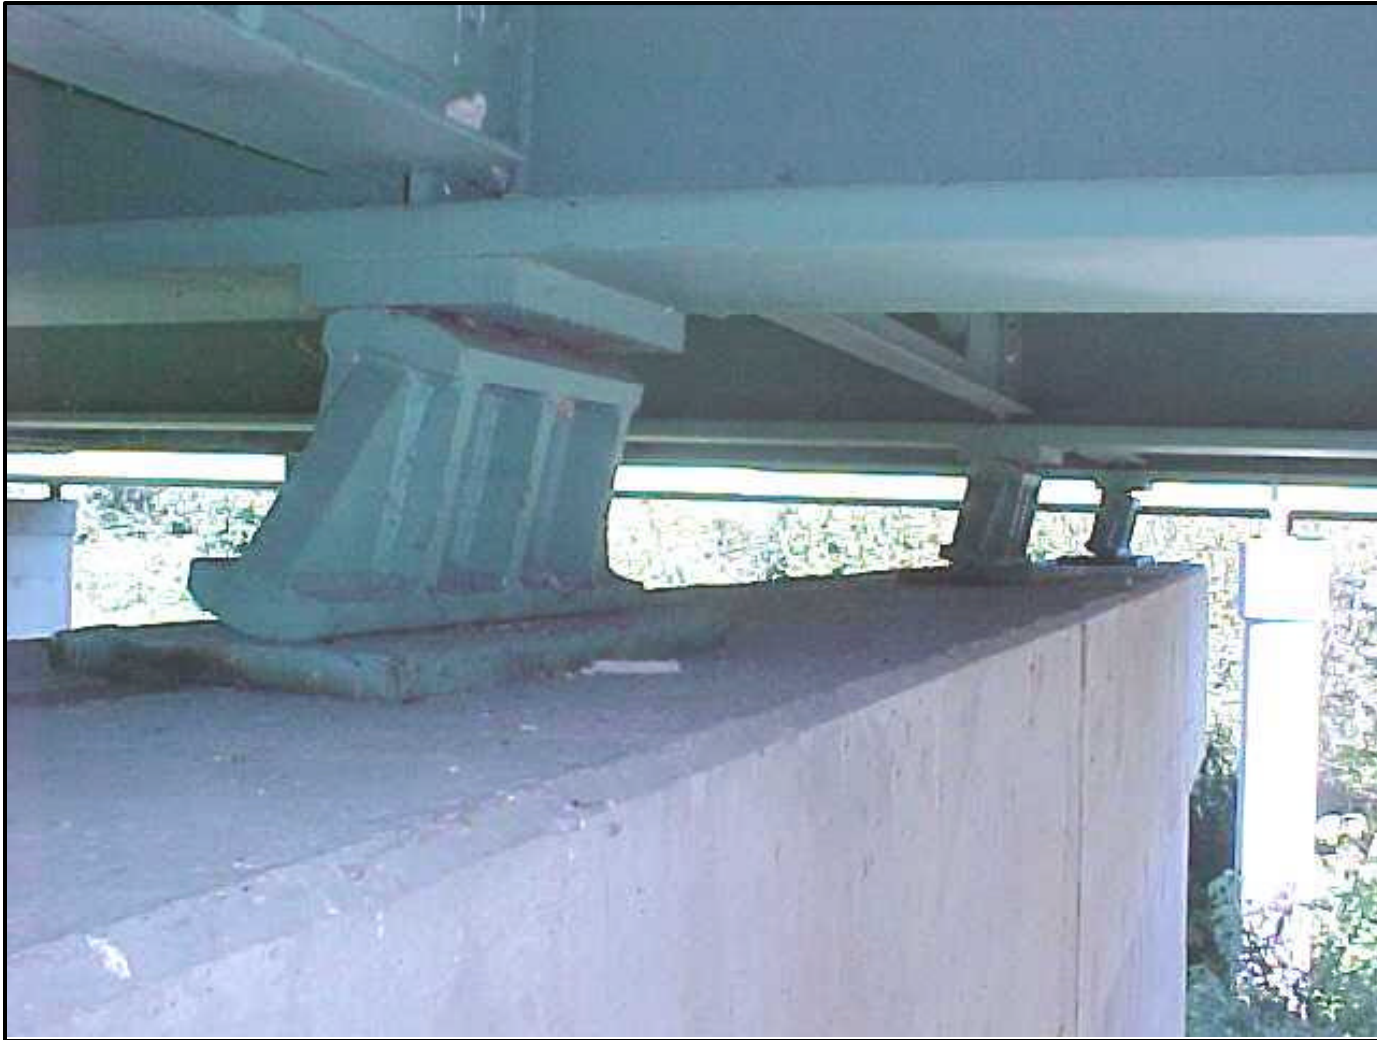
Tilted rocker bearings (INDOT)- Yellow Tag

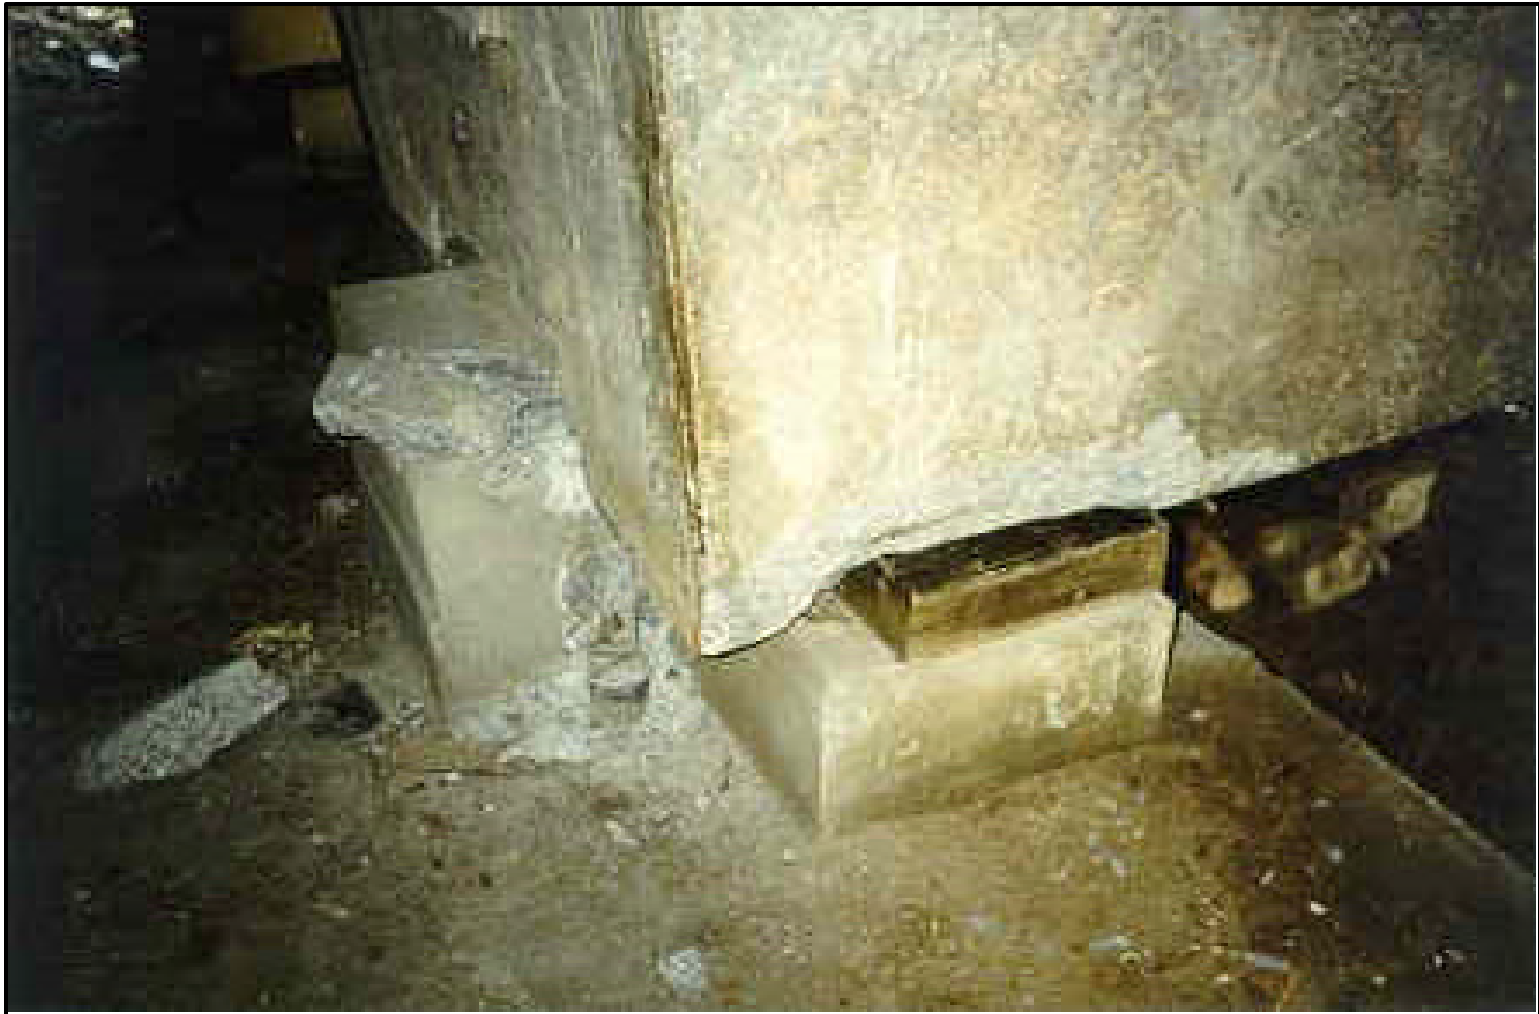
Elastomeric bearing after Izmit EQ 1999 (KOERI)- Yellow Tag

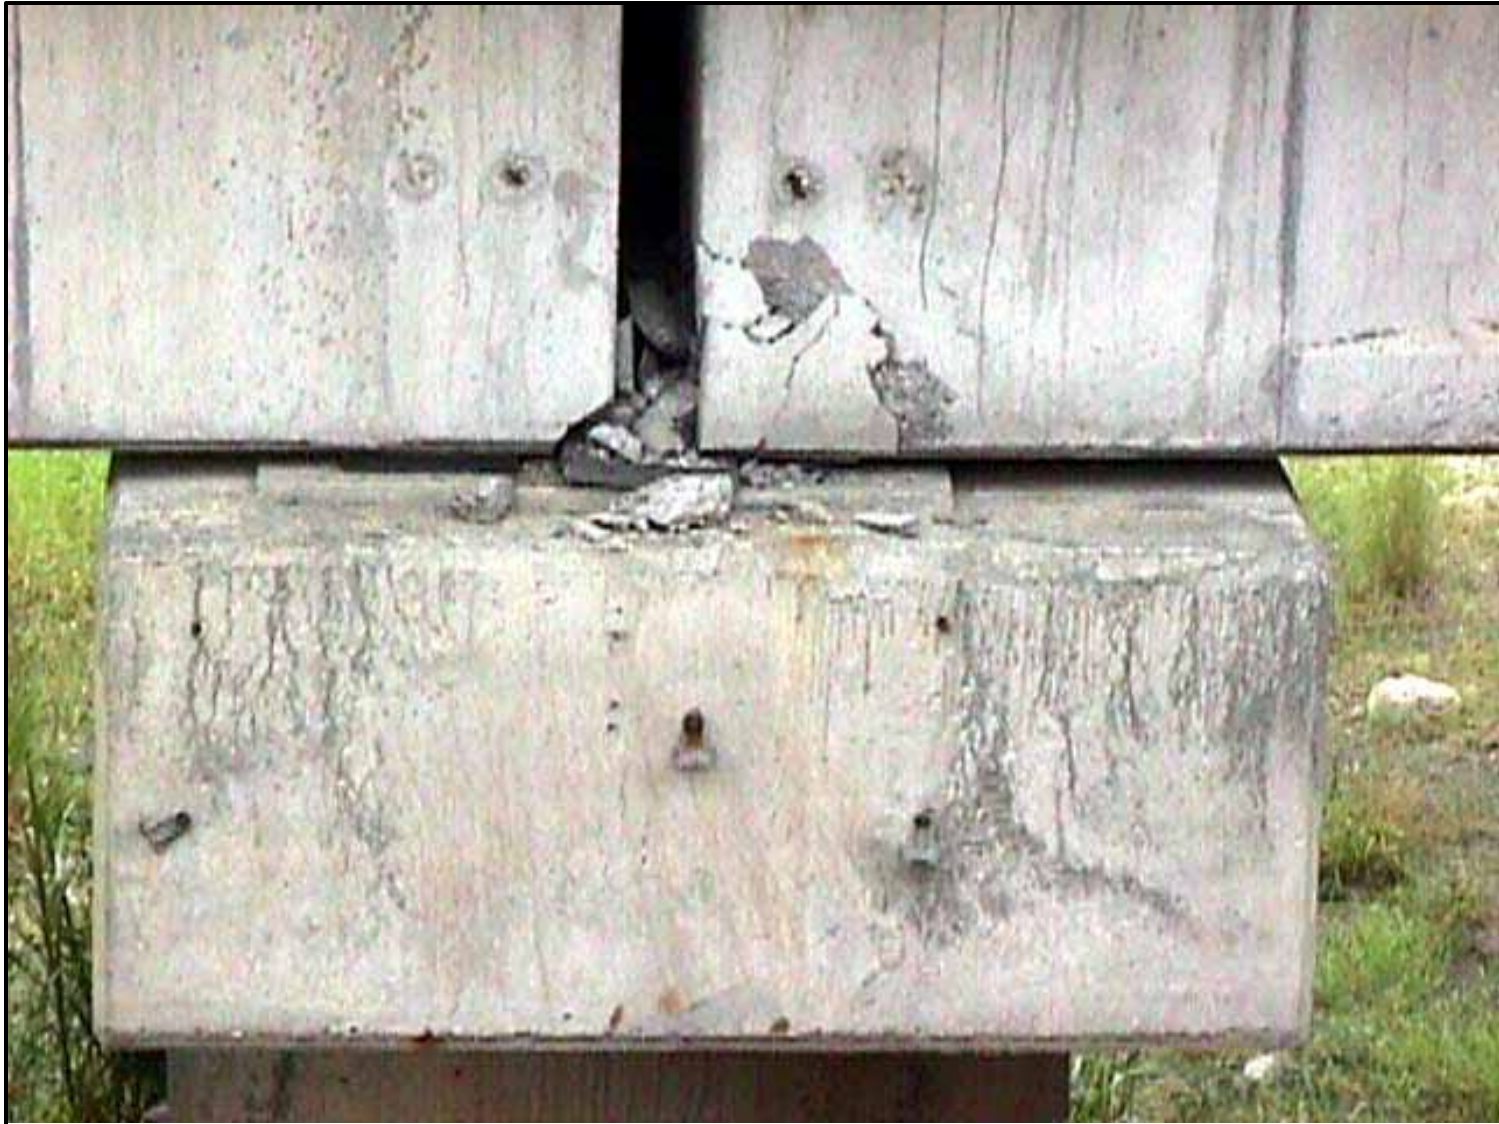
Damaged bearing (Taiwan EQ) Yellow Tag

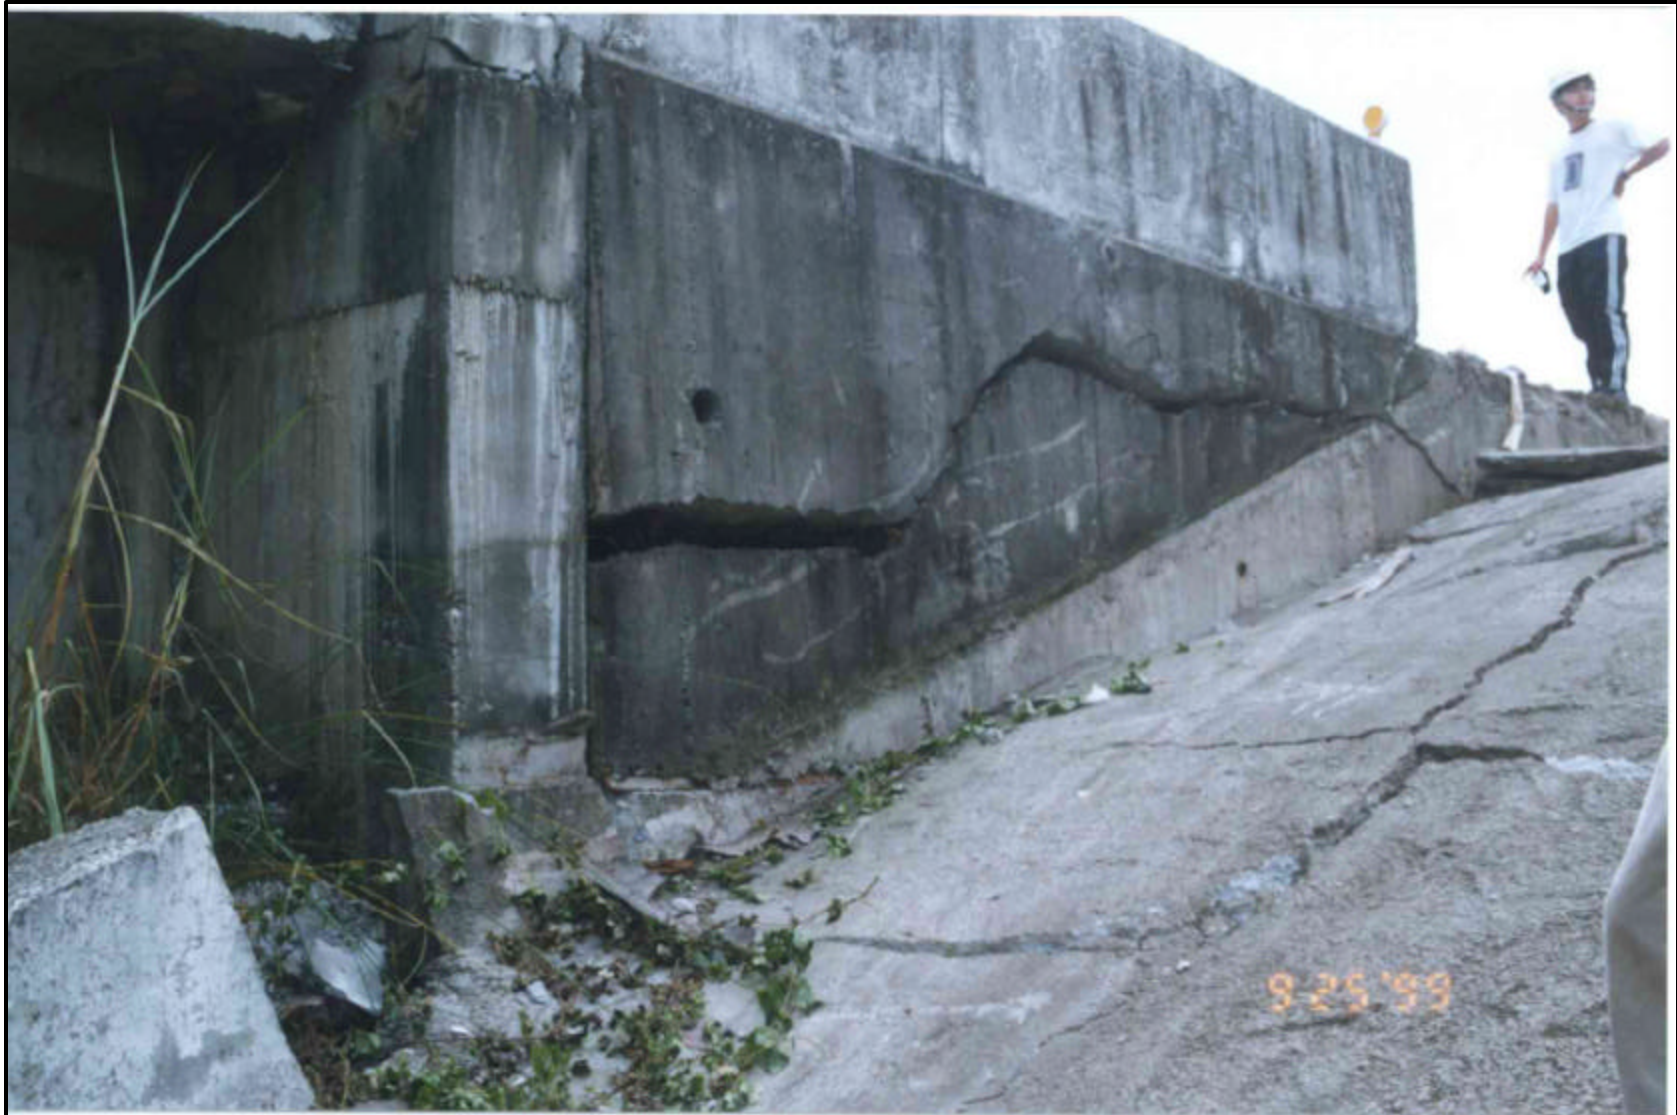
Cracks at abutment wingwall and slope (UCSD)- Yellow Tag

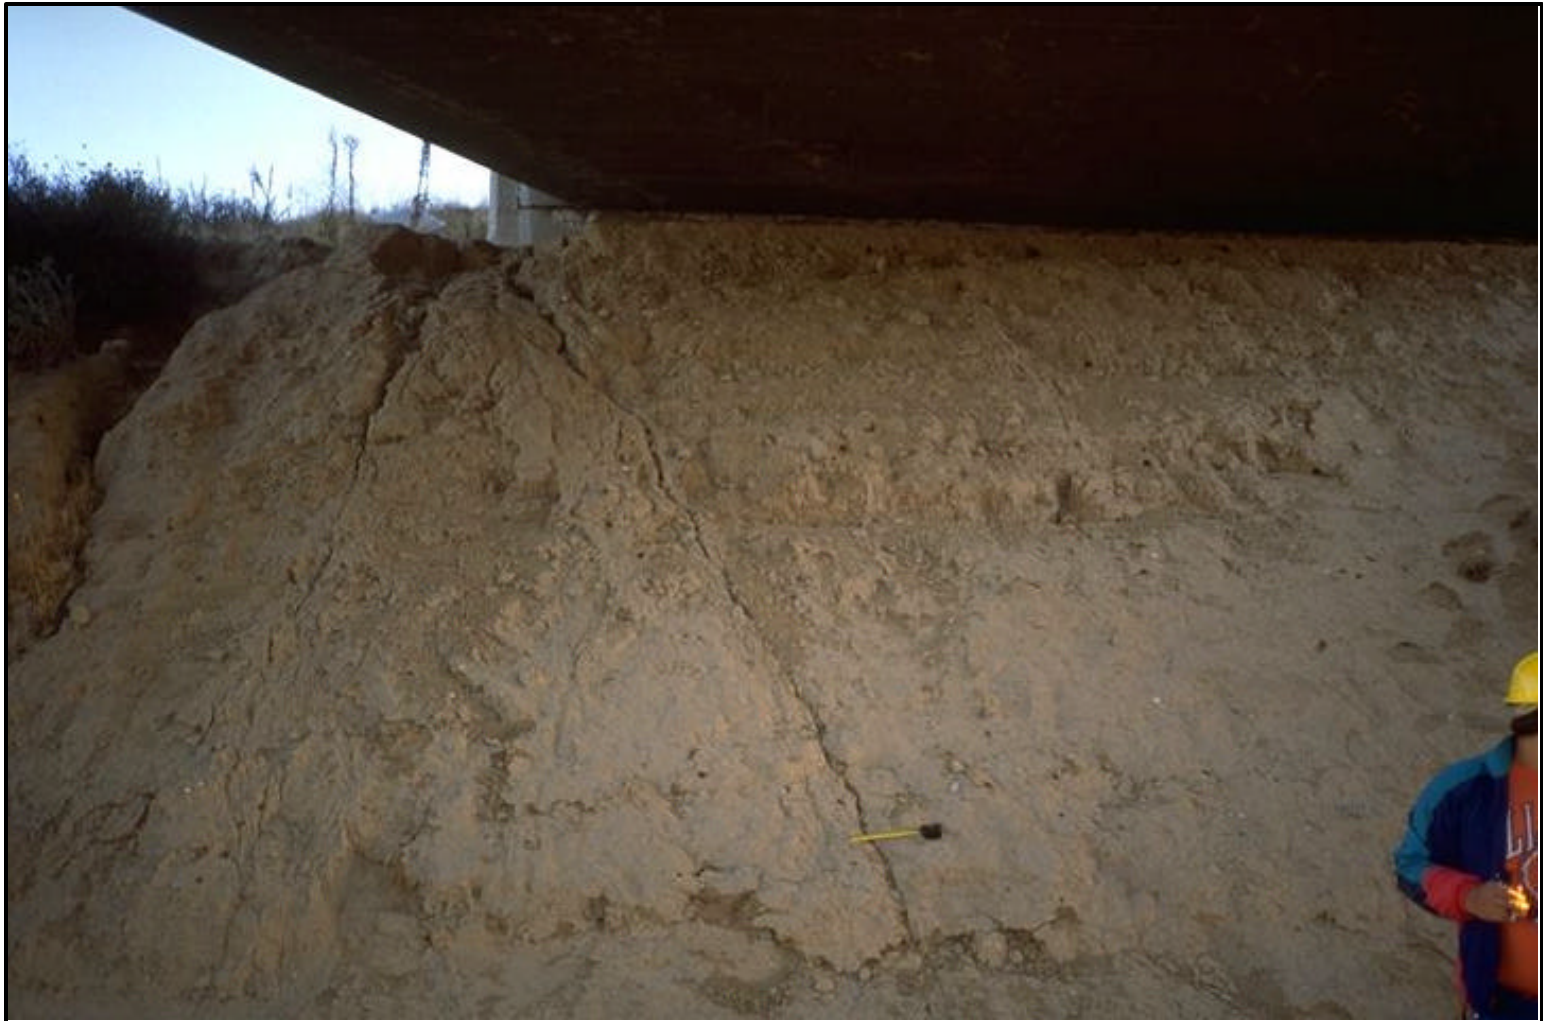
Diagonal ground crack extending under bridge (EERC)- Yellow Tag

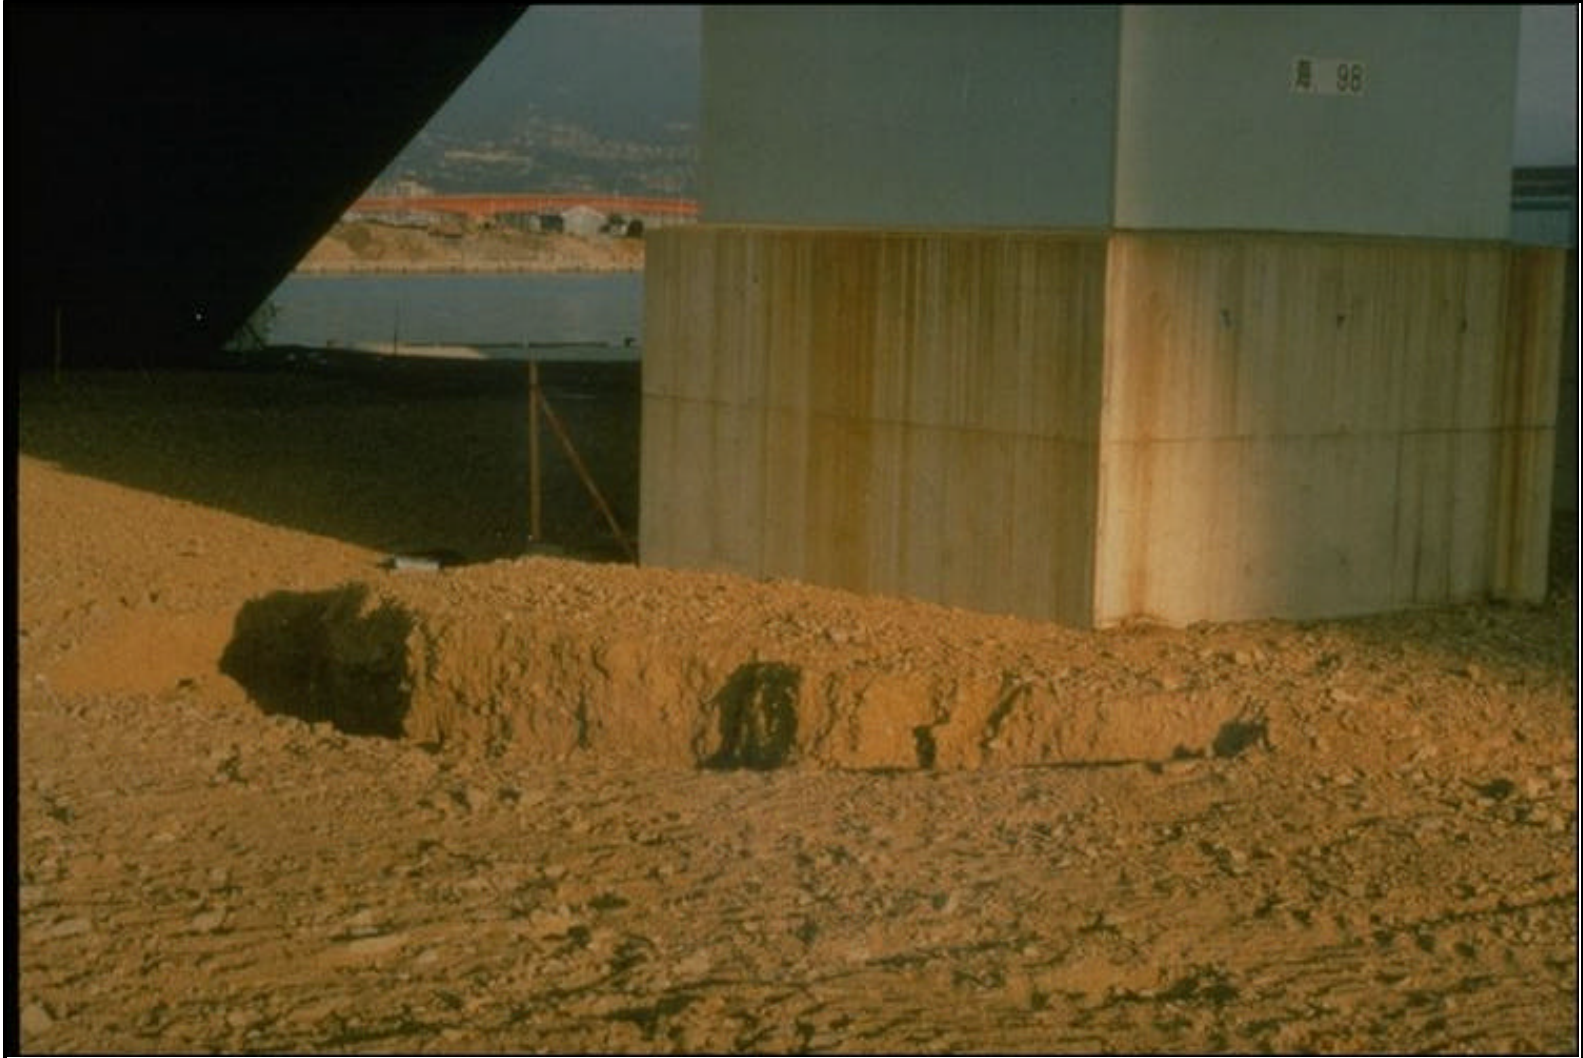
Settlement around pier on pile foundation (EERC)- Yellow Tag

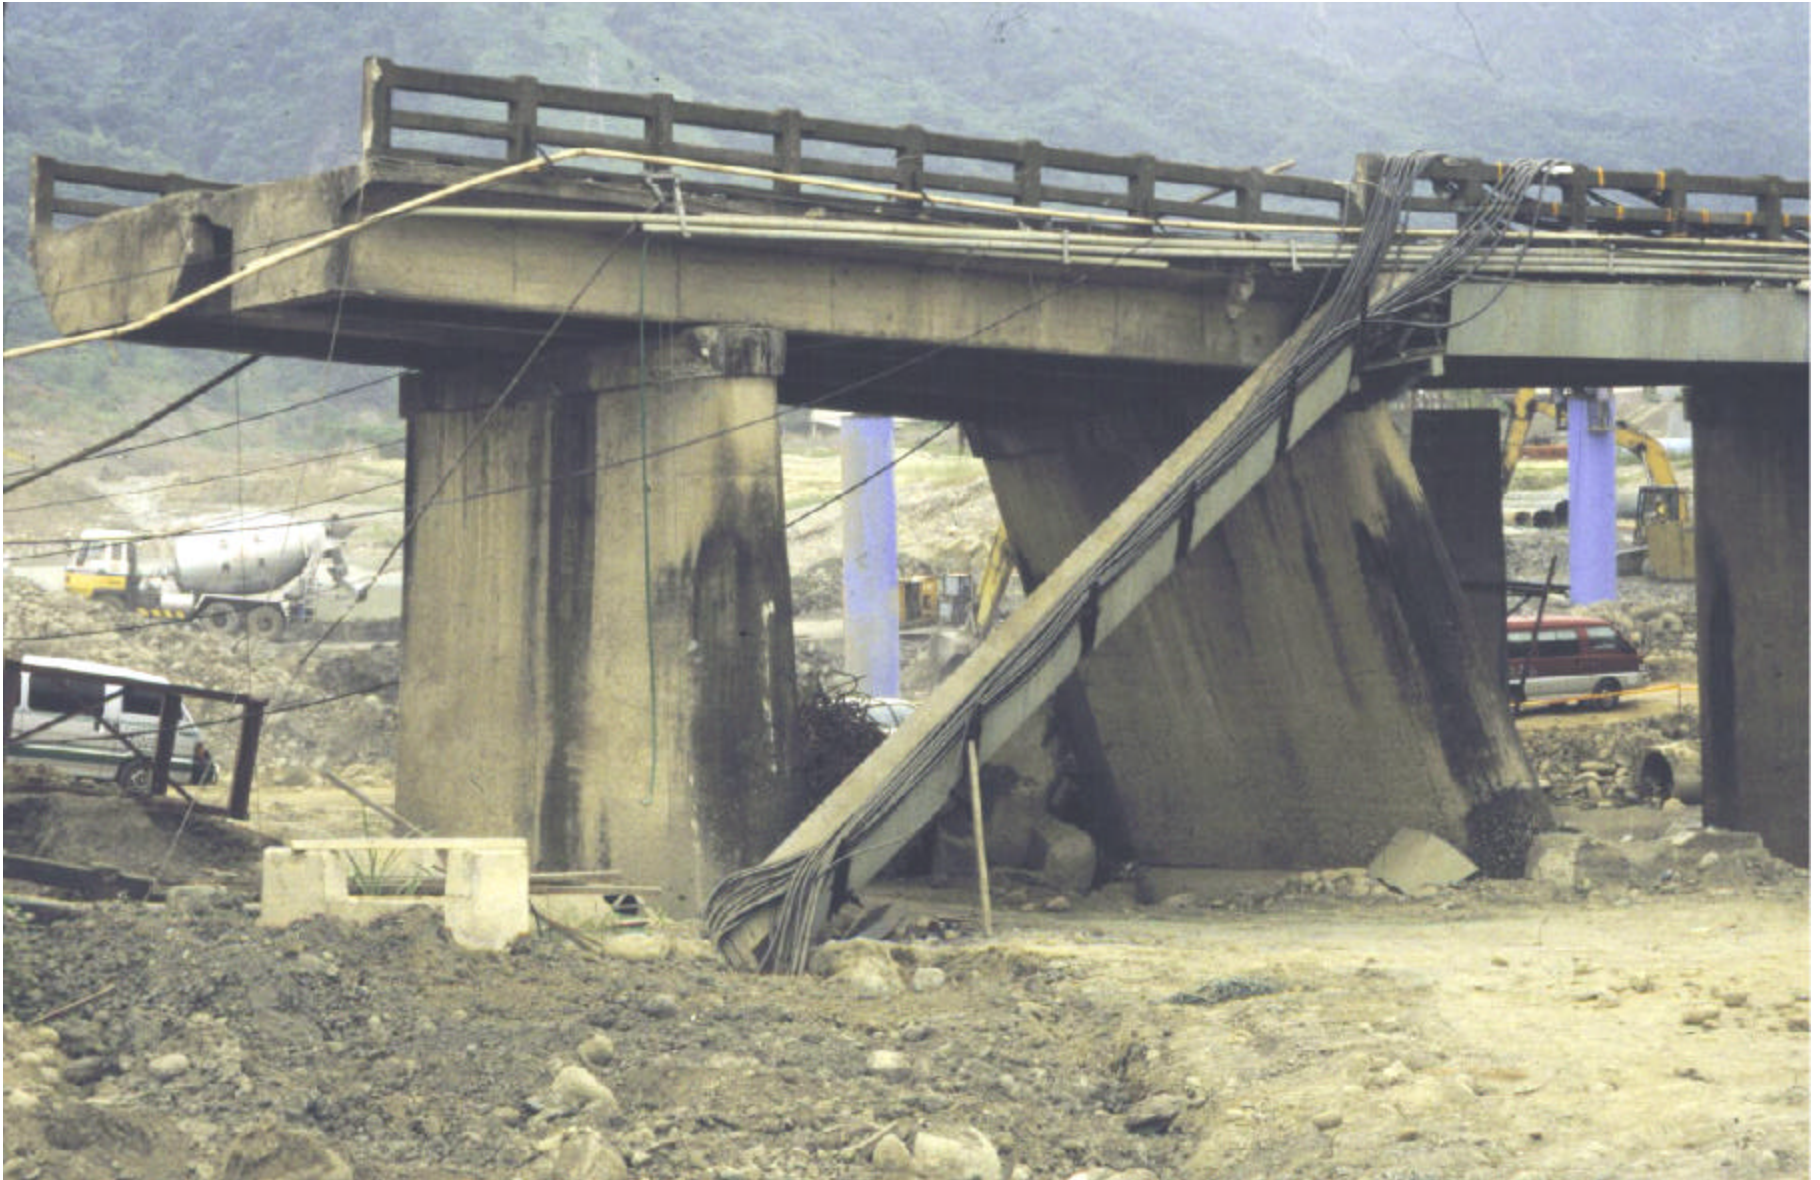
Unseating at Expansion Joints
