POST-EARTHQUAKE SAFETY EVALUATION OF BRIDGES AND ROADS

Purdue University and
Joint Transportation Research Board

Goal

- Develop an effective system to train INDOT personnel of various backgrounds in the safety evaluation of roads and bridges after a major earthquake

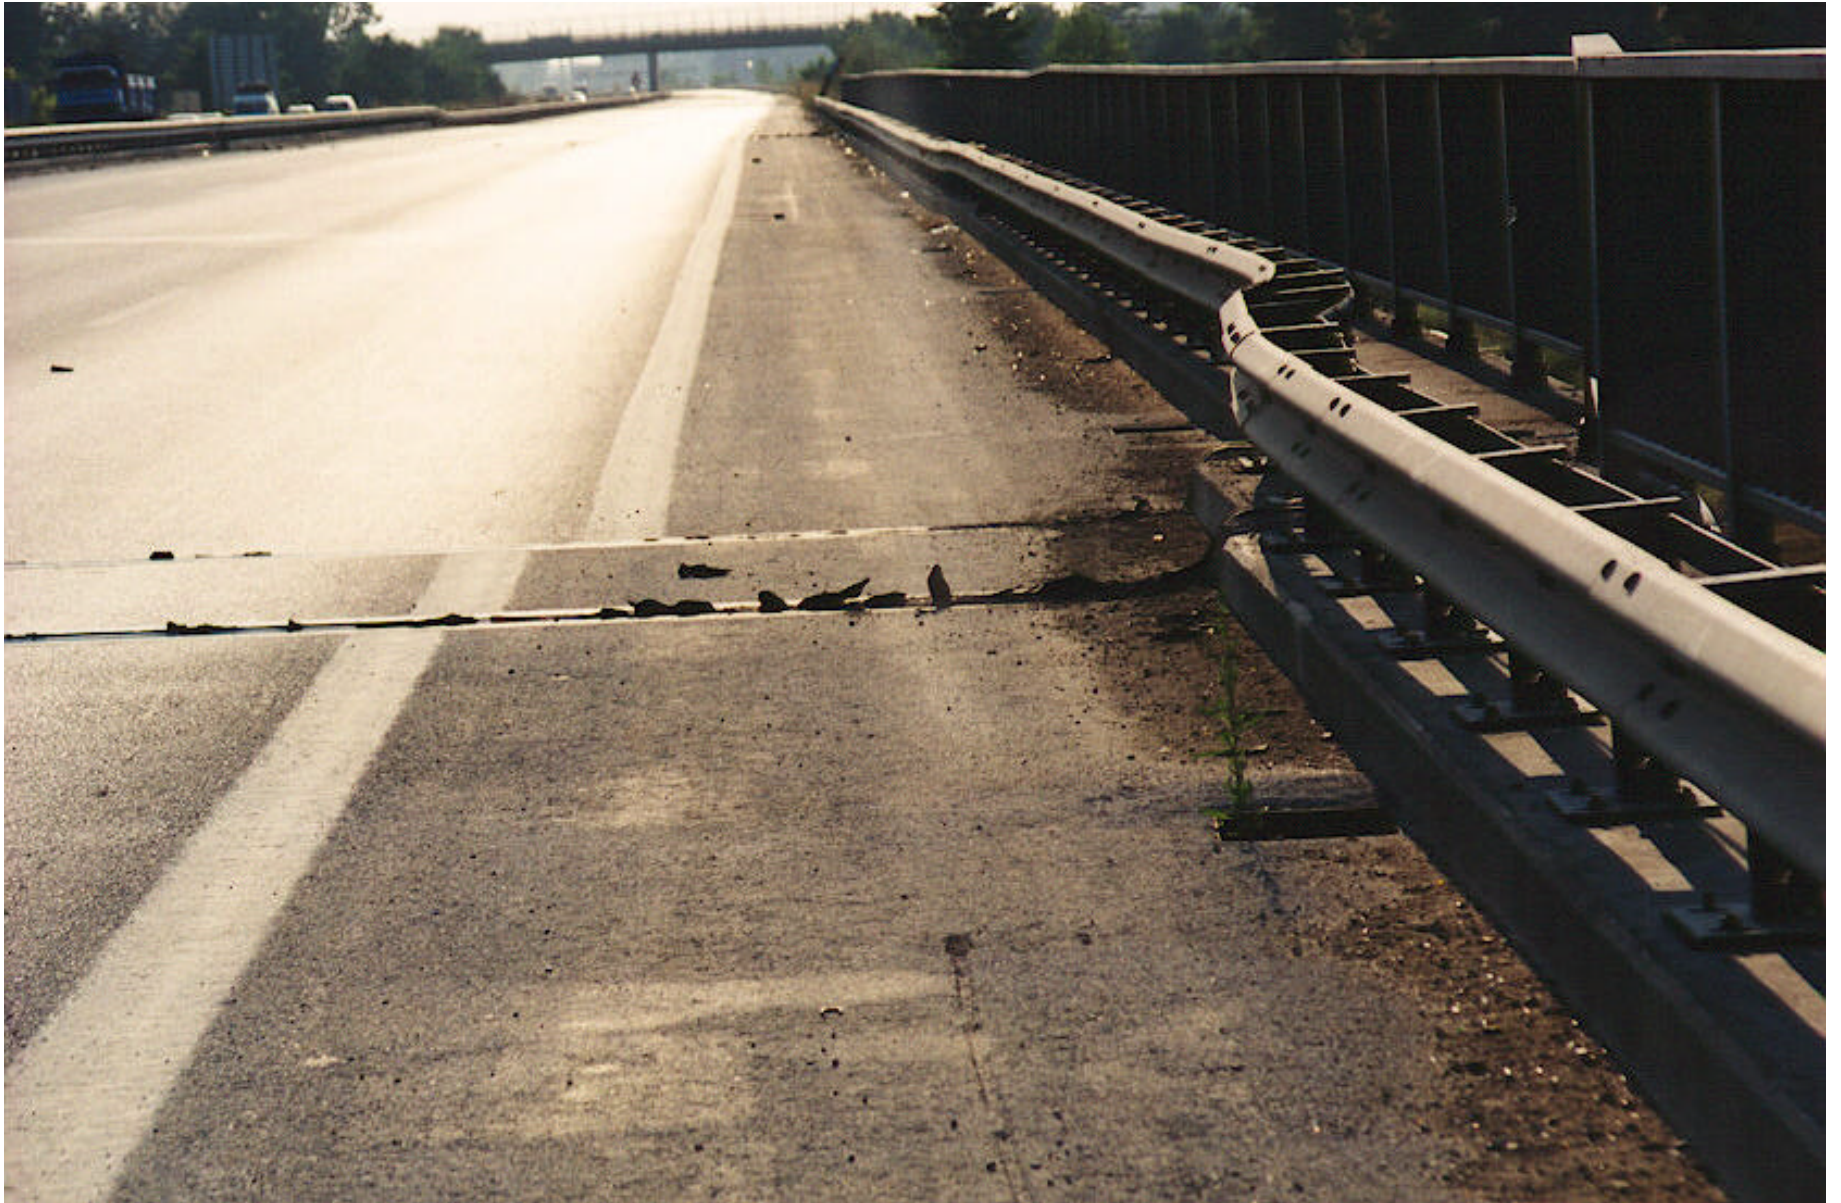
Bearing Damage

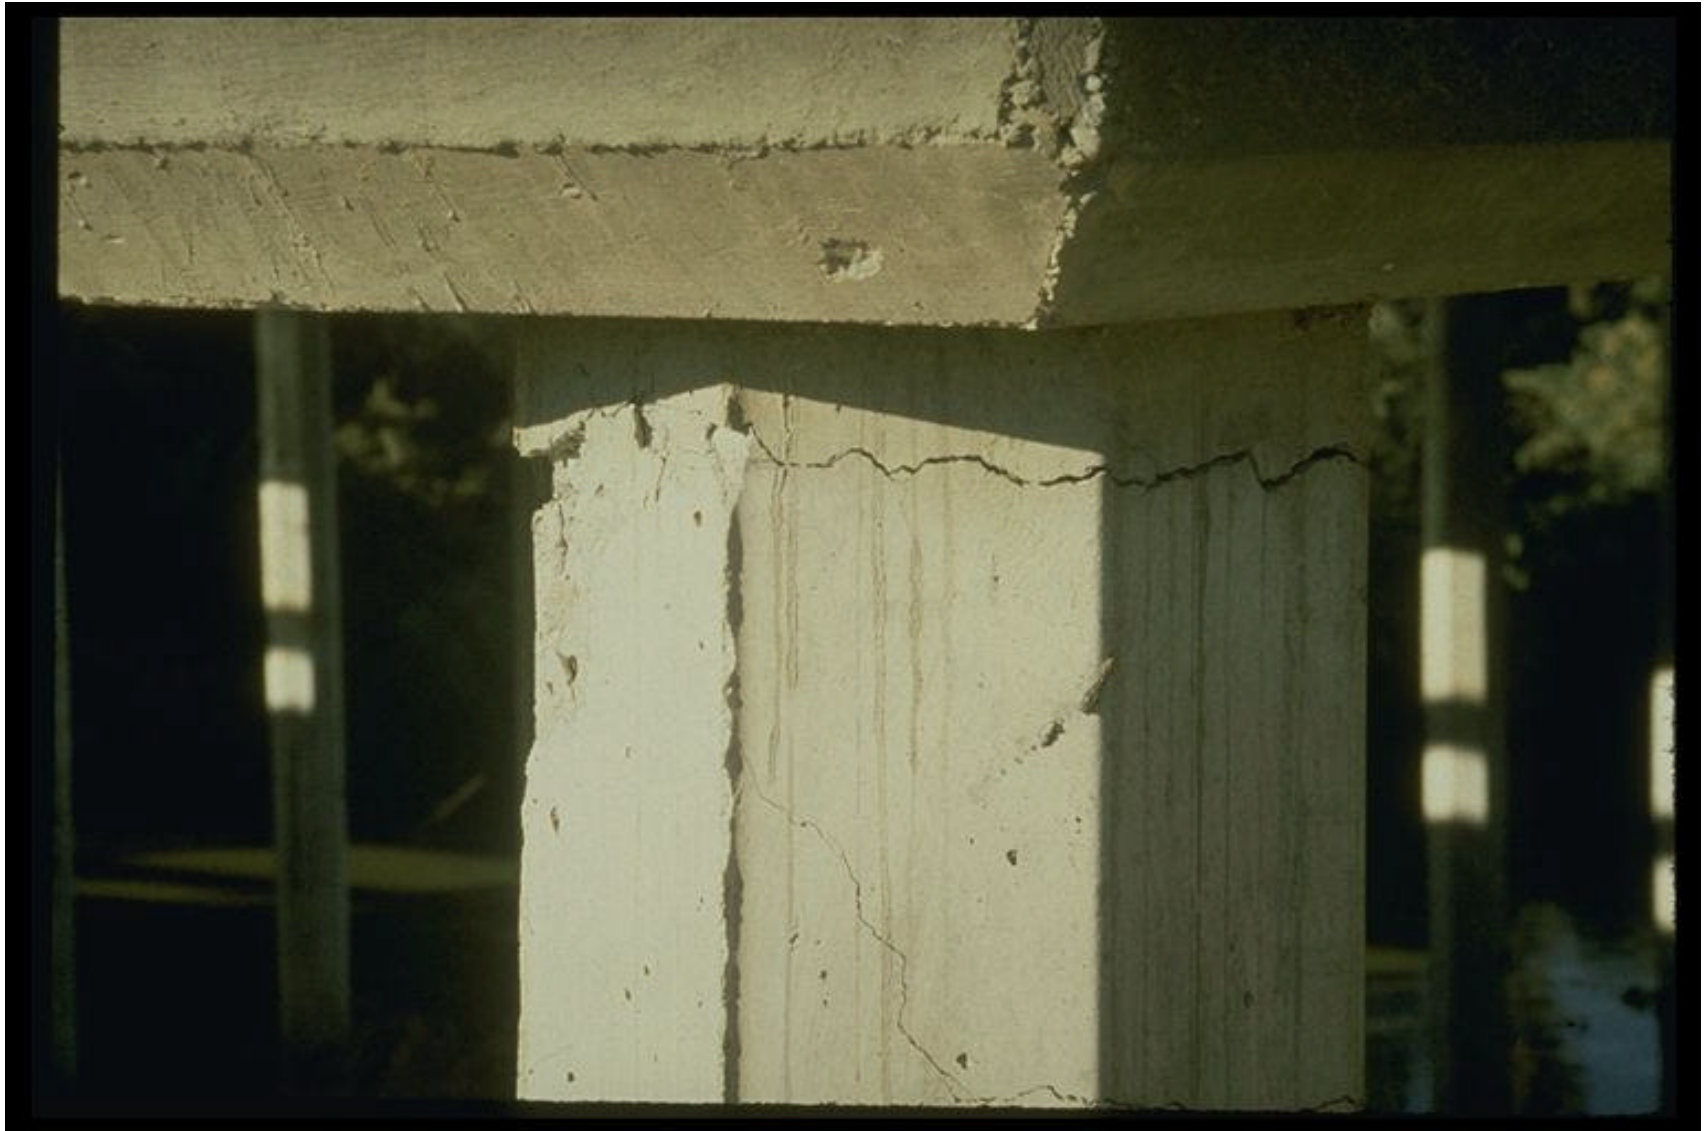
Columns: Flexural Damage

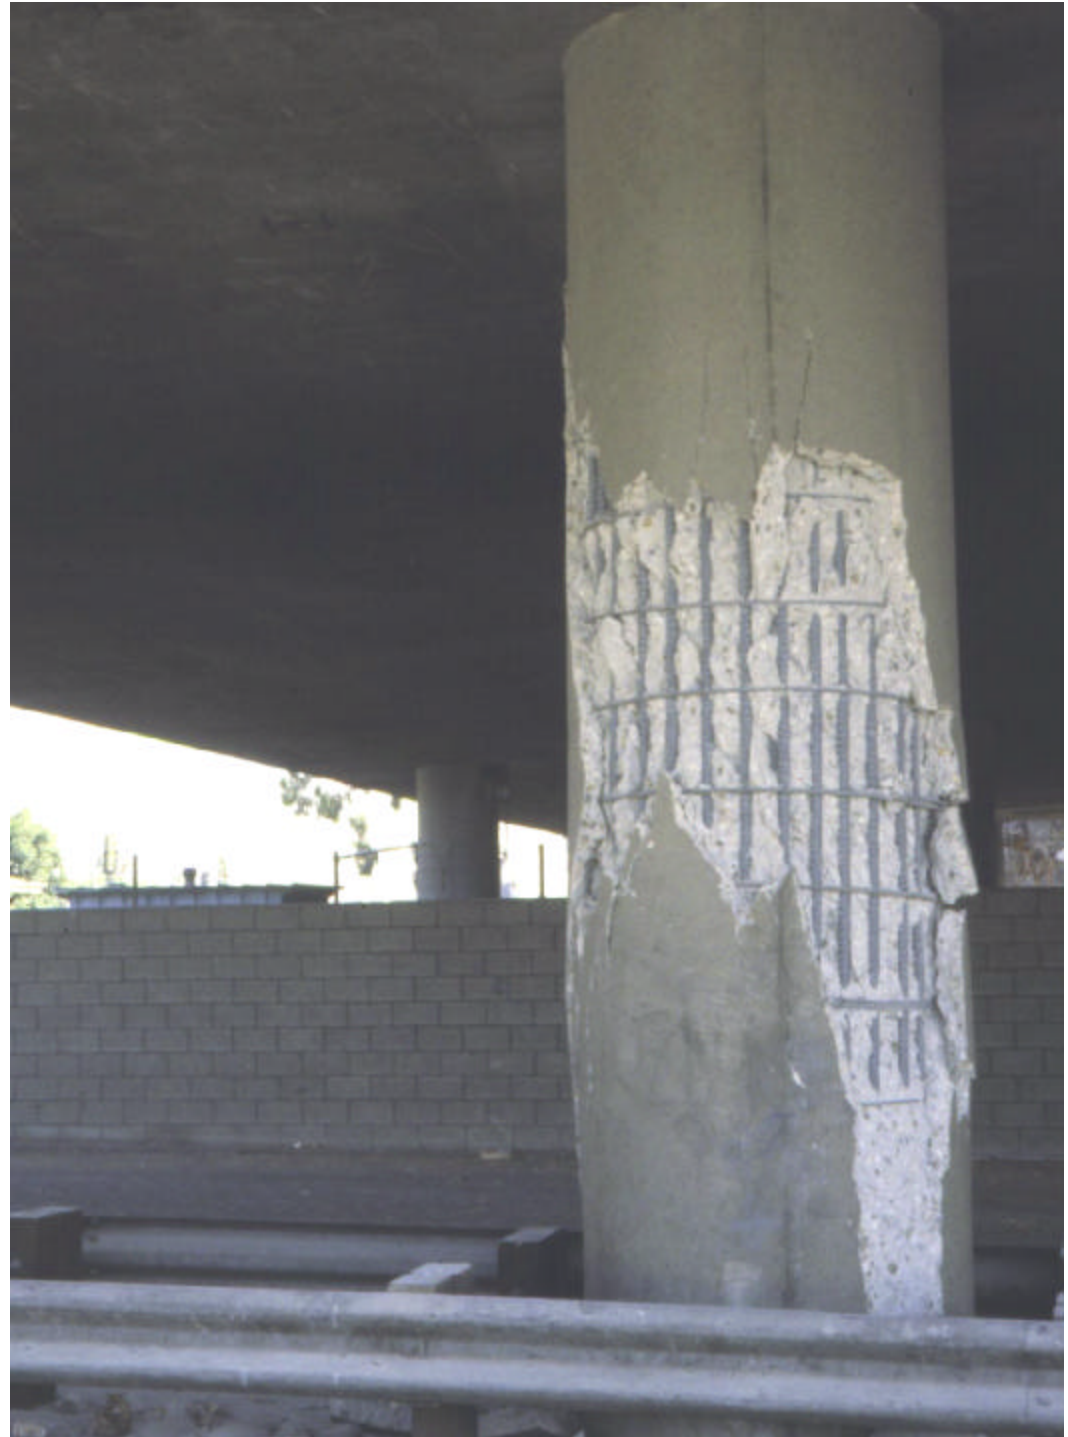
Columns: Shear Failure

I10 at Fairfax Ave.,
1994 Northridge Eq.
(M.O. Eberhard)

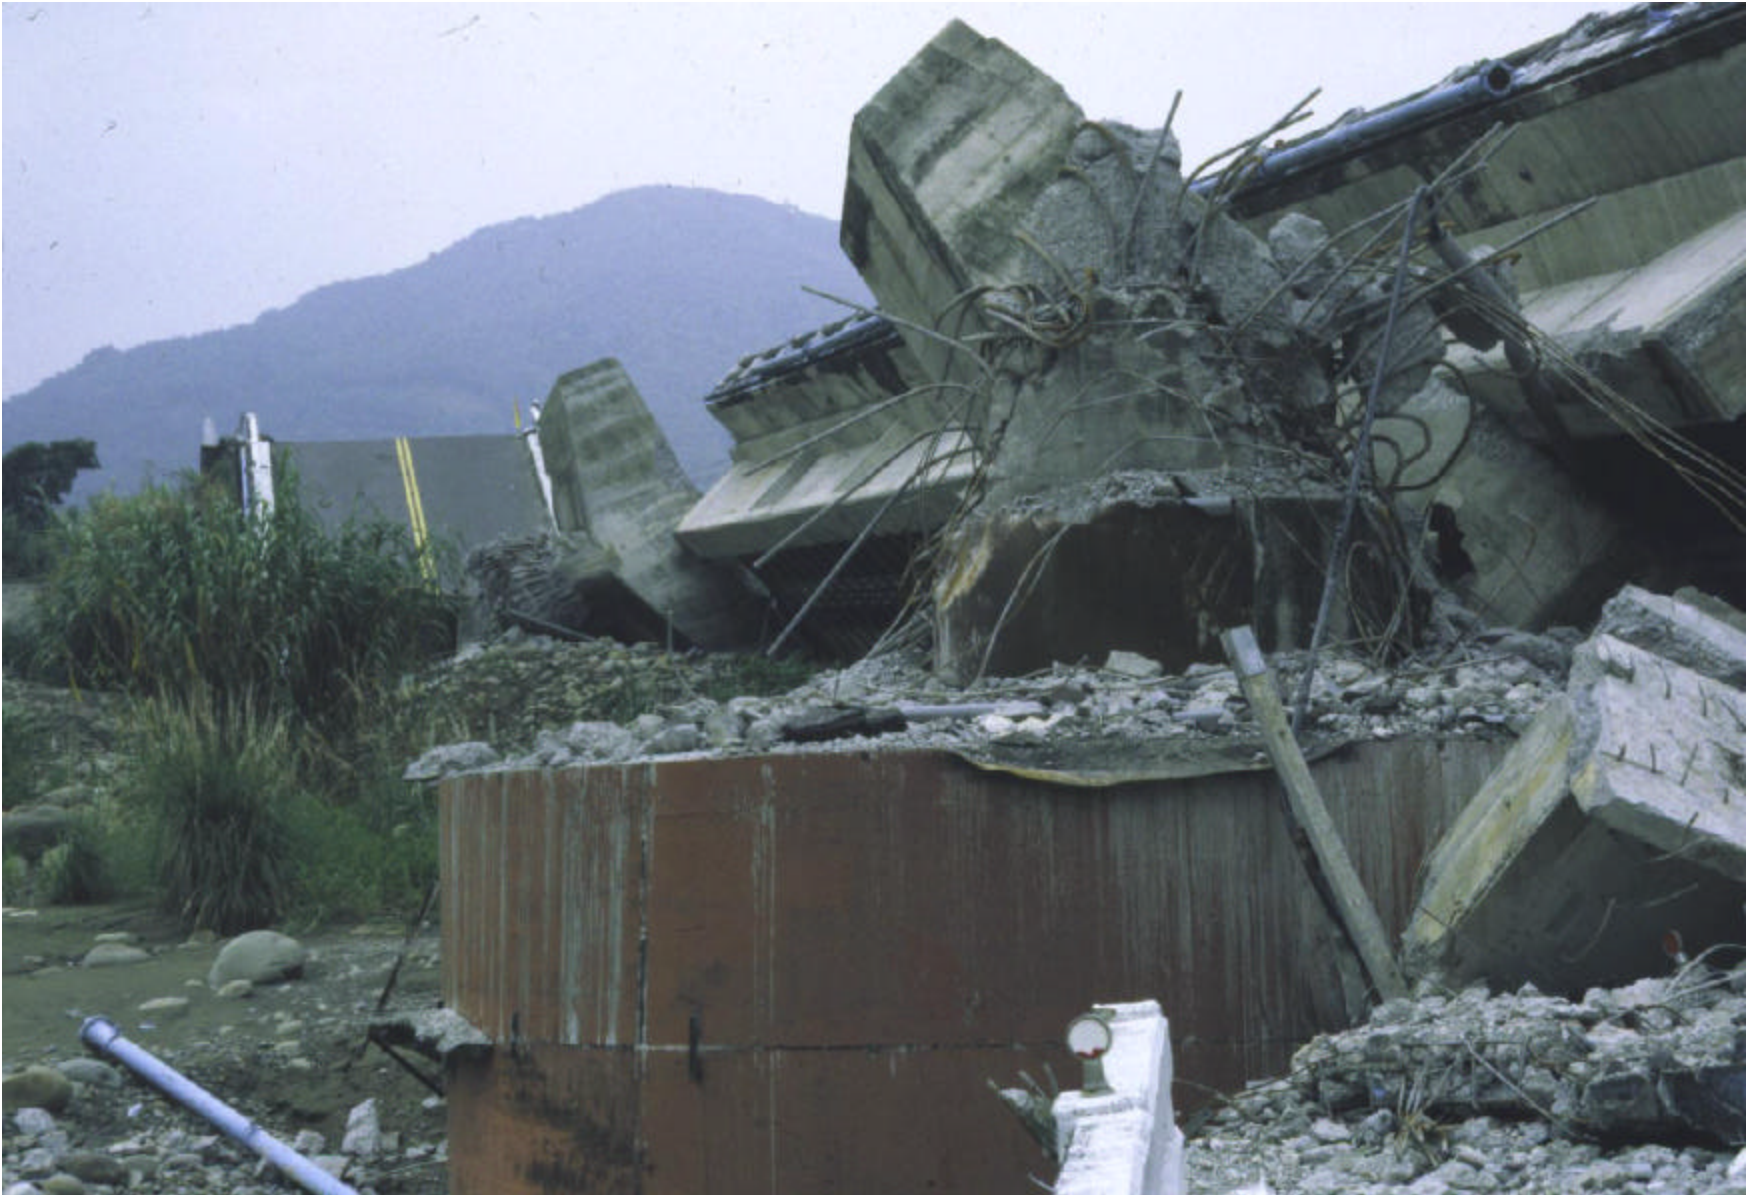
Columns: Shear Failure

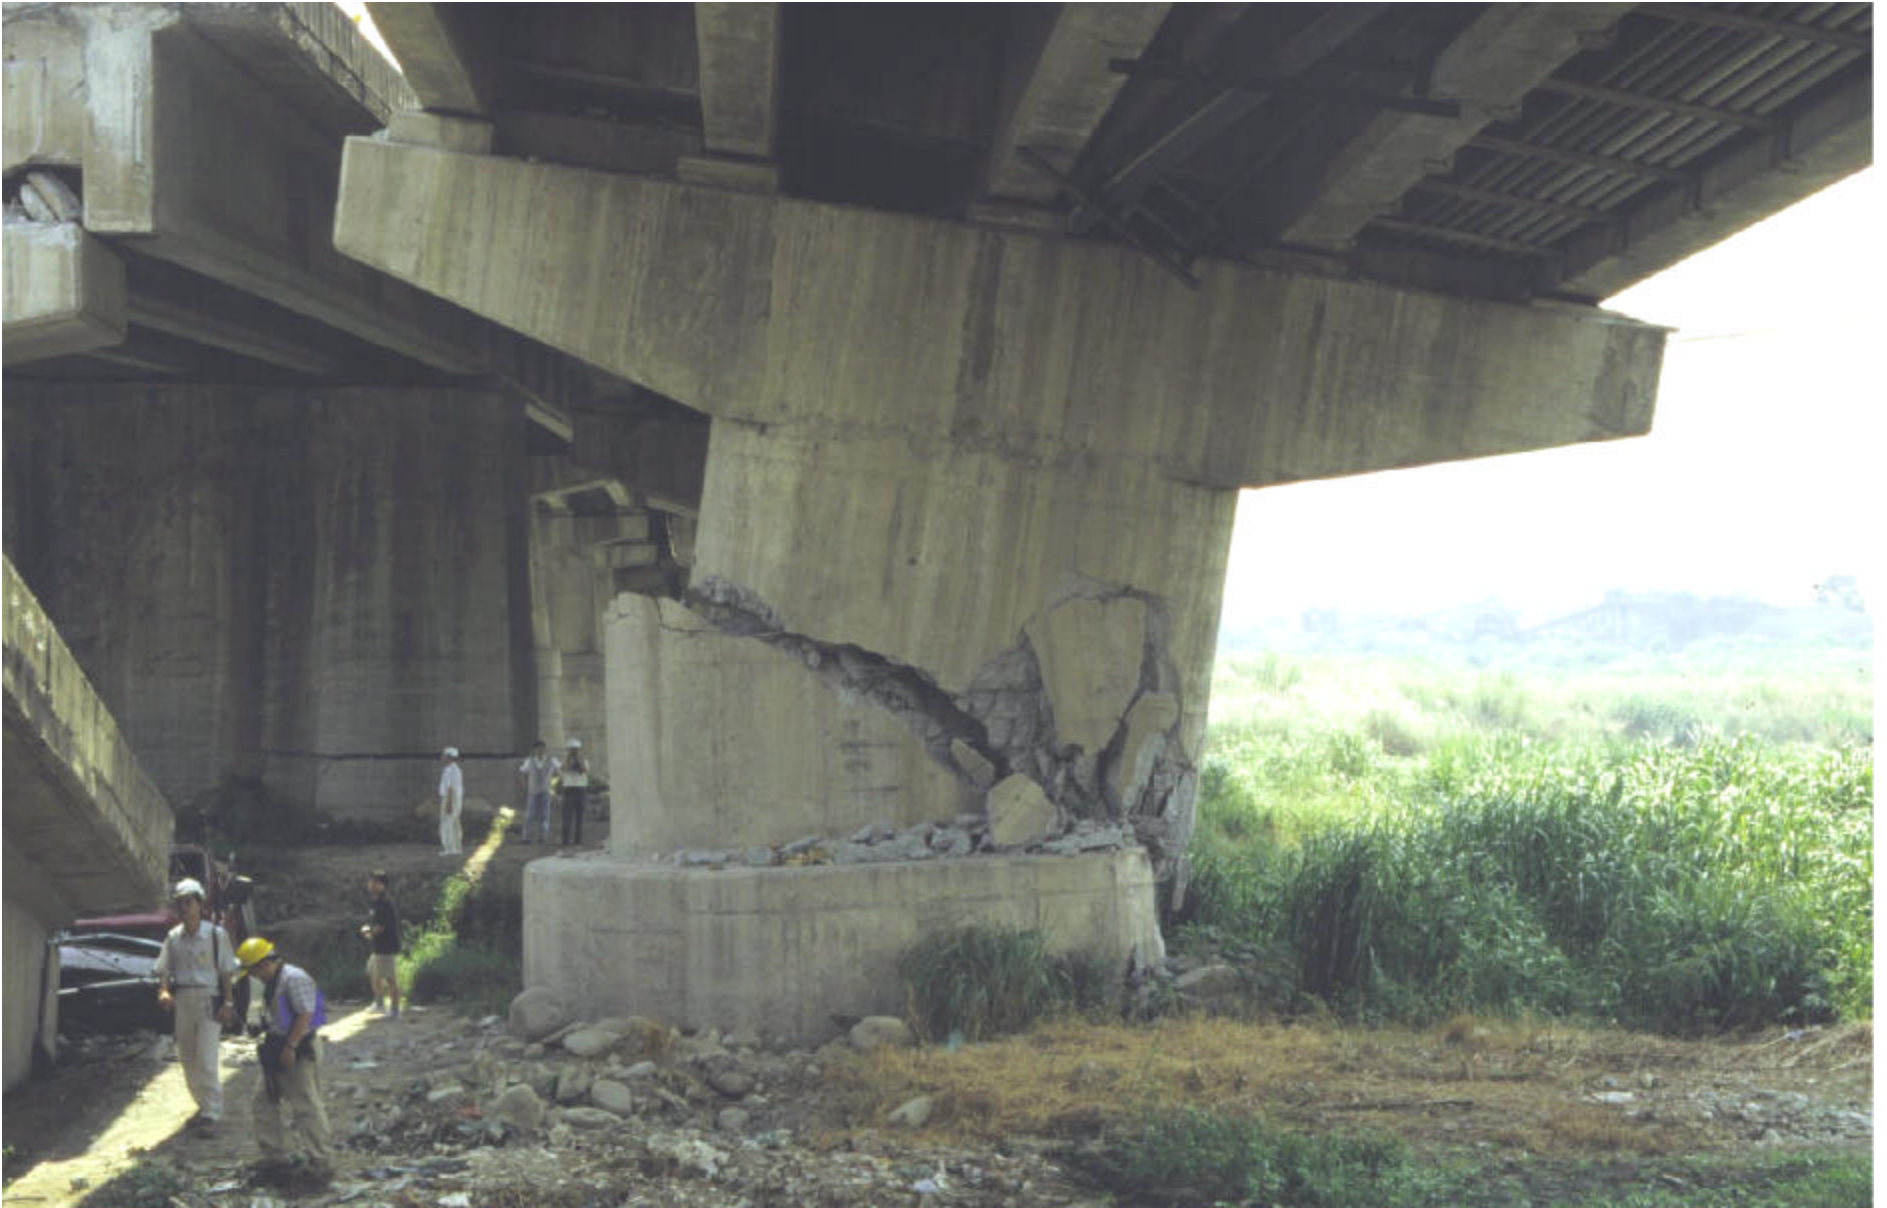
Piers: Shear Failure

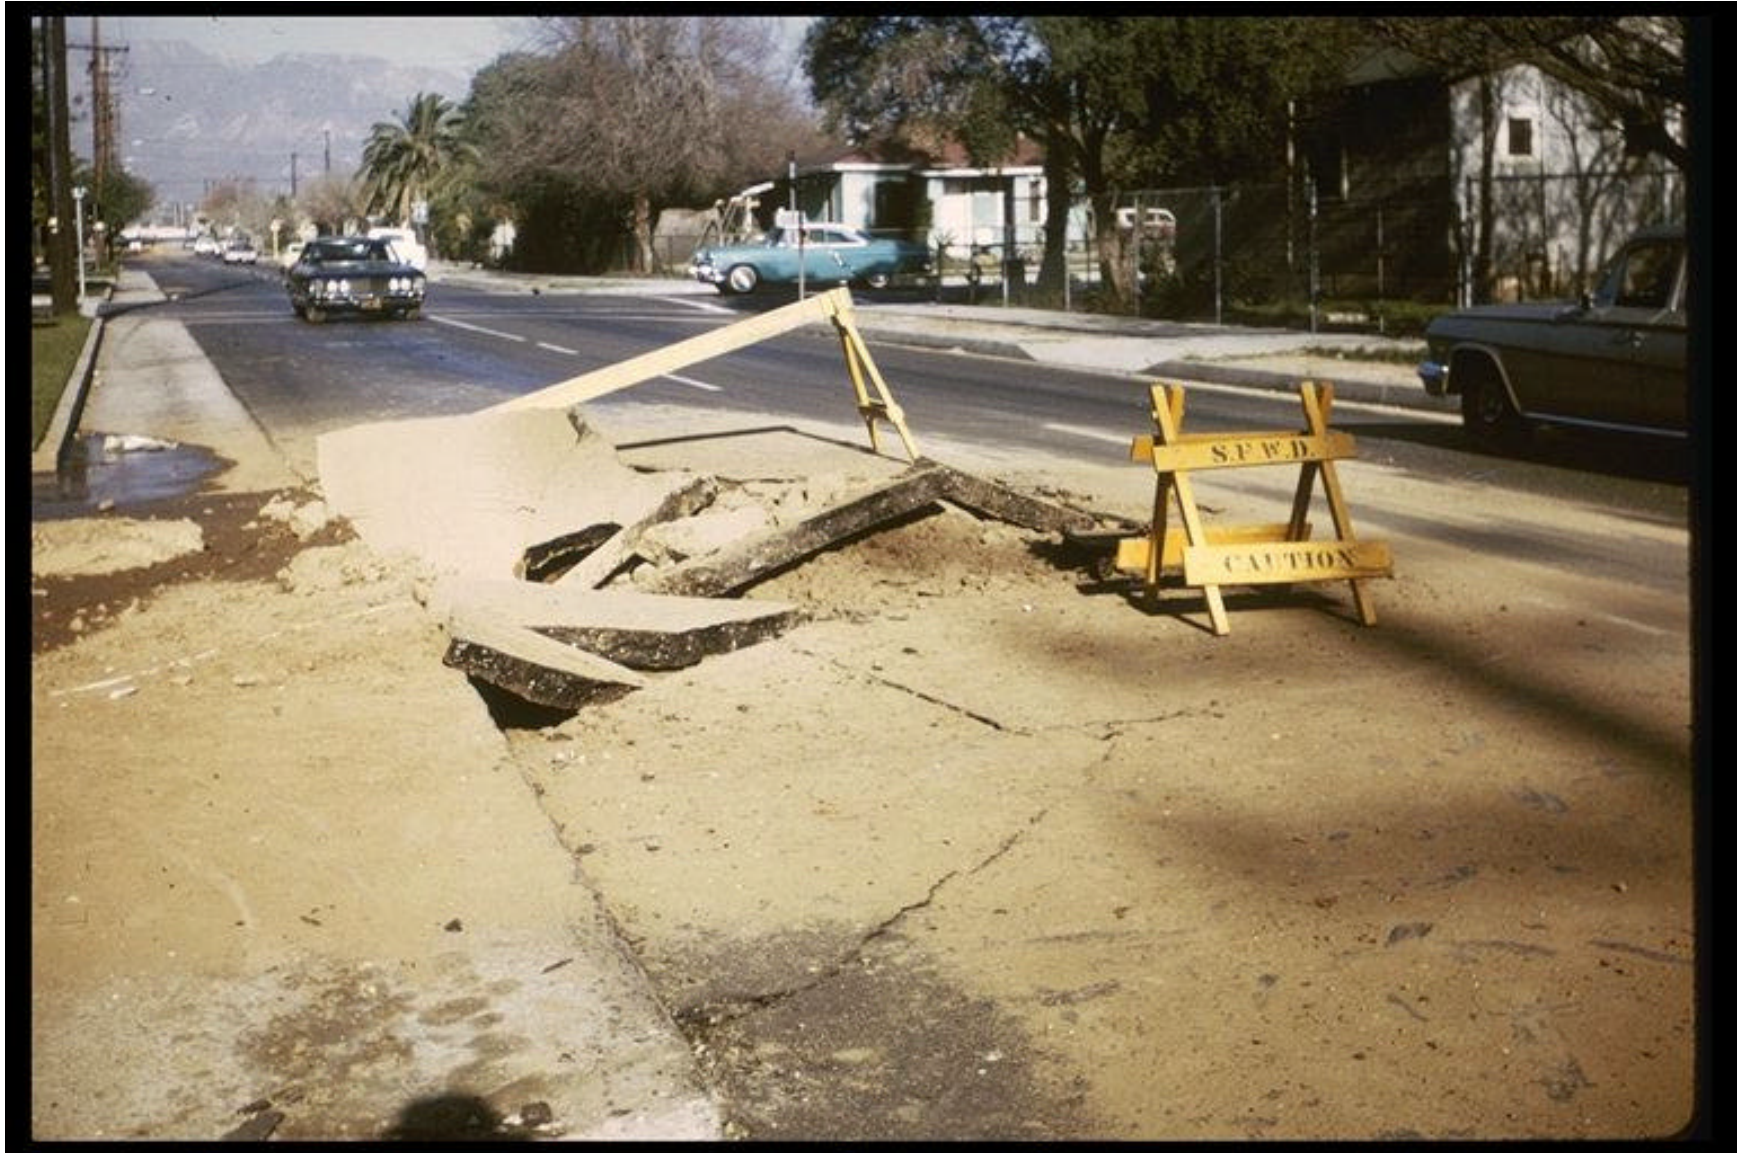
Roadways: (pipe failure)

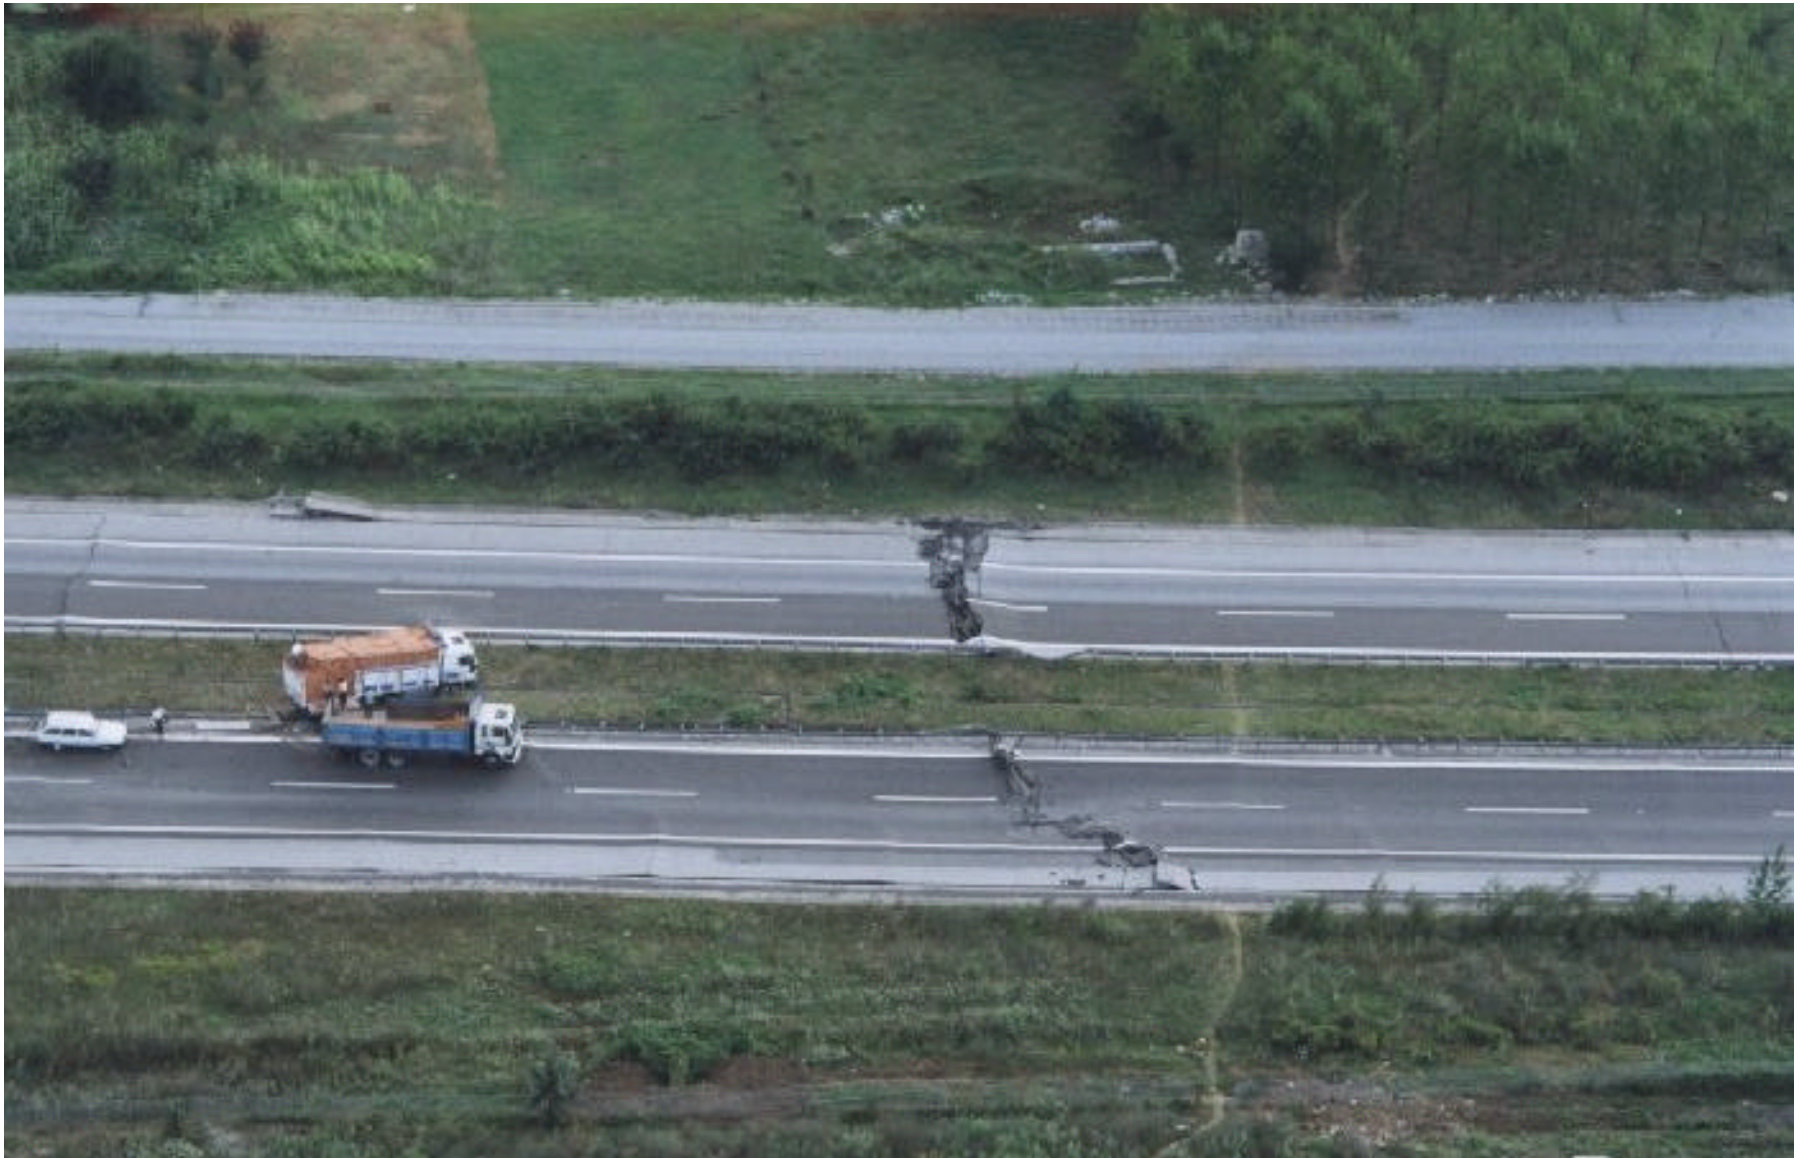
Roadways: (Surface Rupture)

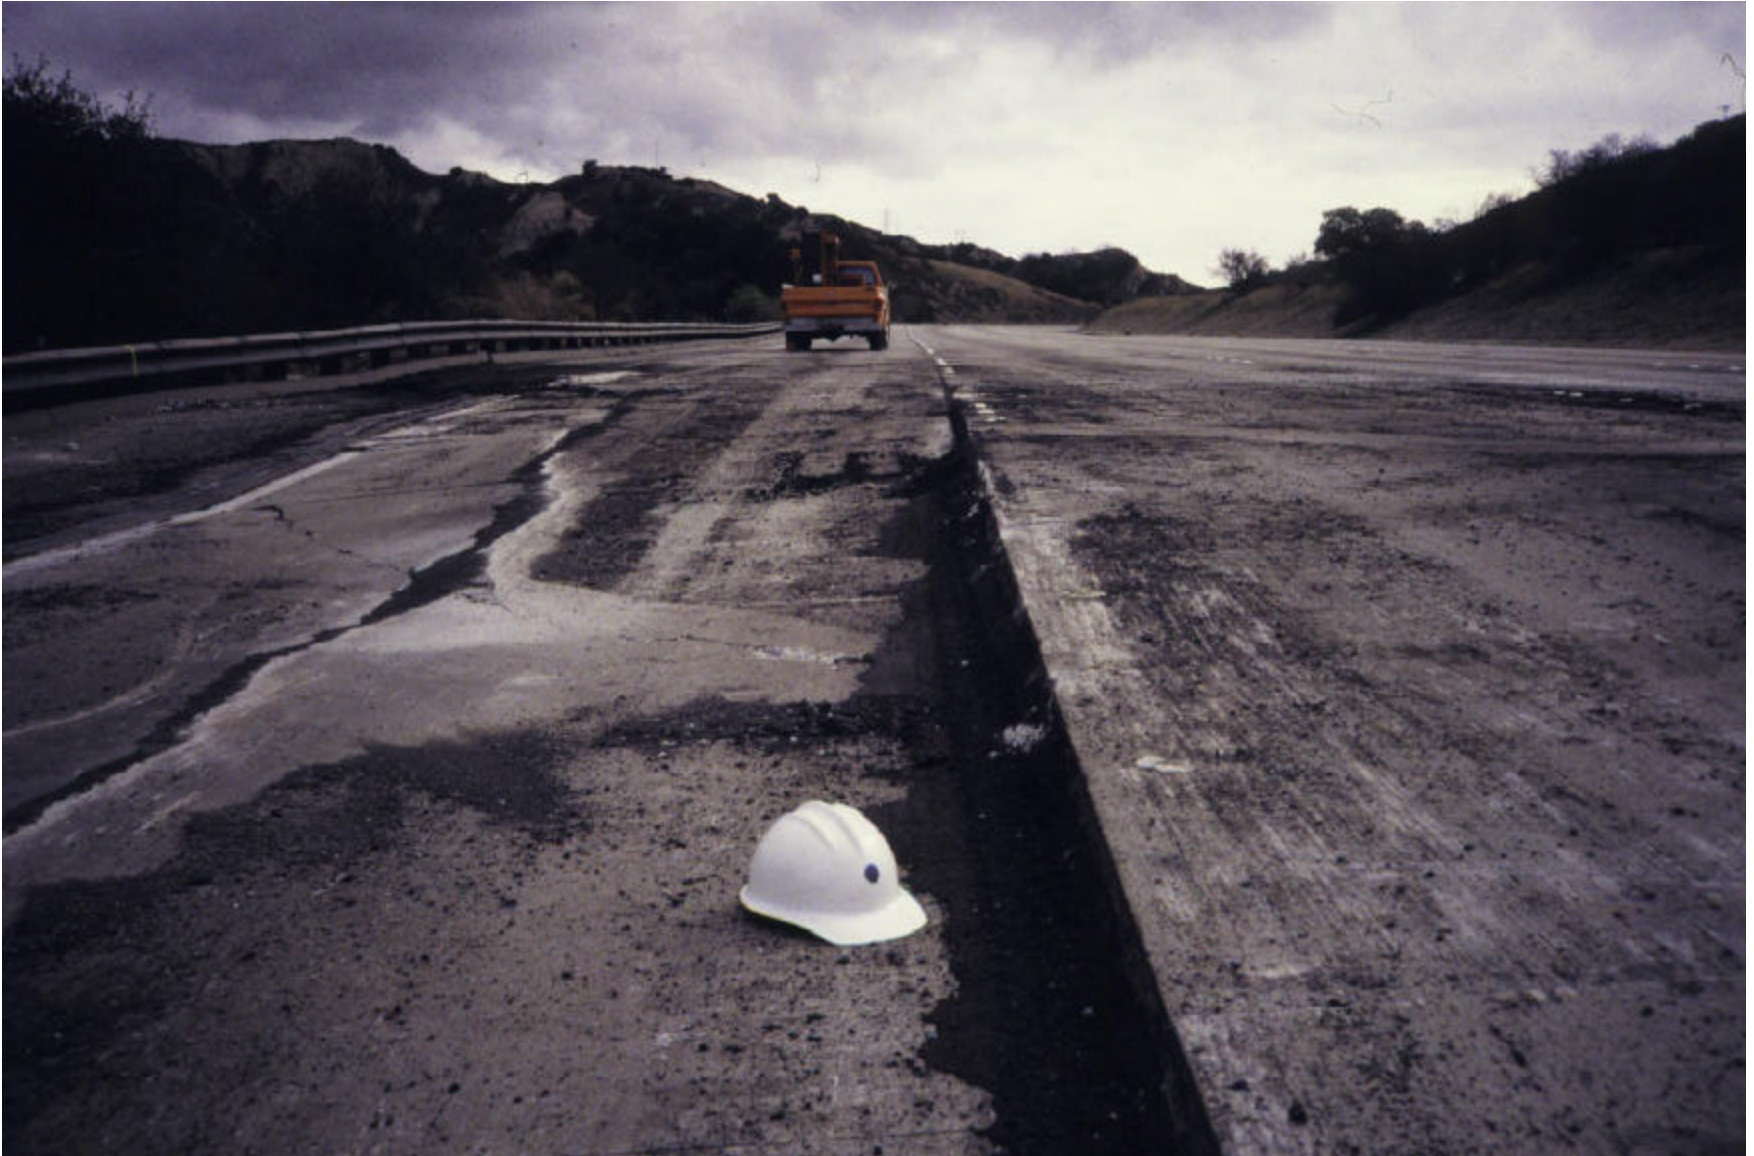
Roadways: (Landslide)

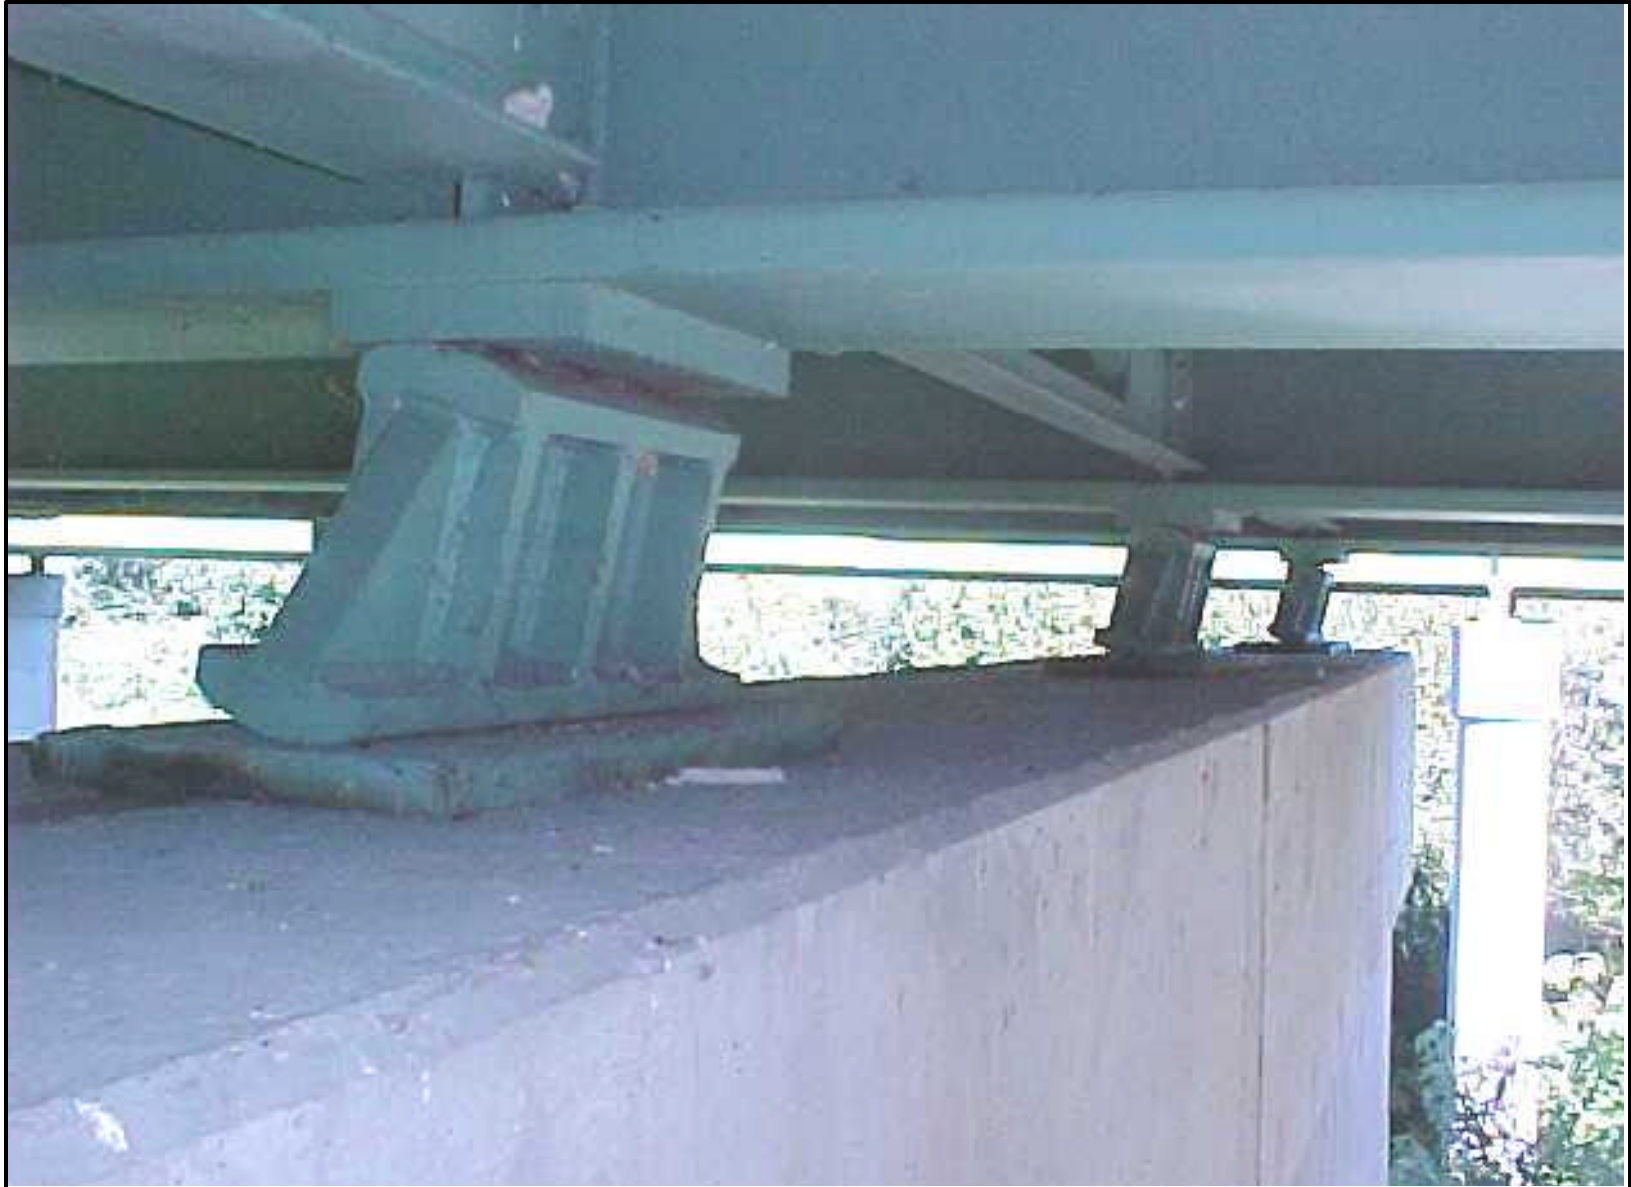
Jacking (Courtesy of INDOT)
